Revista ALCONPAT

Service life evaluation in concrete rehabilitation – a sustainability benefit.

P. C. Stivaros¹*

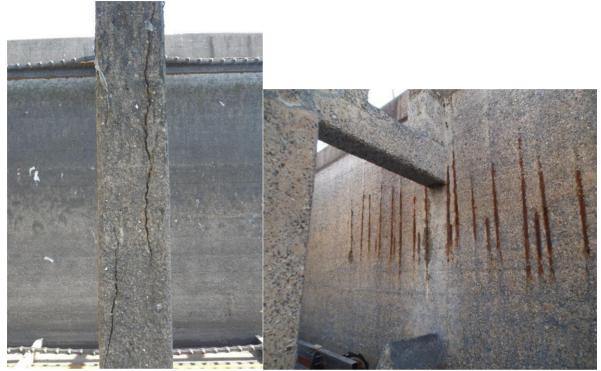
Figure 1. Cracked and spalled concrete columns and repairs. Exposed corroded reinforcing steel bars.

The visual observations were performed in accordance with ACI 201.1R (2008). Observed conditions included: cracks, spalls, exposed aggregates and surface erosion, exposed reinforcement, reinforcement corrosion, and damaged expansion joints. Based on the visual observations, a detailed evaluation program was developed that included nondestructive testing and laboratory testing of concrete samples. Typical defects identified and repairs are illustrated in Figure 1.

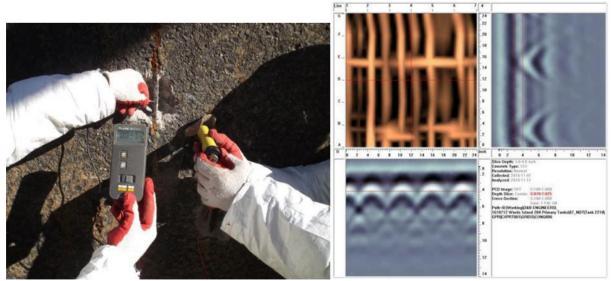
Figure 2. Half-Cell Testing: Measurement of corrosion potentials. GPR: Identify internal faults and rebar location.

Visual observations provide information on readily visible damage only. Hidden damage within the concrete may be identified using nondestructive testing methods, as well as destructive probing. Nondestructive testing was performed at selected locations to confirm the soundness of the concrete, identify internal faults, identify potential reinforcement corrosion, and detect location and depth of reinforcement. Nondestructive testing methods included: steel cover testing, ground penetrating radar (GPR) testing, impact-echo, impulse response, and half-cell to measure the corrosion potentials. Description of nondestructive methods is provided in ACI 228.2R (2013). Photographs of nondestructive testing are illustrated in Figure 2. Summary of nondestructive testing includes:

- Steel cover and GPR testing indicated that the steel reinforcement was located at depths ranging from exposed to as deep as 75 mm, with most of the bars being located at 35 mm to 50 mm from the surface. The design steel bar cover was 50 mm.

- The impact-echo and impulse response testing indicated no significant structural deficiency of the tanks. The tank walls were solid without widespread structural faults and weaknesses. However, the testing indicated that there were scattered areas with localized defects such as shallow delaminations, honeycombing, and voids throughout the concrete tanks. These defects were mostly identified at the locations of exposed corroded steel bars, at crack locations and along the expansion joints.

- The half-cell testing indicated a high probability of ongoing corrosion at the vicinity of the exposed corroded steel bars. The corrosion activity diminishes away from the exposed steel bars. No widespread corrosion activity was detected.

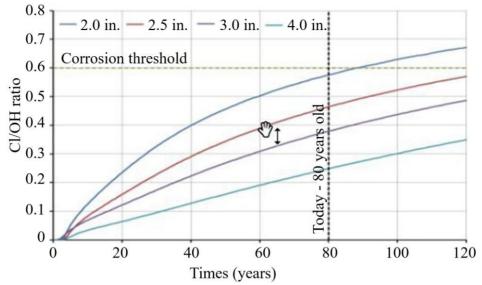
Figure 3. Evolution of Chloride/Hydroxide ratio over time and expected corrosion initiation of steel at different depts with minimal repairs to preserve concrete as it is.

Results of the simulations are shown in Figures 3 and 4. The simulation results indicated that the chloride contaminants could reach at 50 mm depth and cause the reinforcing steel to corrode in approximately seven to ten years. Steel bars located close to the surface in less than 50 mm will start corroding in much less time. For bars located in more than 75 mm depth, the chlorides will require 20 to 40 years before they affect the steel bars. When a protective mortar layer and epoxy coating was introduced into the simulation, the time for corrosion initiation of rebars increased to well beyond 40 years.

In summary, the results of service life simulations indicate that if the concrete is just patched and cracks filled, the corrosion initiation of the reinforcement will likely begin within few years. The simulation suggests that a repair which removes the damaged concrete, replaces it with dense mortar, and seals with a protective coating will likely protect the reinforcement from corrosion well beyond another 40 years, thus increasing the service life of the structures and minimizing their environmental impact.

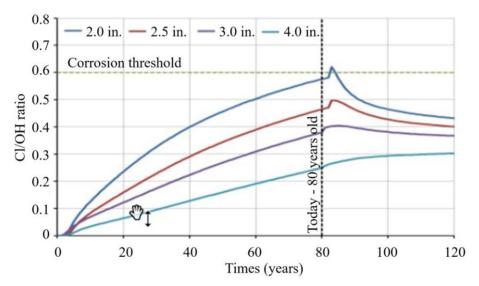
Figure 4. Evolution of Chloride/Hydroxide ratio over time and expected corrosion initiation of steel at different depts using robust repair strategy.
