Service life evaluation in concrete rehabilitation – a sustainability benefit.

P. C. Stivaros[1]*
*Contact author: pstivaros@geiconsultants.com
DOI: https://doi.org/10.21041/ra.v15i2.814

7. CASE STUDY: STRUCTURAL EVALUATION AND REPAIR OF ENVIRONMENTAL STRUCTURES

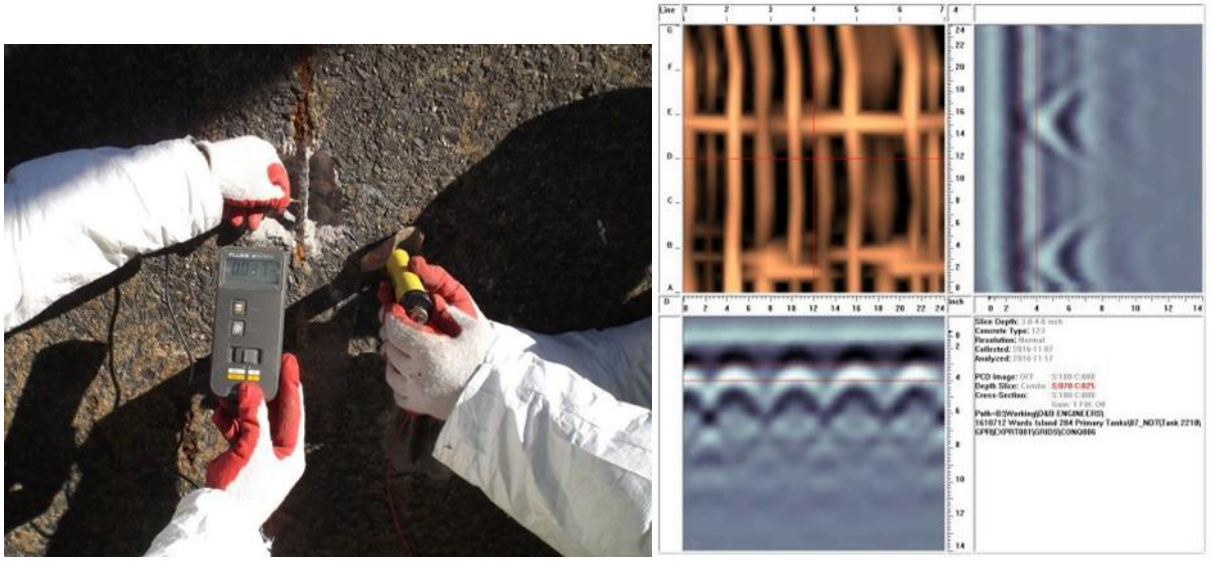
The visual observations were performed in accordance with ACI 201.1R (2008). Observed conditions included: cracks, spalls, exposed aggregates and surface erosion, exposed reinforcement, reinforcement corrosion, and damaged expansion joints. Based on the visual observations, a detailed evaluation program was developed that included nondestructive testing and laboratory testing of concrete samples. Typical defects identified and repairs are illustrated in Figure 1.

Figure 1. Cracked and spalled concrete columns and repairs. Exposed corroded reinforcing steel bars.

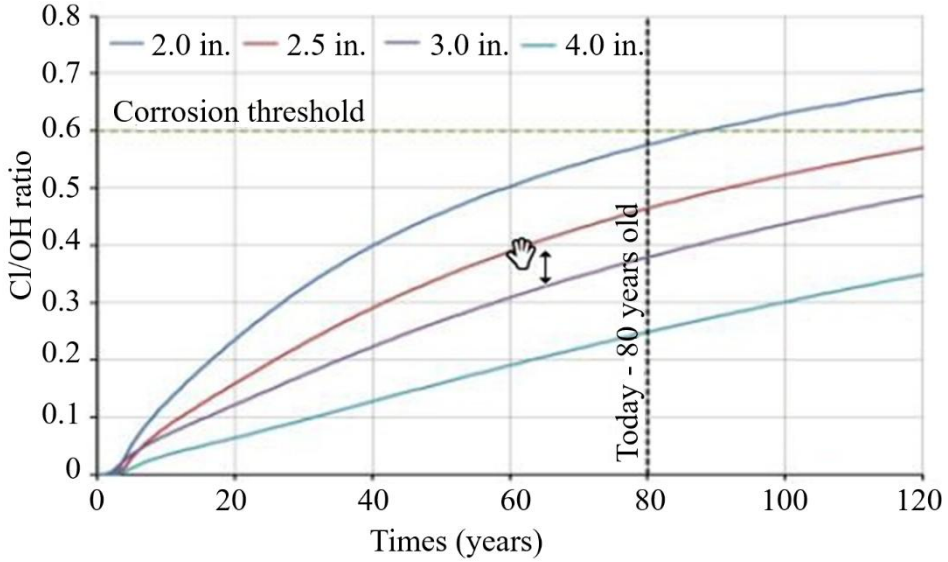
Results of the simulations are shown in Figures 3 and 4. The simulation results indicated that the chloride contaminants could reach at 50 mm depth and cause the reinforcing steel to corrode in approximately seven to ten years. Steel bars located close to the surface in less than 50 mm will start corroding in much less time. For bars located in more than 75 mm depth, the chlorides will require 20 to 40 years before they affect the steel bars. When a protective mortar layer and epoxy coating was introduced into the simulation, the time for corrosion initiation of rebars increased to well beyond 40 years.

Figure 3. Evolution of Chloride/Hydroxide ratio over time and expected corrosion initiation of steel at different depts with minimal repairs to preserve concrete as it is.

a. Perform the minimum required repairs, including repair of cracks, spalls, expansion joints, and corroded rebars.
b. Perform the minimum required repairs as in Item (a), apply a 12 mm thick cementitious silica fume mortar, and apply a protective epoxy coating on all tank surfaces.

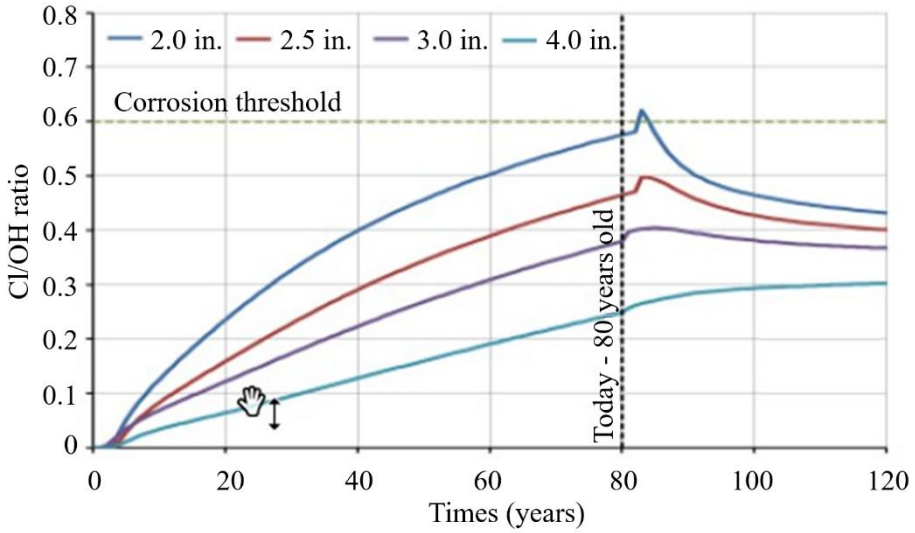
In summary, the results of service life simulations indicate that if the concrete is just patched and cracks filled, the corrosion initiation of the reinforcement will likely begin within few years. The simulation suggests that a repair which removes the damaged concrete, replaces it with dense mortar, and seals with a protective coating will likely protect the reinforcement from corrosion well beyond another 40 years, thus increasing the service life of the structures and minimizing their environmental impact.

Figure 4. Evolution of Chloride/Hydroxide ratio over time and expected corrosion initiation of steel at different depts using robust repair strategy.
