Structural strengthening of a historical building in Rio Branco city – Acre

D. C. S. Amorim¹, D. R. C. Oliveira¹

¹ Civil Engineering Post-graduation Program, Federal University of Para, Brasil.

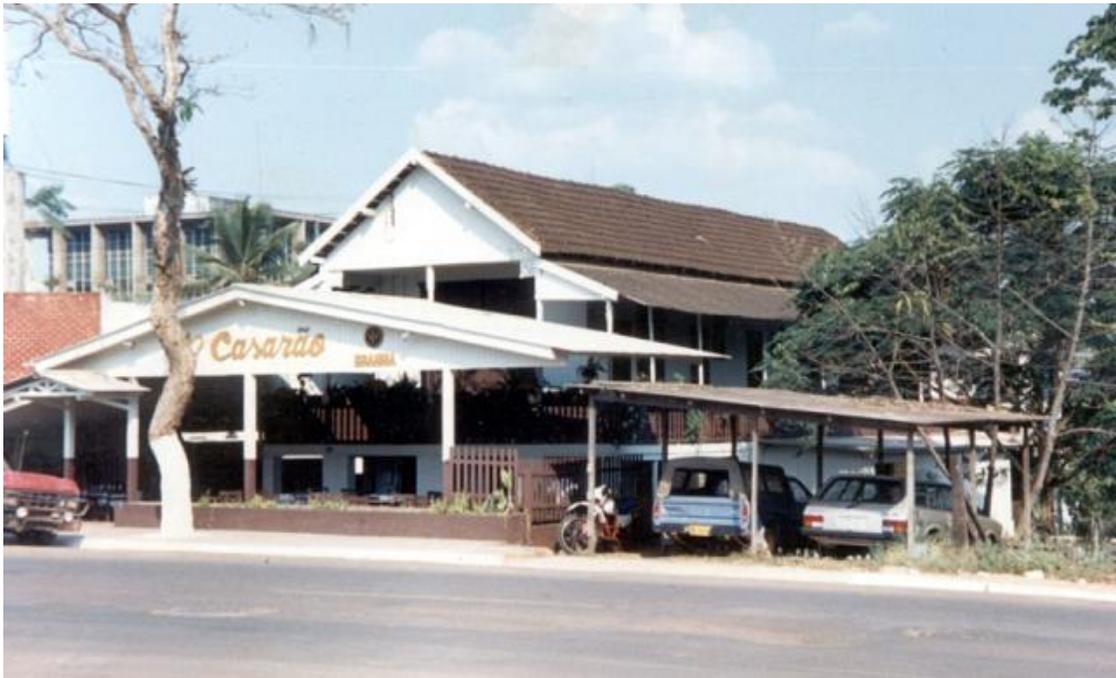
Figure 1. The Casarão.

The "Casarão" (Figure 01), public building built in the 1930s, has mixed structure of reinforced concrete and wood in good condition in its central part, maintaining eclectic Syrian and Lebanese architectural features with European influence, representing a regional style of great cultural importance of the city of Rio Branco, in Acre state. Its revitalization meets a society demand for the state government, which received a petition with hundreds of signatures to this choice. The historic building was listed by the State Board of Historical and Cultural Heritage on August 13, 2009, at the initiative of civil society, and approved on April 30, 2010, by the decree number 5,235, under the protection and supervision of the state government, through the Department of History and Cultural Heritage Foundation of Culture and Communication Elias Mansour.
