## Characterization of failures and estimation of the qualitative seismic vulnerability of two reinforced concrete school buildings located in Falcón State.

The objective of this study was to characterize the structural failures and estimate the qualitative seismic vulnerability of two reinforced concrete school buildings located in Falcón State, Venezuela. The methodology employed included a visual inspection with photographic documentation of failures, environmental classification according to the NTF 4015:2012 standard, and determination of qualitative seismic vulnerability using the FUNVISIS method (Code FUN-002, 2014). The results showed that both schools are exposed to a chloride-corrosive environment (M4). The originality of this study lies in the application of the FUNVISIS method to school buildings in a marine environment. The seismic risk analysis revealed that one school exhibits high vulnerability (P5), while the second showed medium-low vulnerability (P8).

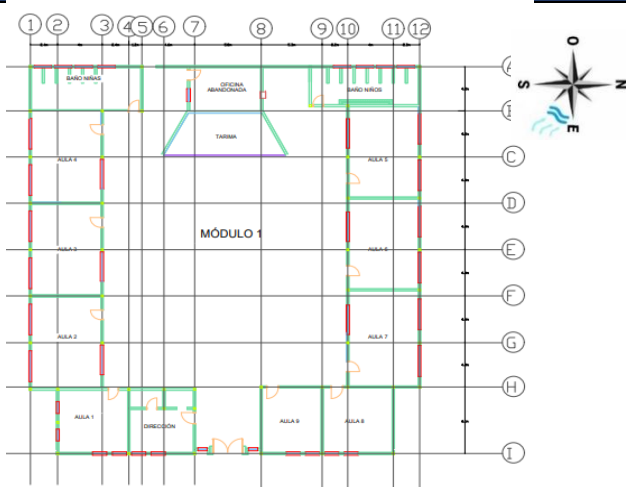
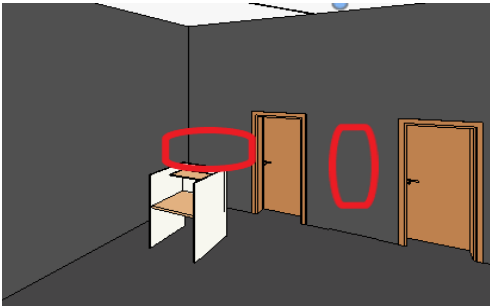
Figure 4. Failure Symptomatology Form. Module 1. 1/3  
Source: Prepared by the authors (Pérez et al., 2022).

| <div style="display: flex; justify-content: space-between; align-items: center;"> <div> <b>FAILURE SYMPTOMATOLOGY FORM</b> </div> </div> | |
|---|---|
| <div style="display: flex; justify-content: space-around;"> <div style="text-align: center;"> <p><b>1</b></p> </div> <div style="text-align: center;"> <p><b>2</b></p> </div> </div> | <p>Moisture, efflorescence, and bulging of the render are observed in the lower third of all enclosure walls in this direction. Detachment of the main coating (paint) is also observed.</p> |
| | <p>It is presumed that the moisture present is due to capillary effects caused by the rise of water contained in the foundations toward the structure through the pores of the slab concrete, the blocks, and the render itself, releasing salts and leaving white stains.</p> <p>In addition, in the specific case of the enclosure wall located between axes H-I and 4-6 (photo 1), there is a possible leak caused by the sanitary installations of the adjacent bathroom.</p> |

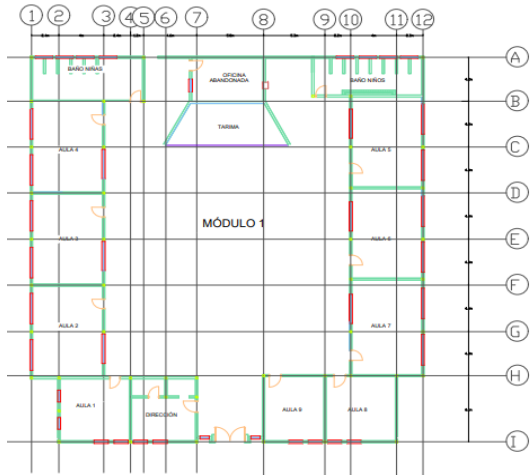
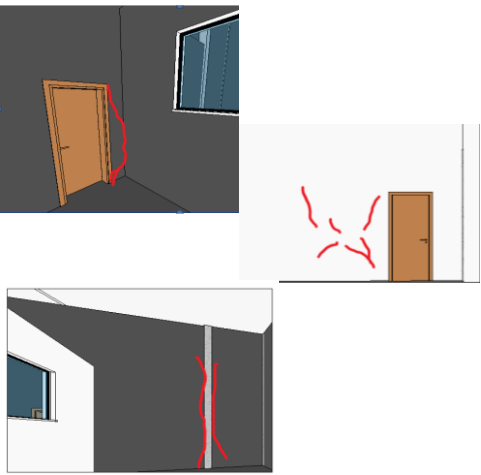
Figure 5. Failure Symptomatology Form. Module 1. 2/3  
Source: Prepared by the authors (Pérez et al., 2022).

| <div style="display: flex; justify-content: space-between; align-items: center;"> <div>FAILURE SYMPTOMATOLOGY FORM</div> </div> | |
|---|---|
| <p>1</p> <p>2</p> <p>3</p> | <p>Concrete bulging is observed, in addition to:</p> <ol style="list-style-type: none"> <li>1. Crack in the external enclosure wall of classroom 1, marked in red, located on axis H between axes 3-4. The crack starts at the upper left corner of the door frame, with a length of 1.24 m and a thickness of 0.05-0.70-0.80mm down to the yellow coating. It continues to the lower edge of the door frame with a length of 1.31m and a thickness &gt; 2mm.</li> <li>2. Cracks in the enclosure wall on axis H between axes 1-4, marked in red, on both the classroom 1 side and the classroom 2 side. In classroom 2, two cracks are visible: one located in the central third of the enclosure wall, 0.70 m long and more than 2mm thick. The second begins at the top of the enclosure wall with a length of 2.52 m and thicknesses of 0.10-0.08-0.60-0.50-0.30-1.50mm.</li> <li>3. Various cracks and fissures, marked in red, on the internal enclosure wall of classroom 1, located on axis H between axes 3-4.</li> </ol> |
| | It is presumed that the "X"-shaped cracks originated from the seismic movements that occurred in 2009. |

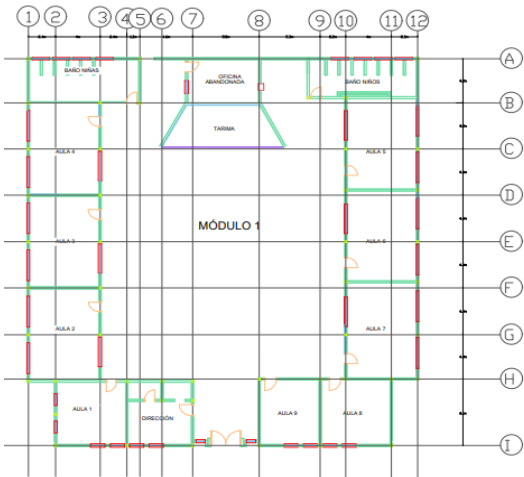
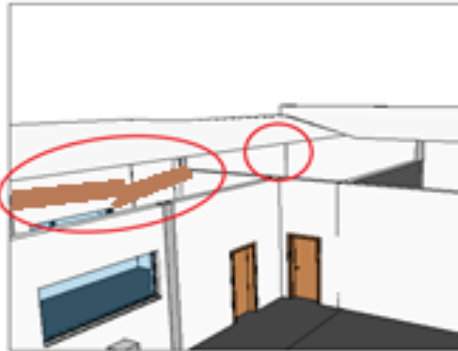
Figure 6. Failure Symptomatology Form. Module 1. 3/3  
Source: Prepared by the authors (Pérez et al., 2022).

| <div style="display: flex; justify-content: space-between; align-items: center;"> <div> <b>FAILURE SYMPTOMATOLOGY FORM</b> </div> </div> | |
|---|---|
| <div style="display: flex; justify-content: space-around;"> <div style="text-align: center;"> <b>1</b><br/> </div> <div style="text-align: center;"> <b>2</b><br/> </div> </div> <div style="display: flex; justify-content: space-around; margin-top: 20px;"> <div style="text-align: center;"> <b>3</b><br/> </div> <div style="text-align: center;"> <b>4</b><br/> </div> </div> | <p>The following is observed on all the tongue-and-groove roofs of the classrooms in Module 1:</p> <ul style="list-style-type: none"> <li>-Moisture stains across the entire roof covering</li> <li>-Detachment of the wooden roof purlins</li> <li>-Rust stains on the metal roof purlins</li> <li>-Loose electrical cables, without protection or covering</li> </ul> <p>On the roof of classroom 7 (photo 4), breaks are observed in the wooden roof purlins. The ceiling support structure also shows detachment, and rust stains are visible.</p> |

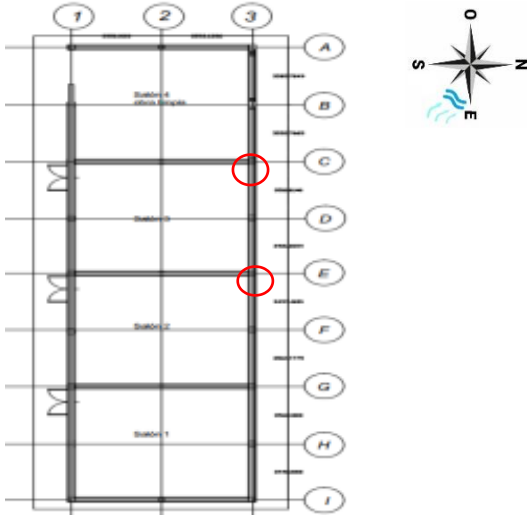
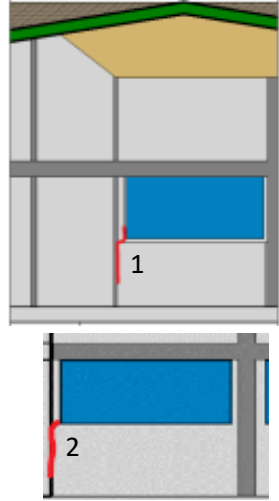
| <div style="display: flex; justify-content: space-between; align-items: center;"> <div style="text-align: center;"> <h2>FAILURE SYMPTOMATOLOGY FORM</h2> </div> </div> | |
|---|---|
| <div style="text-align: center;">1</div> <div style="text-align: center;">2</div> | <p>1. A vertical crack is observed on axis 3, between axes C-D, in classroom 2, module 4. The crack has widths of 0.70 mm at the top, 0.30 mm in the middle and lower sections. The length is 0.74 m.</p> <p>2. A vertical crack is observed on axis 3, between axes G-H, in classroom 3, module 4. The crack has widths of 0.50 mm at the top, 0.10 mm in the middle and lower sections. The length is 0.98 m.</p> |

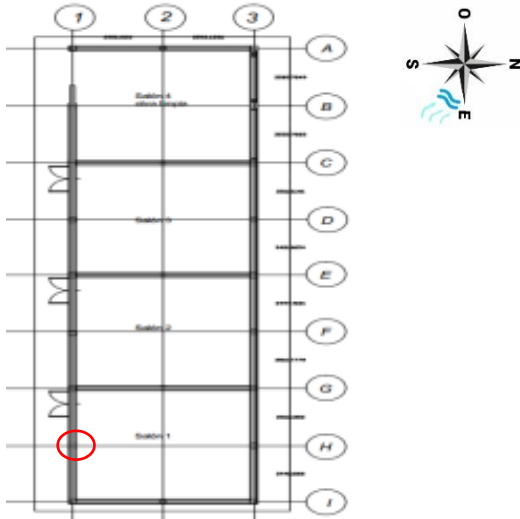
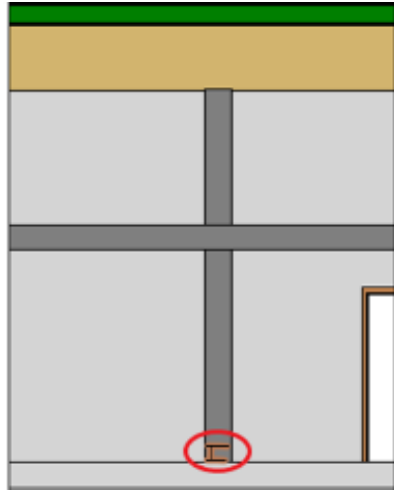
| <b>FAILURE SYMPTOMATOLOGY FORM</b> | |
|---|---|
| | <p>Concrete spalling and exposed reinforcing steel are observed in the column located on Axis 1-H in classroom 1, module 4. The classroom was not accessible; photos taken from the window. The approximate area of exposed steel is <math>0.40\text{m} \times 0.15\text{m} = 0.06\text{m}^2</math></p> |

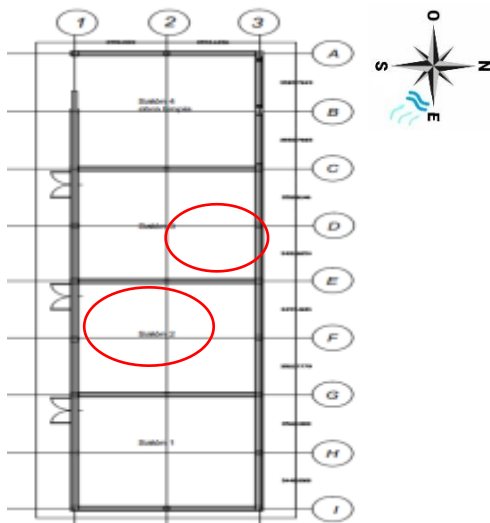
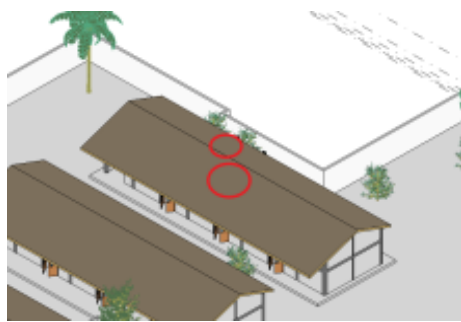
| <div style="display: flex; justify-content: space-between; align-items: center;"> <h2 style="margin: 0;">FAILURE SYMPTOMATOLOGY FORM</h2> </div> | |
|---|---|
| | <p><b>1.</b> Moisture staining is observed on the interior of the tongue-and-groove roof of classroom 3, module 4, located on axes 1-2 between axes C-D.</p> <p><b>2.</b> A black moisture stain is observed on the interior of the tongue-and-groove roof of classroom 2, module 4, located between axes F-G and 2-3.</p> |
