## Potential of thermographic analysis to evaluate pathological manifestations in façade cladding systems

O. T. Takeda<sup>1</sup>, W. Mazer\*<sup>1</sup>

DOI: <http://dx.doi.org/10.21041/ra.v8i1.181>

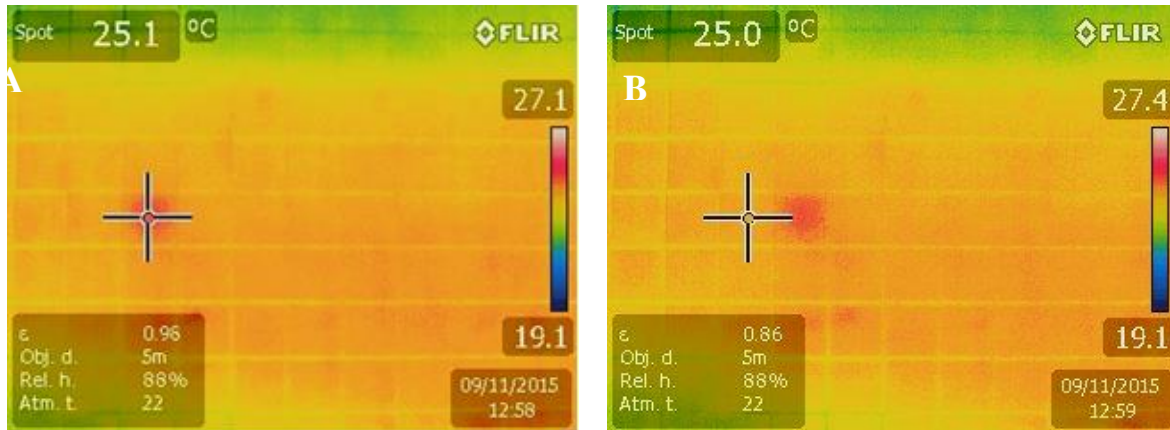
Figure 4. Ceramic cladding emissivity determination.

The test consisted in measuring the surface temperature of the insulation tape, thermally stable with the surface indicated by point A, followed by the measurement of temperature in the material region to be analyzed, indicated by point B, modifying the emissivity parameter of the thermal imager until the temperature indicated at point B is equal to the temperature measurement indicated on the insulating tape surface. Figure 4 shows the calibration performed on the thermal imager for a ceramic cladding.
