## Adaptation of a damage map to historical buildings with pathological problems: Case study at the Church of Carmo in Olinda, Pernambuco

In view of the above, this article is the result of a Master's research project in progress and presents the processes of drawing a damage map based on the methodologies adopted by IPHAN, seeking to implement them in a real case study on the façades of the Carmo Church in the municipality of Olinda, PE.

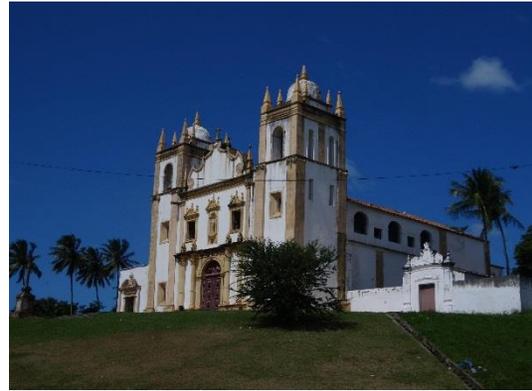
In 1907, the Franciscan convent, which can be observed in Figure 1, was demolished by order of the Olinda prefecture, as it had structural problems that constituted a serious threat to the population and to the Carmo Church itself (Gusmão Filho, 2001). At present, remains of the vestibule of the lobby and of the former convent's foundation can be seen (see Figure 2).

Figure 2. Current Carmo Church: vestiges of the Carmelite convent.  
Source: Authors.
