An approach to the convent of Santa Clara de Asís in Havana. Study of its conservation status and intervention proposals

ABSTRACT

Santa Clara de Asis Convent High Choir timber truss has been victim of humidity and attack of abiotic and biotic agents which have caused its gradual degradation. For the identification of pathological processes associated with these agents and because of its patrimonial character, a diagnosis study based on an organoleptic inspection and superficial tests was carried out with the available instruments, which allowed identifying the causes. By modeling the structure with SAP 2000 program, we obtained the results that were used to calculate the solutions proposed for the identified pathologies, mainly for the loss of connection between the wall plate and the tie rod beam.

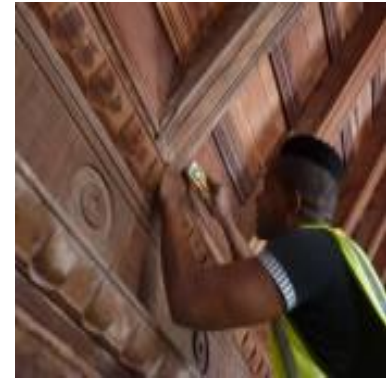
Figure 23. Measurement of superficial humidity on elements.

Values higher than 18% were detected in specific areas. This confirms the presence of humidity due to seepages in the roof which is one of the main causes of damage. Humidity ranging from 18 to 20% and higher than this value creates a favorable environment for the proliferation of fungi from rotteness and other xylophagous organisms which can affect the mechanical properties of wood.

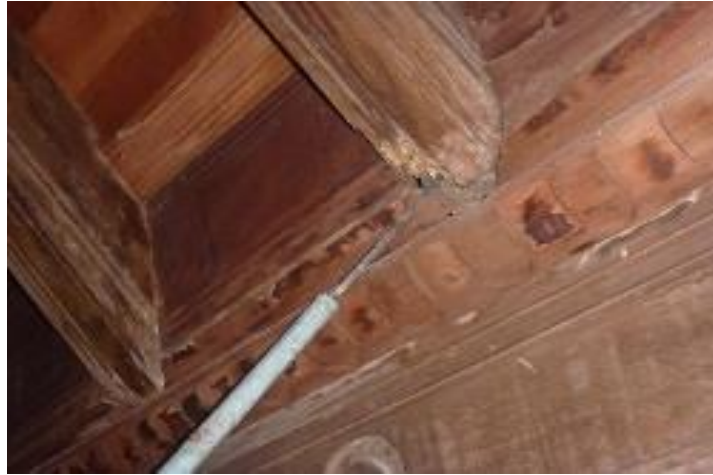
Figure 24. Investigation in wooden elements with graduated punch.

The objective of this test is to determine the state of conservation of the rafters in the area close to the supports, according to the measure obtained from the penetration of a graduated punch, see “Figure 24”. The value depends on the characteristics and the specific hardness of the wooden element being analyzed. When the punch does not penetrate or is superficial, it means that the studied element is in good shape. However, higher values of penetration (from 2-5 cm) are obtained when the elements are rotten and shredded. The result of this test reveals that the commonest identified damages are: shredding in the area of the rafters and angle braces head in the lower part and sides of 70% of the rafters which make up the ceiling gable, as well as other damages like

cracks, putrefaction, splintering and damp patches.

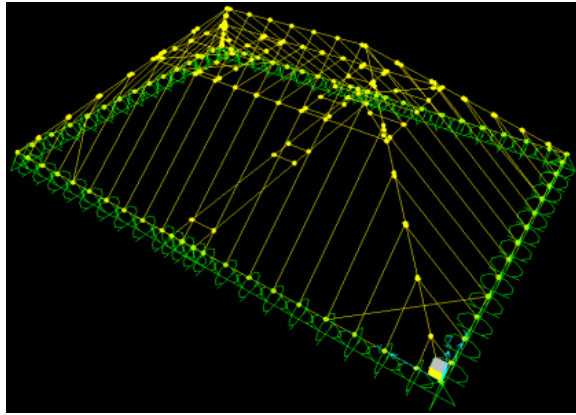
Figure 30. Modeling the structure with the SAP 2000 program.

Results of axial stress modeling in the tie rod beam 1: $NT1=60,15\text{kN}$ and in the tie rod beam 2: $NT2=52,49\text{kN}$, obtained from the less favorable combination.
