## Application of GUT Matrix in the assessment of pathological manifestations in heritage constructions

The present paper presents the application of GUT (Gravity, Urgency, Tendency) Matrix methodology as a tool in the assessment of pathological manifestations in buildings. Three heritage constructions of the historic center of Sobral, Ceará, Brazil were studied through *in situ* inspections, photographic records and elaboration of the damage map. The GUT Matrix was used as a tool to rank, in each building, priority levels for each damage in order to define their order of treatment. Thus, it was possible to conclude that the applied method can be used as a useful tool to manage the maintenance of buildings through prioritization of the most significant problems and, to contribute directly to the preservation and safety of the built historical heritage.

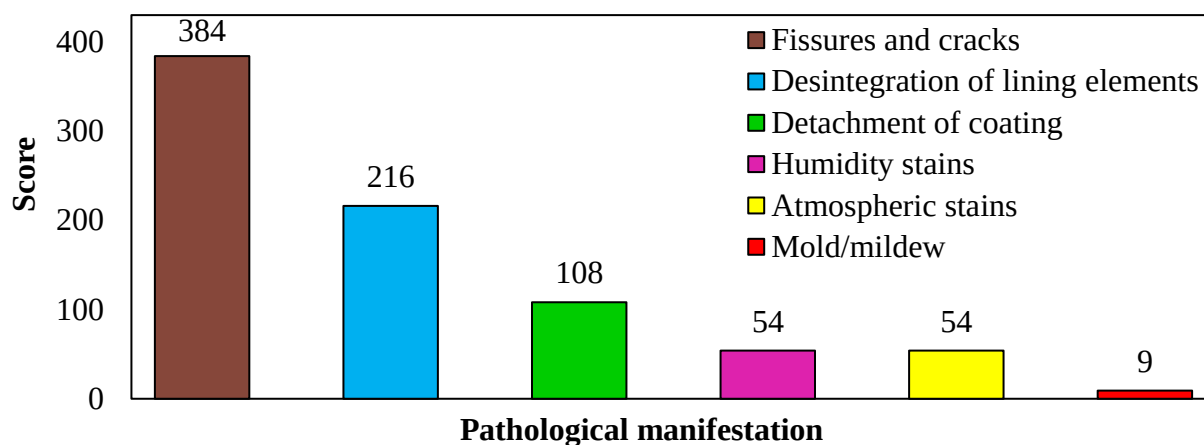
Figure 6. Priority graphic of the Nossa Senhora do Rosário Church.

From the application of the checklist of the GUT Matrix in this building it was possible to elaborate the graph of priorities, which is represented by Figure 6, where it is possible to verify that priority pathological manifestations, that must be treated first, are fissures and cracks, in this case, in the main altar of the church, because it presents the highest scores, 384 scores, and represents a high priority damage, according to the descriptions in Tables 1, 2 and 3 of Section 2.

Second, in the order of priorities, it is the disintegration of lining elements with a total of 216 scores, being framed as an average damage. In the third position are the detachments of coating with 108 scores, being also framed in the degree of average damage. Humidity stains and atmospheric stains, both with 54 scores, are also identified as average damage. The damage with lowest severity, which is in the last position of the order of priorities, is mold /mildew, with 9 scores and low damage.

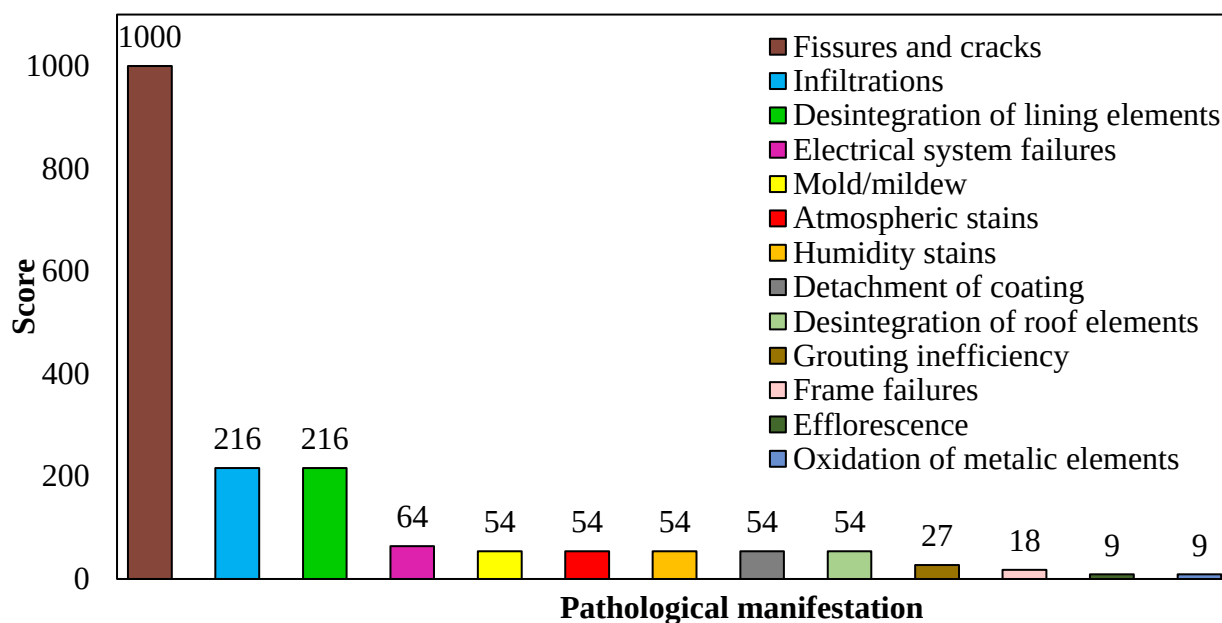
Figure 9. Priority graphic of the Nossa Senhora das Dores Church.

The data obtained from the application of the GUT Matrix in this building were organized in the priority graph shown in Figure 9, where it is verified that the pathological manifestation of highest priority is the crack in the central arch of the main nave, with a total of 1000 scores, which classifies it as a total damage, that is, of extreme gravity, urgency of solution and fast tendency of evolution. In addition, the difference between this damage and the two other (infiltration and disintegration of lining elements, both with 216 scores each) is very high, that corresponds to 784 scores, which show the severity of this crack.

Four pathological manifestations presented the same scores (54 scores): mold/ mildew, atmospheric stains, humidity stains, detachment of coating, which evidences pathological manifestations of average damage. The damages: grouting inefficiency (27 scores), frame failure (18 scores), efflorescence (9 scores) and oxidation of metallic elements (9 scores) correspond to category of low potential damages, the latter two occupying the final position of the order of prioritization. This building presented the largest number of pathological manifestations and this fact is connected to the lack of maintenance of the structure, moreover this church is now interdicted. The existing

damages, if left untreated, can evolve into more severe problems that can seriously compromise the stability and safety of the structure.

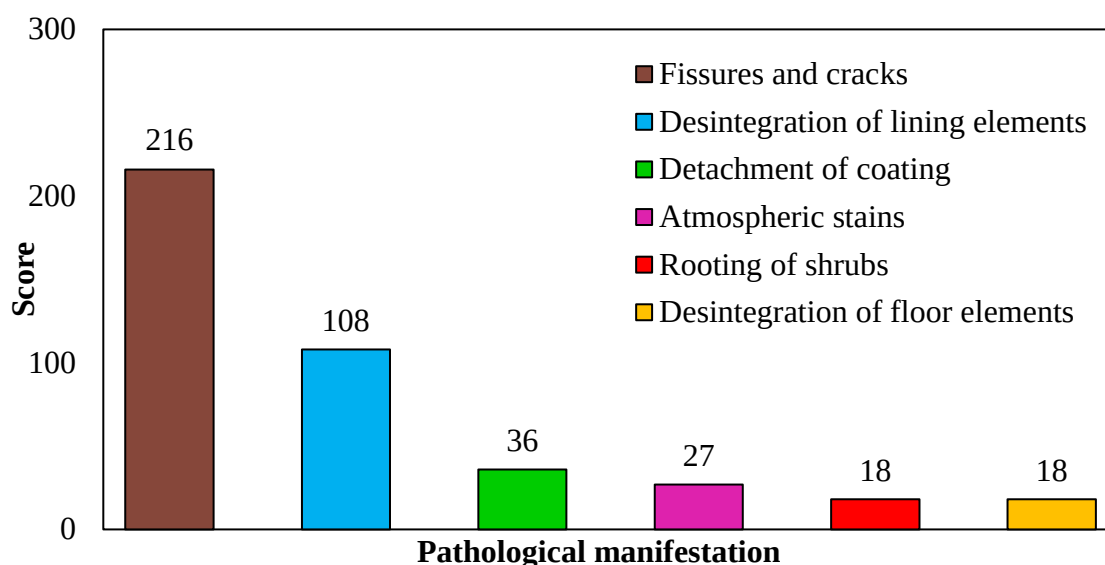
Figure 12. Priority graphic of the Menino Deus Church.

With the results of the checklist of GUT Matrix applied in this building, the graph of priorities was constructed and it is illustrated in Figure 12, where it is verified that the most prioritized pathological manifestation are the fissures, which can be observed in the upper opening of the front facade door (Figure 10) and also in an internal wall of the left lateral facade (Figure 11 (a)). The scores of this anomaly corresponds to 216 and are obtained by applying to the Severity, Urgency and Tendency 6 scores per each one, being therefore an average priority damage. In second position is the detachment of coating that presents a total of 108 scores, being also an average damage. In third and fourth positions are the disaggregation of lining elements and atmospheric stains, with 36 and 27 scores each one, being classified as average and low damage, respectively. In the final positions in the order of priorities, are the rooting of shrubs and the disintegration of floor elements, with 18 scores each, classified as low damage.

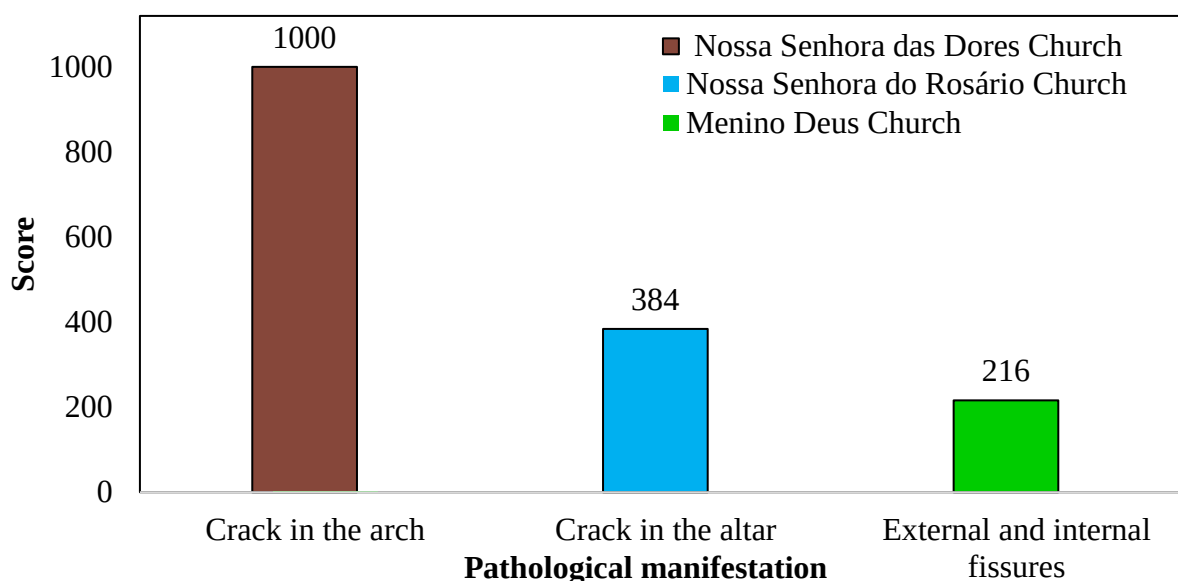
Figure 13. Comparative graphic between the most severe pathological manifestations for each church.

By the comparative analysis of the pathological manifestations listed in first position for each church and having as parameter its total score, among the three buildings studied, the Nossa Senhora das Dores Church presented the most severe damage with a total of 1000 scores for the crack in the central arch of the main nave. The second most severe was the Nossa Senhora do Rosário Church with a total of 384 scores also for a crack in the main altar. And finally, the third most severe damages were the fissures present in the main facade near the opening of the upper window, in the lower part of one of the columns of a tower and in walls of the internal part of the Menino Deus Church with a total of 216 scores. Figure 13 shows the comparison between the most severe damages of these churches.
