Inspection and evaluation of roofing systems: a case study

The roof system of one of the buildings of the University of Brasília - DF is characterized and evaluated. The main existing anomalies in the roof systems are analyzed and the intervention priority is systematized, in order to correlate them with the corrective measures. The limiting factors for the inspection of the structures were accessibility as well as the lack of intervention projects. The results obtained reported that the main anomalies found in the systems are related to the lack of maintenance. The study also brings, as a contribution, indications and technical recommendations for the resolution of situations.

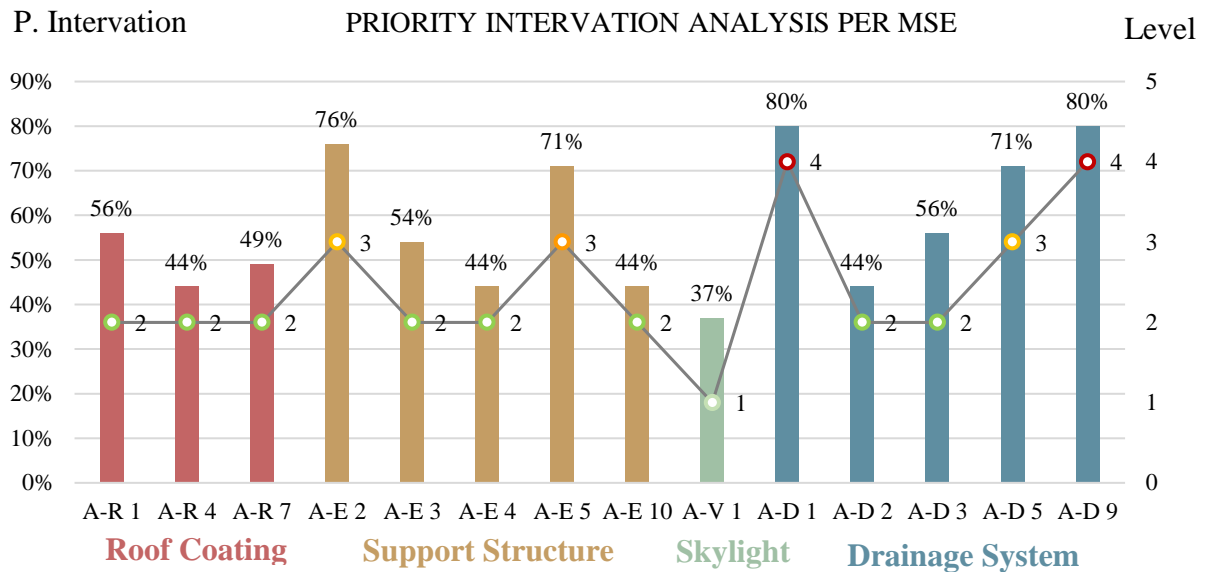
Figure 12. Intervention priority per MSE (Author, 2018).

In addition to the tables and solutions presented, anomalies that obtained higher levels of intervention priority were also analyzed. Figure 12 shows the relative contribution of each anomaly to the total sample of anomalies detected in the flat cover and allows to measure the intervention priority level of the anomalies through the MSE.

It is noticed that the Support Structure and Drainage System obtained the highest Intervention Priority Levels. This means that for levels 3 and 4 found in the MSE resulted in an Intervention Priority in the range of 70% to 80%.

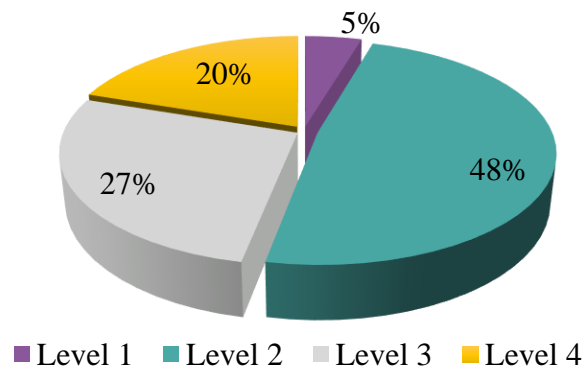
Figure 13. Distribution of priority intervention levels for detected anomalies (Author, 2018).

Figure 13 shows the distribution of intervention priority levels. It is worth noting that level 3 requires short-term actions, and concentrate a total of 27% of the anomalies, while for level 4, with an immediate priority action, a total of 20% was obtained. Thus, the priority intervention given at level 3 and level 4 corresponds to almost 50% of the total observed anomalies, concentrated in cracks, disintegration, surface dirt, and no-drain points.
