## Fire and collapse of the Wilton Paes de Almeida building in São Paulo, Brazil. Lessons learned

P. Helene<sup>1\*</sup>

DOI: <http://dx.doi.org/10.21041/ra.v10i1.419>

The objective of this work was to make a diagnosis that explains the mechanism of collapse, in just 80 minutes, of the Wilton Paes de Almeida building, which was surprising for the engineering of structural concrete. Previous fires, such as that of the Andraus Building, the Joelma and the Great Avenue, withstood more than 4 hours of fire without collapsing and are currently in use. To understand this unusual collapse, an experimental investigation of the characteristics and properties of the concrete and the reinforcement used in that structure was carried out, based on a "hypothetical structural project" that considered the actual characteristics of the materials used. Based on the diagnosis, recommendations were established so that cases like this do not recur.

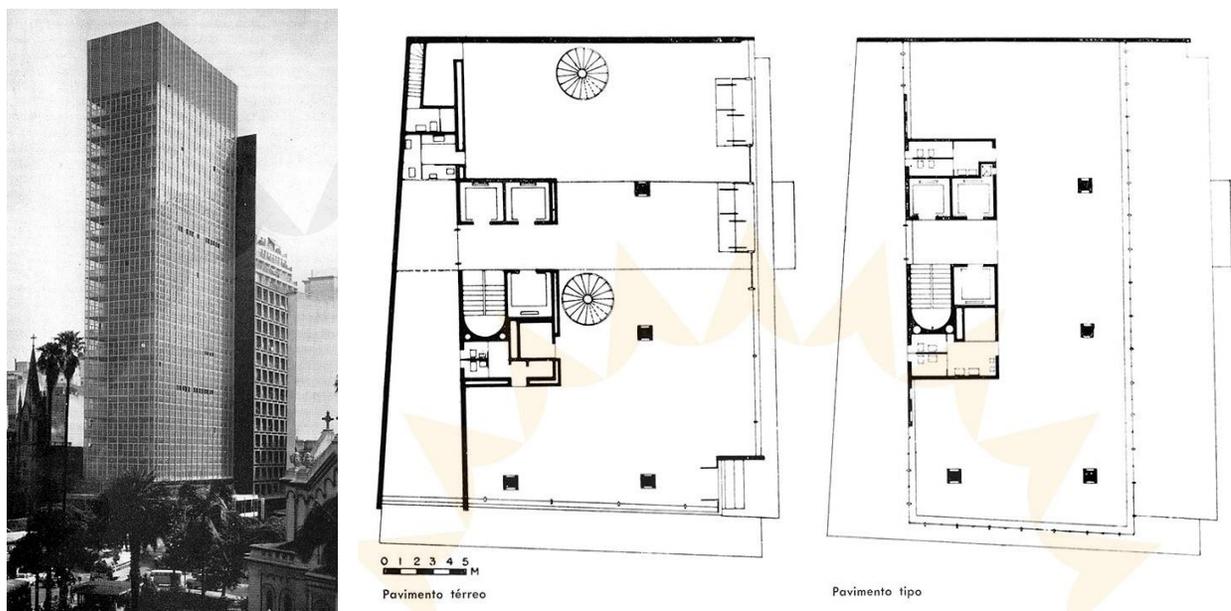
With characteristics of a typical Miesian building, it had a reinforced concrete structure, with only 04 (four) recessed columns with “H” section, supporting a ribbed concrete slab in the central region and a cantilever slab in the periphery (Figure 1). In the facade, the thin thickness of the slabs made possible to use an equally thin aluminum window frame fixing the “glass skin” blades of green glass made by the *Rayban* house.

Figure 1. View of the Wilton Paes de Almeida building and ground floor and typical stories (source: Revista Acrópole, 1965)

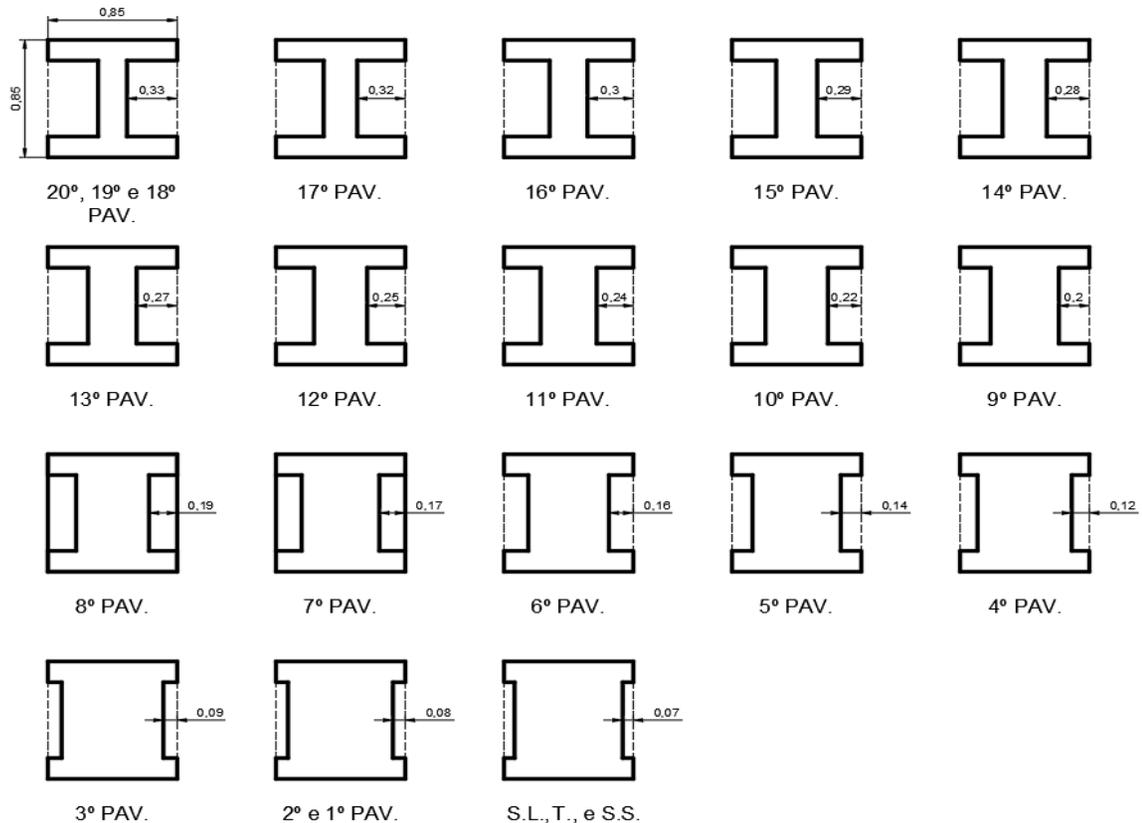
Under a hard work of research to obtain the information and design sheets of the building, some architectural sheets describing the geometry of the columns were found in the records of FAU/USP (Faculty of Architecture of the University of São Paulo). Interestingly and surprisingly the outer section of the columns was square and constant with 85cm by side, but its sturdy cross-section with the shape of the letter H was staggered and variable from floor to floor. In addition, two opposing faces defined a “shaft” that was continuous throughout the height of the columns, from the underground floor to the rooftop, as shown in Figure 5. These “shafts” have been designed and constructed for the central air conditioner system.

Figure 5. Scheduling of the columns (Source: executive architectural design found in the library of FAU. USP)

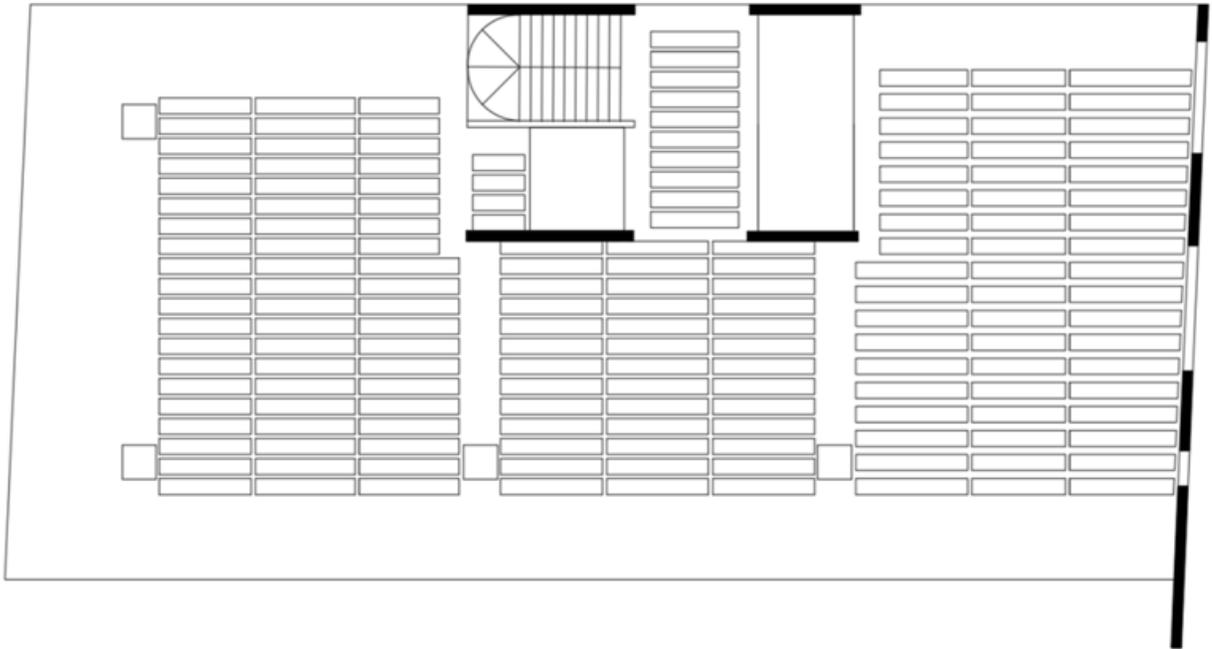
The building slabs were ribbed and were placed *in situ* with thickness of the topping slab of 6 cm (Figure 7). The ribs were 10 cm width and 28 cm high to the bottom of the topping slab, and were spaced every 50 cm. From the columns to the limit where it was installed the glass skin, the slab was a cantilever slab with variable cross-section (Figure 8).

Figure 7. Grid Slab Scheme (Source: FAU-USP)

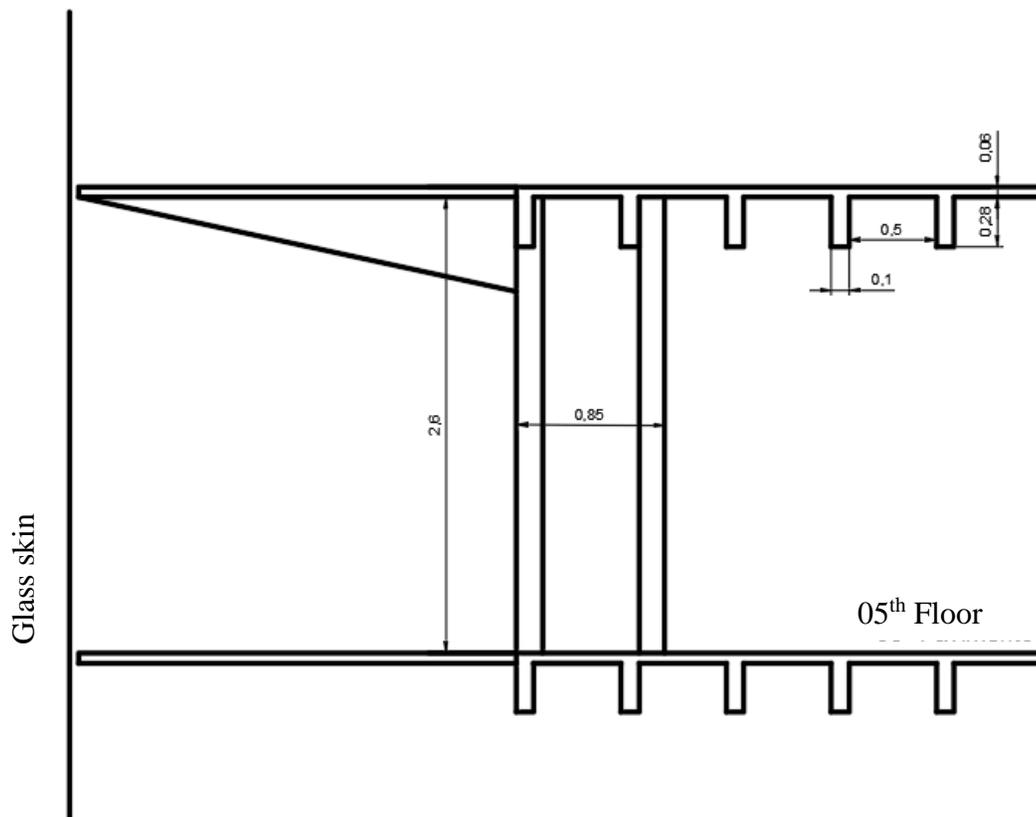
Figure 8. Grate slab cutting (Source: FAU-USP)

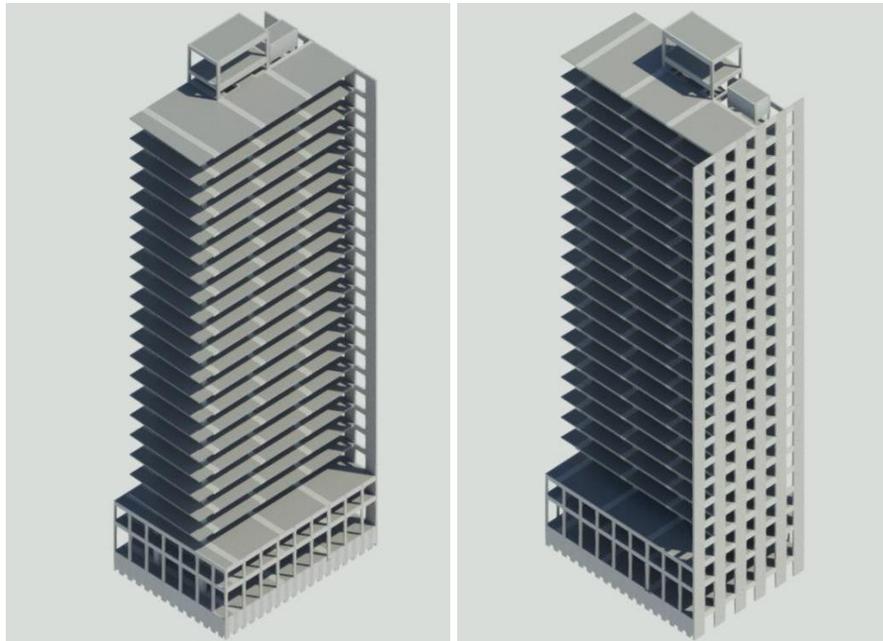
Thus, the main structural system of the structure, responsible for its lateral stability, was composed of concrete columns with “H” section, forming frames in one direction with the strip beams with the same height of the slab, added to concrete shear-walls in the lift and staircase and further a large wall crosslinked to the bottom, consisting of columns, beams and masonry, making a structural frame-wall, as can be seen in the hypothetical model shown in Figure 9.

Figure 9. Frontal and posterior perspectives of the structure of Ed. Wilton Paes de Almeida (source: interpretation of existing projects at FAU-USP, SPU and Acrópole Magazine).

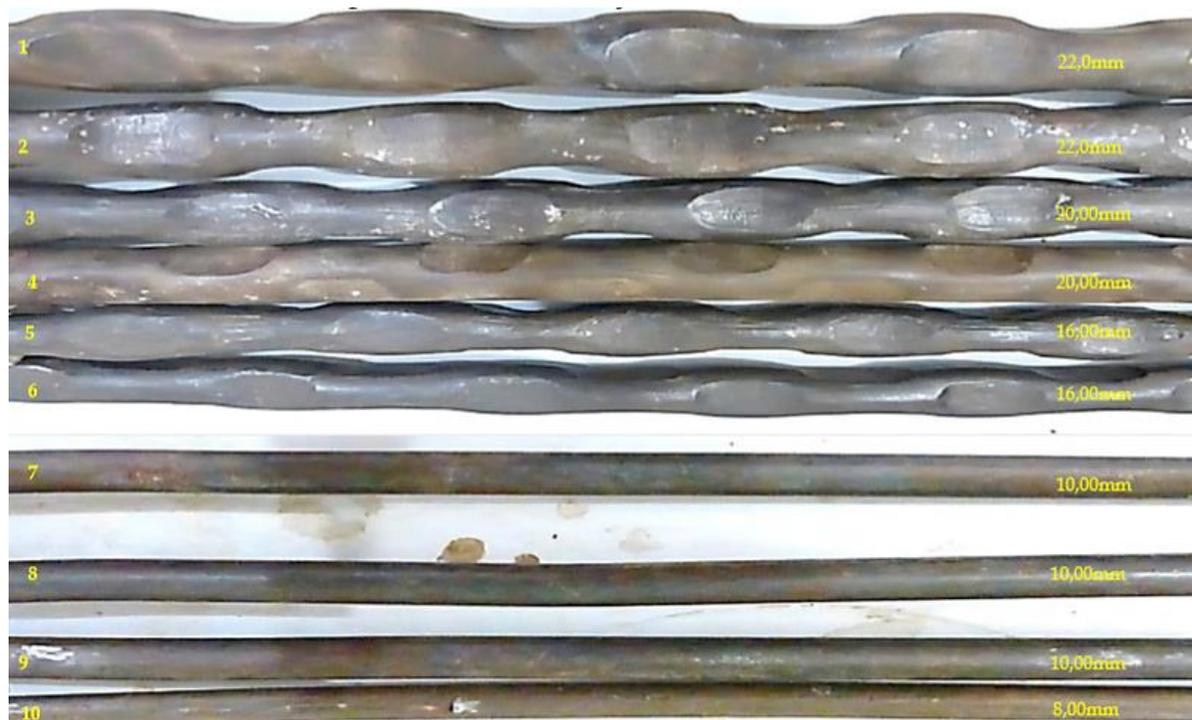
The steel used in the WPA reinforcement was of two types, and they were named notched and smooth due to their surface conformation. Due to the original format, the rebars "notched" presented with depressions arranged uniformly so vary their angle of 90°, as shown in Figure 14.

Figure 14. Classification of steel samples according to his gauge (Source: Arcelor Mittal)
