## Conservation of cultural heritage buildings: Methodology and application to case studies

P. B. Lourenço<sup>1</sup>

### ABSTRACT

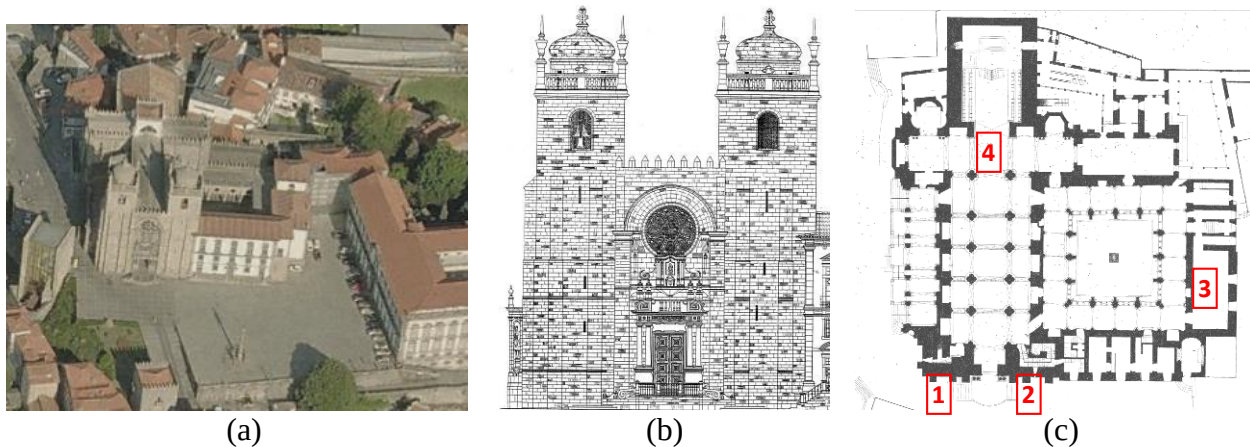
Figure 3 shows selected views of the compound of the Cathedral, which has dimensions about 60 × 60 m<sup>2</sup> in plan, with a maximum height of the towers about 35 m. The compound includes the church, a gothic cloister on the south side, side chapels, a gallery on the north side, a sacristy, several chapels and other annexes. The church has a typical Latin cross, with three naves and five spans, and two rectangular towers facing west.

Figure 3. Aspect of the Cathedral: (a) Aerial View; (b) Façade; (c) Plan.

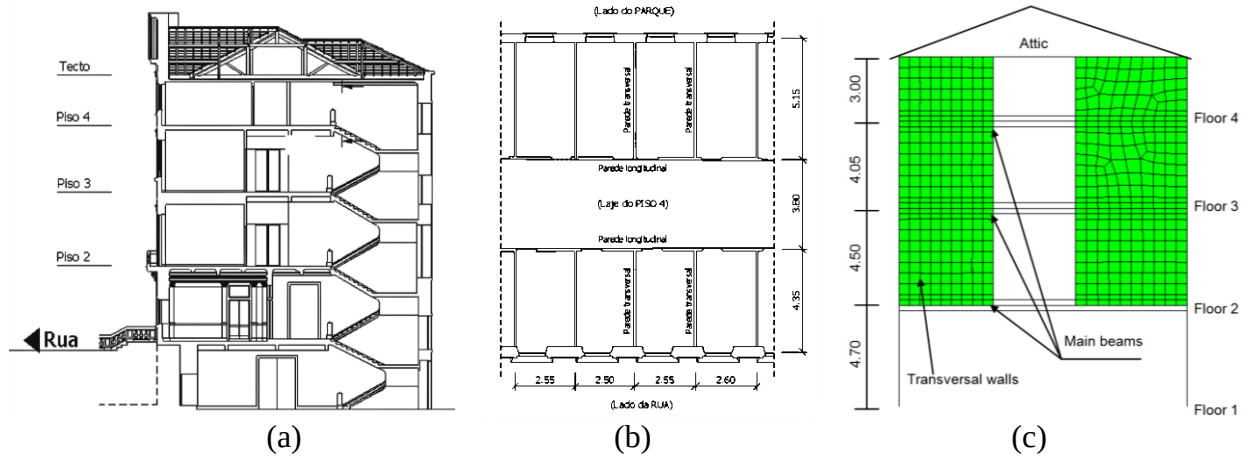
This building has  $110 \times 15 \text{ m}^2$  in plan and 5 floors, as shown in Figure 9a. The inner walls and slabs are made of an early 1930s reinforced concrete structure, while the external walls are made of ashlar granite masonry. Floor 5 is an attic with a timber structure, while floors 3 and 4 were used as students' dormitory in the past. The slabs at these levels are supported in beams supported in the external masonry walls. The internal walls between floors 2/3, 3/4 and 4/5 are made in reinforced concrete. Floor 2 is used as office rooms for lecturers and this floor is supported in a reinforced concrete beams grid. The objective was to use the upper floors as an archive, which required a safety assessment and a strengthening design. For details see Lourenço et al. (2004).

Figure 9. Theological school: (a) Vertical section; (b) Plan; (c) Main transversal structure.

Figures 9b,c present the geometrical survey of the building and the main structure. Cores and steel samples were obtained from the building in order to characterize the materials used. The transversal walls are separated each 2.6 m, with asymmetric location of the longitudinal walls. The thickness of the external masonry walls varies between 0.30 and 0.60 m. The transversal beams have cross sections of  $0.25 \times 0.50 \text{ m}^2$  (floors 3 and 4) and  $0.30 \times 0.60 \text{ m}^2$  (floor 2). The thickness of the slabs is 0.12 m and the internal walls have a thickness of 0.06 m. The concrete strength found was  $24.6 \text{ N/mm}^2$  (slabs) and  $11.9 \text{ N/mm}^2$  (walls). All the reinforcement found is unribbed and mild steel. The slabs have a single layer of reinforcement with  $\phi 3/8''@0.125$  for the main reinforcement and  $\phi 3/8''@0.25$  for the secondary reinforcement. The walls have also a single layer of reinforcement with  $\phi 3/16''@0.25$  in the vertical direction and  $\phi 5/32''@0.25$  in the horizontal direction. The lower reinforcement in the transversal beams is  $3\phi 1''$  (floors 3 and 4) and  $4\phi 1\frac{1}{4}'' + 4\phi 1''$  (floor 2). Besides the dead load, for the current use of the building the live load according to the Portuguese code is  $3.0 \text{ kN/m}^2$  in general with  $5.0 \text{ kN/m}^2$  is the access zones. With the new use, the planned live load is  $14.8 \text{ kN/m}^2$  for floor 2,  $13.5 \text{ kN/m}^2$  for floor 3 and  $11.0 \text{ kN/m}^2$  for floor 4.
