Documentation of the pathological manifestations of the Portico of the Cultural Baptism of Goiânia - *Art Déco* historical monument

T. L. Pio Santos^{1*}

, P. F. Silva Júnior¹

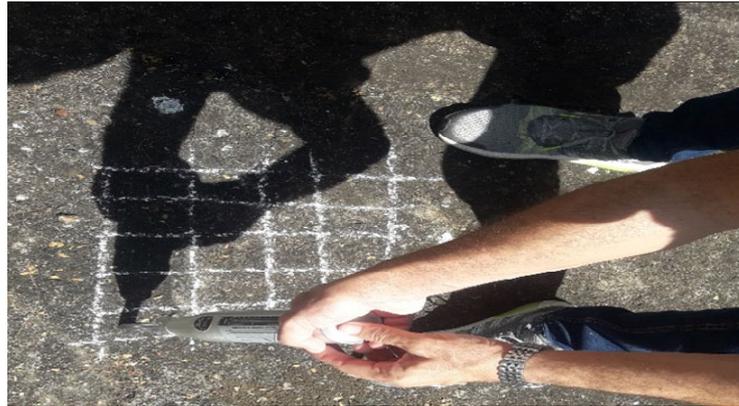
Figure 7. Carrying out the sclerometer test

The sclerometer test was performed in four regions of the slab. Locations where there was no segregation of concrete and with homogeneous and regular surfaces were sought. Figure 7 shows the test execution and Figure 8 illustrates the location of the tested areas along with their dimensions.

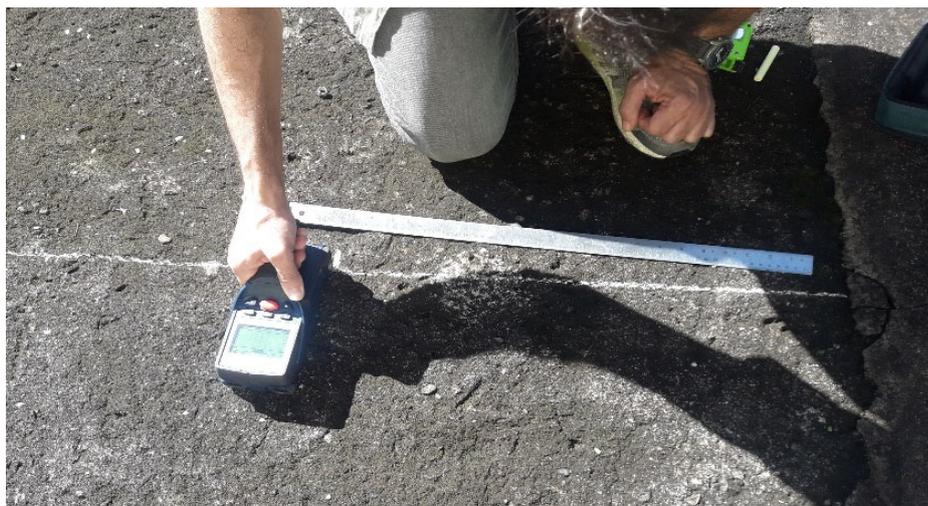
Figure 9. Carrying out the cover meter test

The cover meter was also carried out aiming to obtain information about the location of the slab reinforcement as well as verifying the coverage of the reinforced concrete. The areas chosen for the test were those that presented the best conditions for the device to work which are the areas that were free of mold and dirt. In Figure 9 the test being carried out is shown.

It was observed in some places the value of “0” which, according to the equipment, means lack of depth would indicate that the reinforcement is superficial and without covering. However, the same was not observed visually.

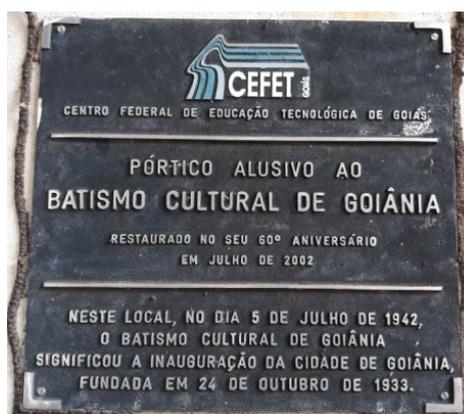
Regarding the maintenance plans and maintenance monitoring reports, it was reported that these did not exist, as well as the original Portico project. Near the Portico, a plaque was found (Figure 16) indicating that it was restored on its 60th anniversary, in 2002, but there are no records detailing how this intervention took place.

Figure 16. Portico identification sign
