Diagnosis and solutions proposal to the damages present in the ceiling of the Convent of Santa Clara de Asís

The Convent of Santa Clara de Asís was inaugurated in Havana in 1644, becoming the first religious convent founded in Cuba. In 2018, the Office of the Historian of Havana (OHCH) began a restoration and recovery project that has involved professionals and students from different branches of technical careers, and professionals linked to the field of construction and conservation of built heritage. The results that have been obtained from these investigations allowed the establishment of priorities and methodologies for its gradual intervention and recovery (Guevara et al., 2019).

The objective of this work is to evaluate the state of conservation in the structure of the wooden ceiling of the circulation gallery located on the upper floor of the first cloister, for which a series of NDTs were combined that allowed identifying the pathologies present and determining the magnitude of the injuries in the beams and wood stud that make it up. This implies a proposed solution that is discussed at the end of the work.

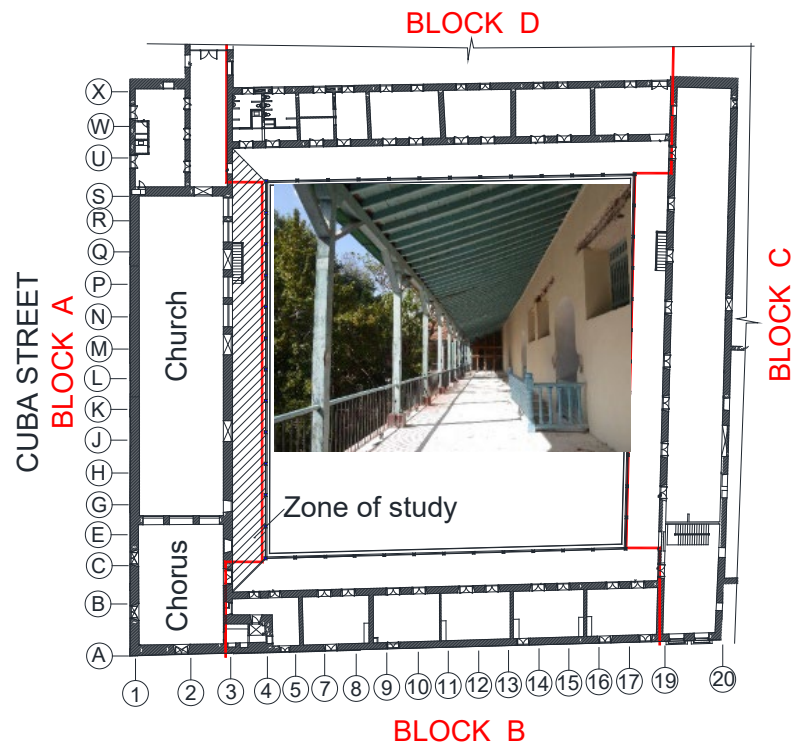
The structure is located on the upper floor of the first cloister, towards block A (Figure 1). It is based on a wood and plank slab made up of 98 beams of 9 cm x 13 cm (base x height), spaced between 43 cm and 45 cm with an inclination of 17 degrees from the wall towards the wood studs, supported on the 3rd axis on the rammed earth wall that forms the church, and along the axis 4 on a sliding beam that rests on 13 wood studs. The slide beam is made up of 12 beams joined by scarf joint, which rest on the right feet (Table 1). The roof is made up of red ceramic tiles.

Figure 1. Floor plan sketch of the first cloister, signs and photograph of the gallery studied

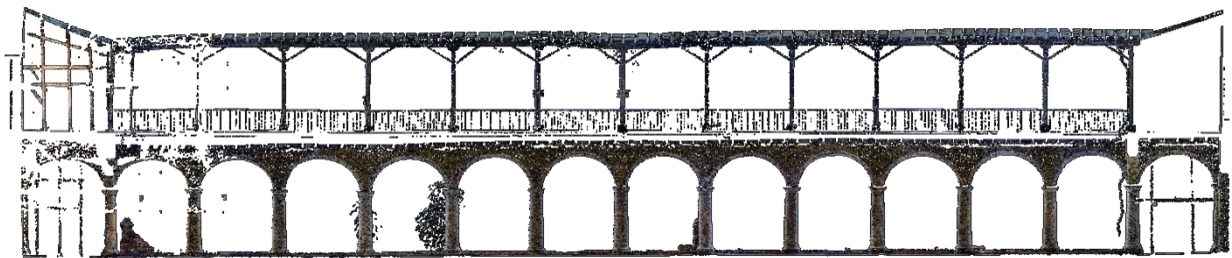
Figure 2. Orthoimage obtained from the gallery of block A

For the structural analysis of the slab beams, orthoimages were extracted using the Reconstructor software, and cuts were made using the Autodesk Recap software from beam number 17 to 98. All the beams that make up the slab present deformations to a greater or lesser extent, and some show flexural failures due to a decrease in their bearing capacity. The Cuban standard (NC 53-179:88, 1988), establishes that the maximum admissible deflection is $1/240$ of length for full load. This indicates that the admissible deflection for the wood beams is approximately 1.5 cm, but the values obtained on site are 2 cm to 4 cm higher than those acceptable by calculation. The standard establishes that the deflection of the beams will increase for load periods of more than 10 years by 50% for dry wood, and 100% for wet wood. Considering this, the allowable deflection would increase by 2.25 cm and 3.0 cm, respectively, for which there are still differences between allowable and actual values (Figure 4). It is important to note that not all the maximum deformations found are located in the center of the span, for the reason that there are areas where the element is more deteriorated than others; that is why the beams deform and fail in the most vulnerable area. It was identified that not all the beams are of the same wood species, which is why their hardness and resistance to bending also vary. In the right feet 1 and 7, the deterioration in the joints has caused the displacement of the same and of all the elements that adjoin it. These vertical movements that the right feet have suffered vary between 3.5 cm - 20 cm approximately, and the separation in the scarf joint between the beams that make up the sliding beam ranges between 1 cm to 2 cm, which represents considerable displacements.

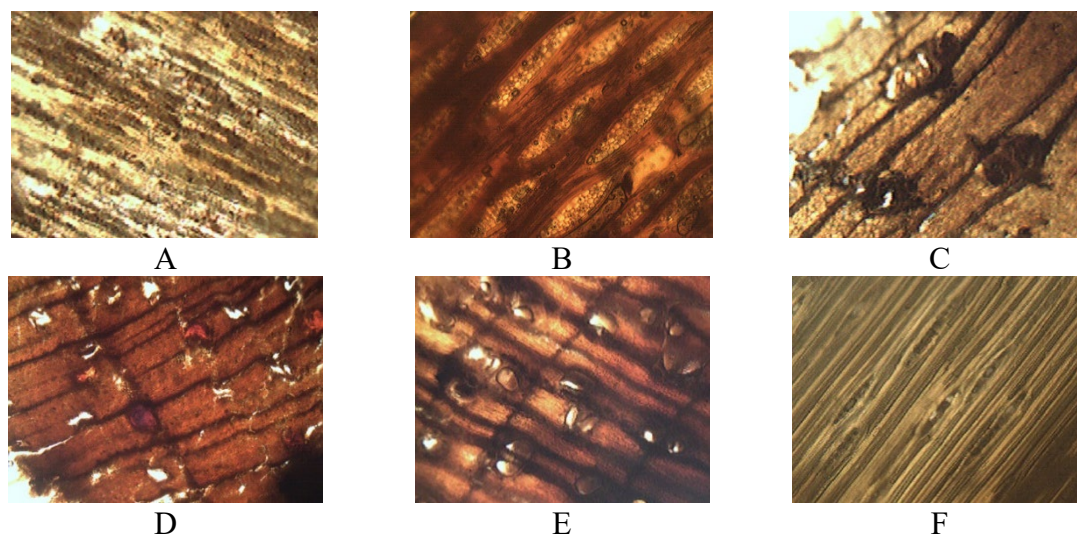
Through the application of the comparative anatomy method from the histological sections made in transverse, tangential and radial directions, it was obtained as a result that the species of wood that form the structure of the roofing and the support system of the wood stud are: cedar (*Cedrela odorata*), pine (*Pinus sp.*), baría (*Cordia gerascantus*), caguairán (*Guibourtia hymenifolia*) and ácana (*Manilkara grisebachii*). Figure 5 shows the histological sections made to identify the existing wood species.

Figure 5. Histological sections at 40x of the identified wood species: A- ácana (longitudinal cut), B- baría (longitudinal cut), C- caguairán (cross-section), D- cedar (longitudinal cut), E- najesí (cross cut), F- pine (lengthwise cut)

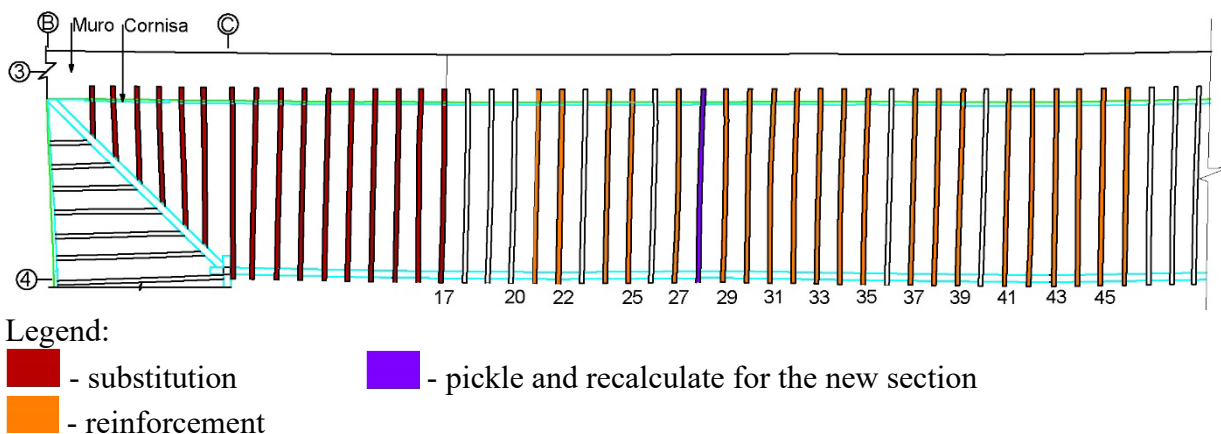
Figure 10. Proposal for a solution to the ceiling between beams 1-49

In the floor beams, it was determined that 17 of them need to be replaced as a result of their advanced deterioration. Additionally, another 45 beams must be structurally reinforced in different areas, depending on the pathologies developed in each one. Of the remaining 34 beams for which no significant injuries were identified, it will be necessary to disassemble and strip 2 of them due to superficial damages, in order to subsequently recalculate the load for the new beam section (Figures 10 and 11). All the wood studs showed deterioration that required structural reinforcement actions, as well as in the sliding beams, where it will be necessary to replace two sections and reinforce another 3 sections (Figures 12 and 13). The significant decrease in the density of the wood is the result of exposure to wetting and drying cycles, mainly in the rainy months, with the consequent proliferation of fungi and termite infestation. The deformations present in the beams are not only the result of the increase in weight due to excess water and the growth of higher plants, but also due to the loss of their timber properties, which increases the risk of structural failure.

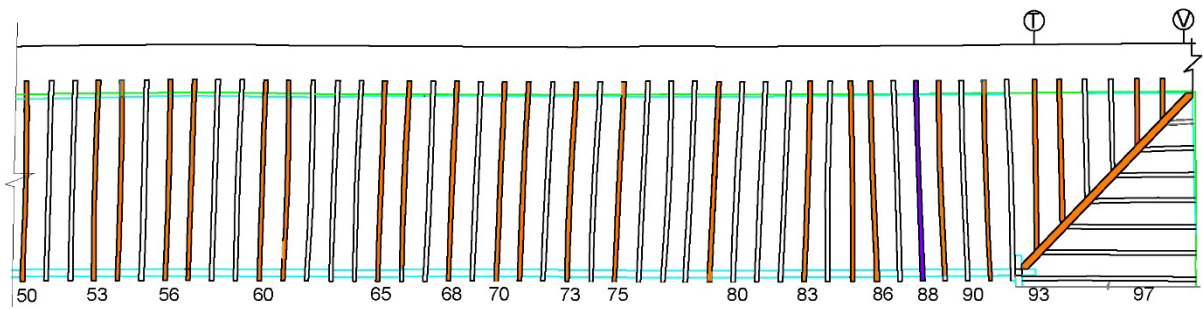
Figure 11. Proposal for a solution to the ceiling between beams 50-98

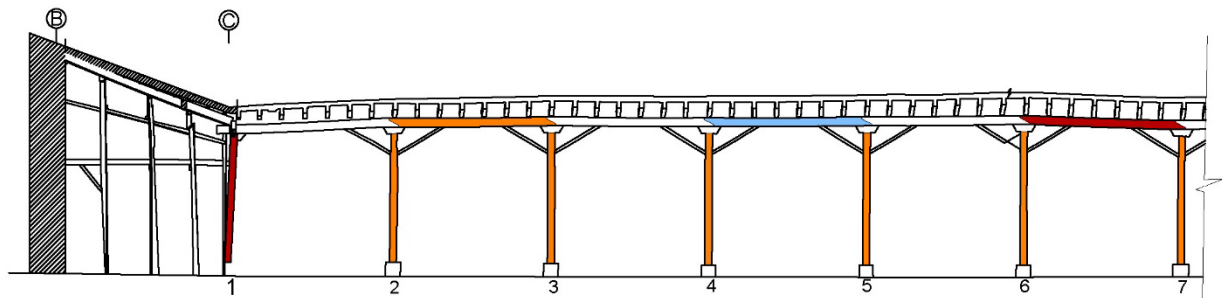
Figure 12. Proposal for a solution to the wood stud 1-7 and section of the sliding beam

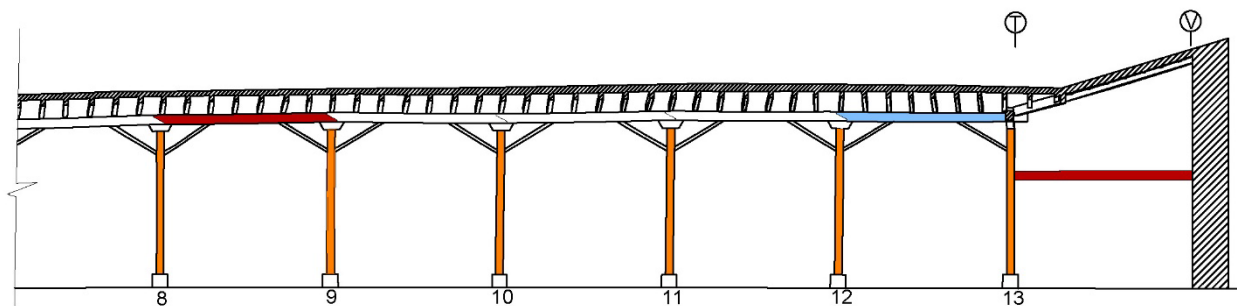
Figure 13. Proposal for a solution to the wood stud 8-13 and section of the sliding beam
