Evaluation of the pathological manifestations of the Rio Negro Building in Anápolis-Goiás

This paper shows the application of the methodologies GDE (Degree of Structure Deterioration) and GUT (Severity, Urgency, and Tendency) quantifying the pathological manifestations and determining the points of greatest need for maintenance. Thus, a quantitative perspective was used with the application of the previously mentioned methodologies and after building inspections and visual analysis with a photographic record, notes and mappings the methodologies were applied and it was obtained that most of the pathological manifestations that occur in the structure of the building have humidity as origin, resulting in efflorescence, spots or infiltration. Thus, this work defined the points that need priority, directing measures that can later be taken. The methodologies proved to be efficient and important for decision-making.

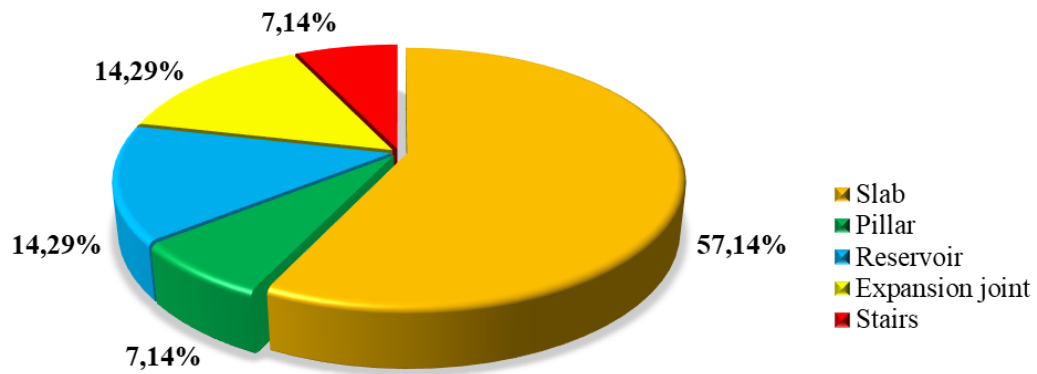
First, it was observed that the family that has the largest number of elements that present pathological manifestations is the slab family, with 57.14% of the identified anomalies, as can be seen in Figure 5.

Figure 5. Graph of the frequency of pathological manifestations by family of elements.

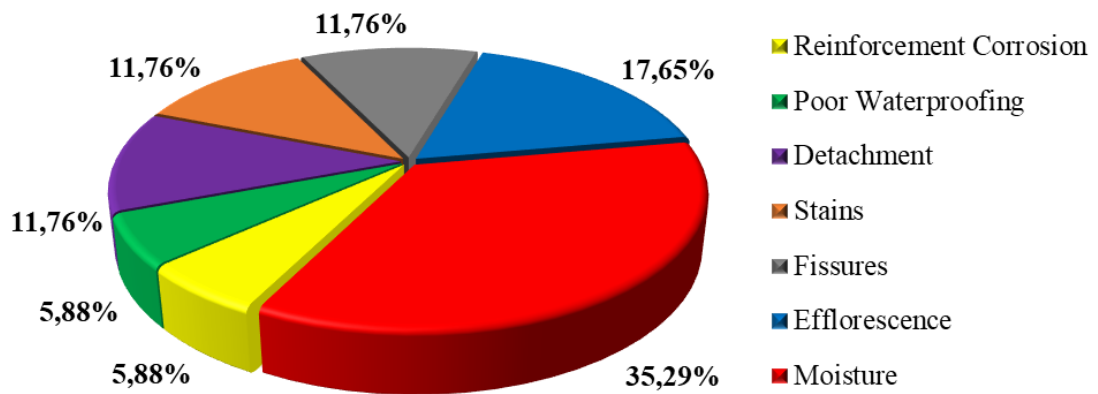
Through the mapping of the pathological manifestations that affect the building, it was noticed that in the 14 structural elements inspected, 35.29% of the pathological manifestations are originated due to the infiltration of humidity as we can see in Figure 6. In addition, other pathological manifestations such as efflorescence (17.65%) and dark spots (11.76%) also have a similar cause.

Figure 6. Graph of the frequency of pathological manifestations in the elements.
