Revista **ALCONPAT**

January - April 2018

Service life analysis of reinforced concrete structure under uniform corrosion through ANN model coupled to the FEM

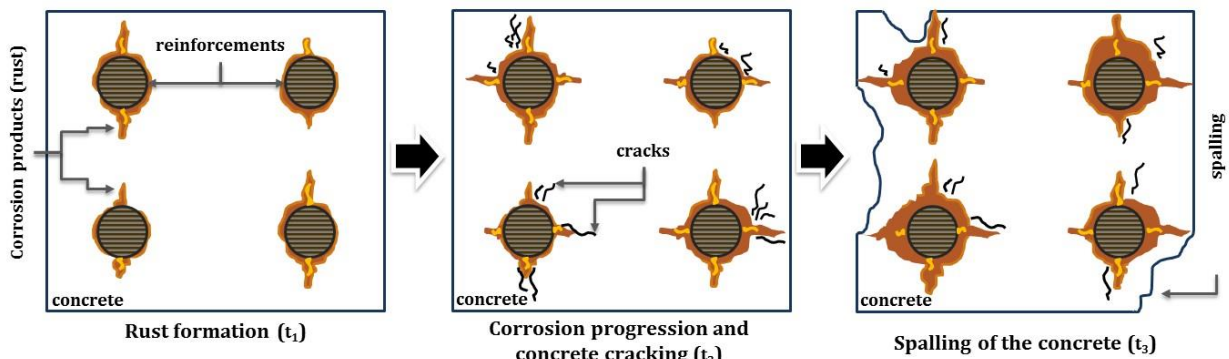
Figure 2. Stages of concrete damage during the period of corrosion progression.

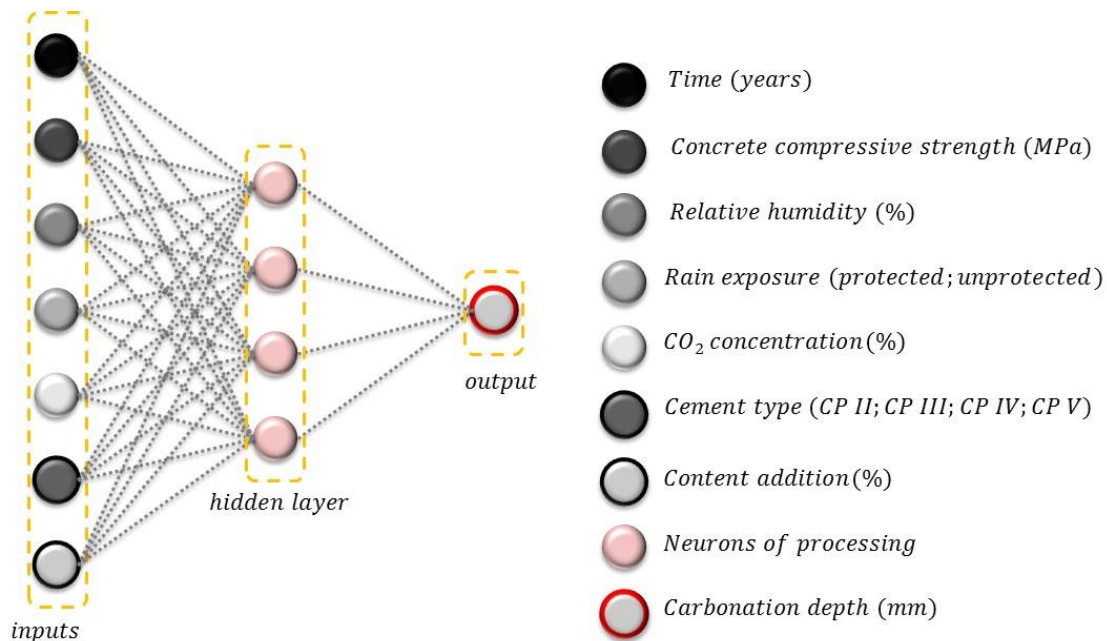
Figure 3. Model inputs and ANN topology (Félix et al., 2017).

To determine when occur the steel reinforcement depassivation (referent to the DL), a concrete carbonation depth predictive model based on Artificial Neural Network Model (ANN) and developed by Felix (2016), was coupled to the PFEM code. The Figure 3 present the model inputs and the ANN topology (the neural architecture) utilized to developed the concrete carbonation model.

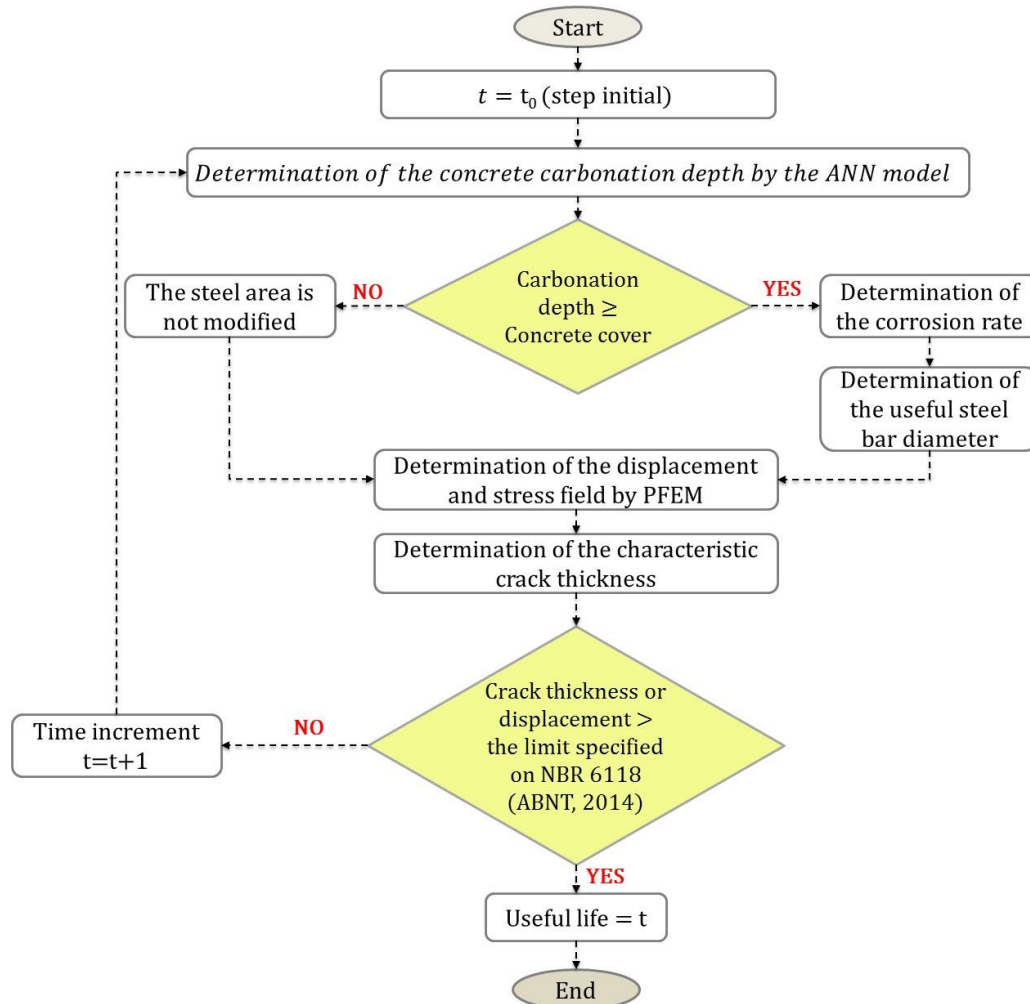
Figure 4. Flowchart of the calculation process for the implemented code.

The Figure 4 show the flowchart referent to the model code implemented to determine the service life of reinforced concrete structures subjected to the uniform.

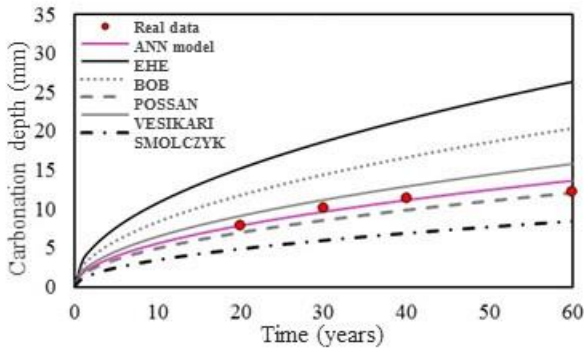
Figure 5(a). Carbonation scenery I.

The results show the model applicability and that it presents as an efficient numerical tool to predict the carbonation concrete depth.

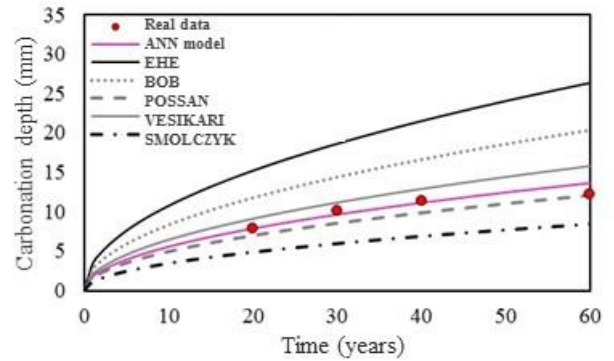
Figure 5(b). Carbonation scenery II.

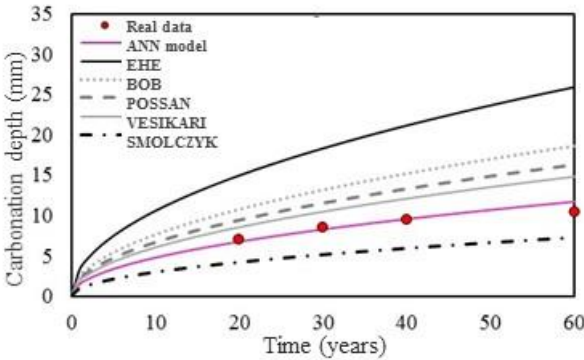
Figure 5(c). Carbonation scenery III.

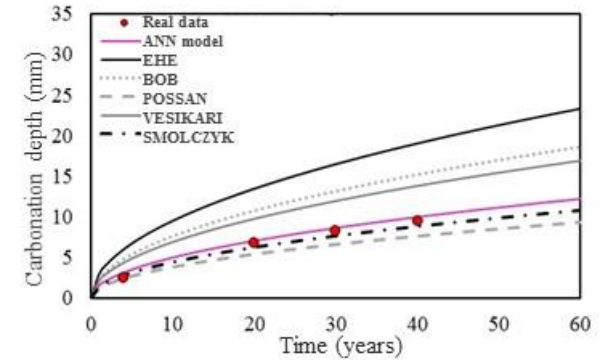
Figure 5(d). Carbonation scenery IV.

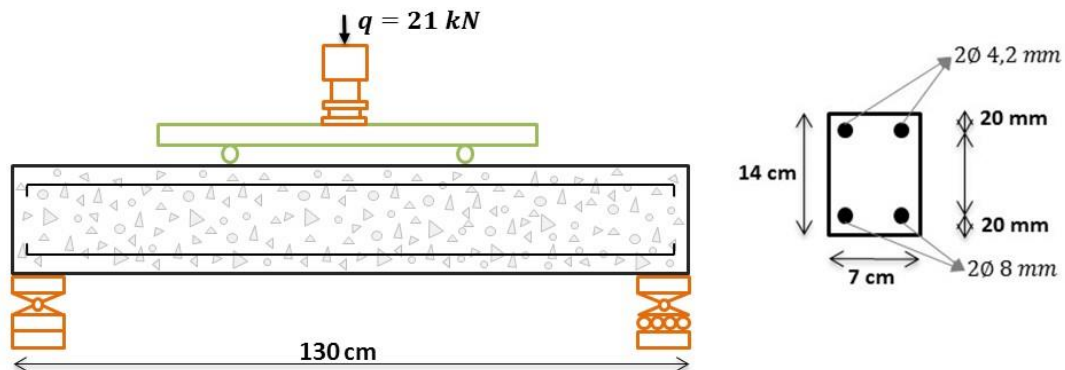
Figure 6. Construction and designing details of the reinforced concrete beam.

In order to validate the numerical model implemented and proposed in this work, a reinforced concrete beam subjected to the uniform corrosion was modeled, the results are compared with the experimental results obtained by Graeff (2007). The modeled structure consist in a reinforced concrete beam with a rectangular section. The beam dimensions is specified in the Figure 6.

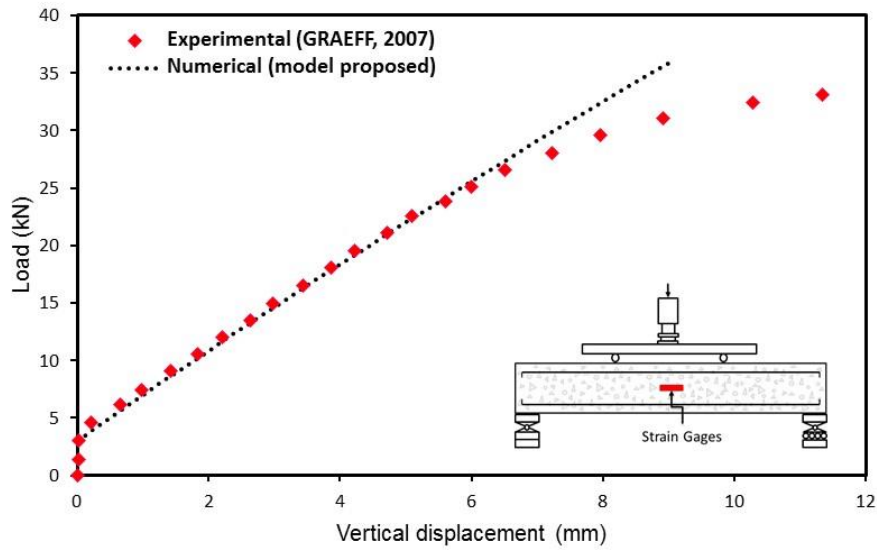
Figure 7. Comparison between experimental and numerical displacements.

A comparison between the experimental, realized by Graeff (2007), and numerical (obtained with the model proposed) results of the vertical beam displacements is shown in the Figure 7. It is possible verified that the numerical model proposed represent efficiently the beam displacement field in the elastic linear regime of the material.

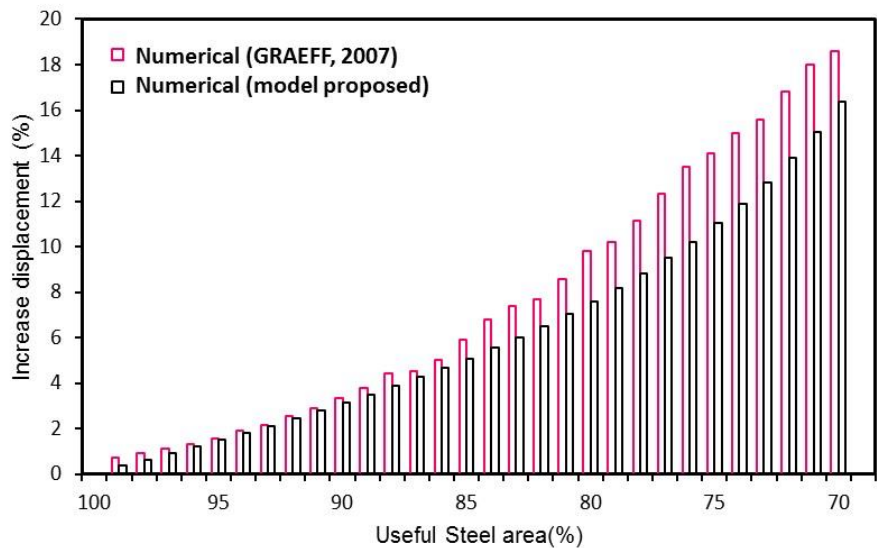
Figure 8. Comparison of the displacement increase rates.

It is observed in Figure 8, that the difference between the responses of the two models is increasing with the evolution of the deformation of the armature, this is due to Graeff (2007) adopting in its model a nonlinear constitutive law. However, the model proposed in this work obtains displacements equivalent to the Graeff (2007), presenting 3.20% of average deviation.

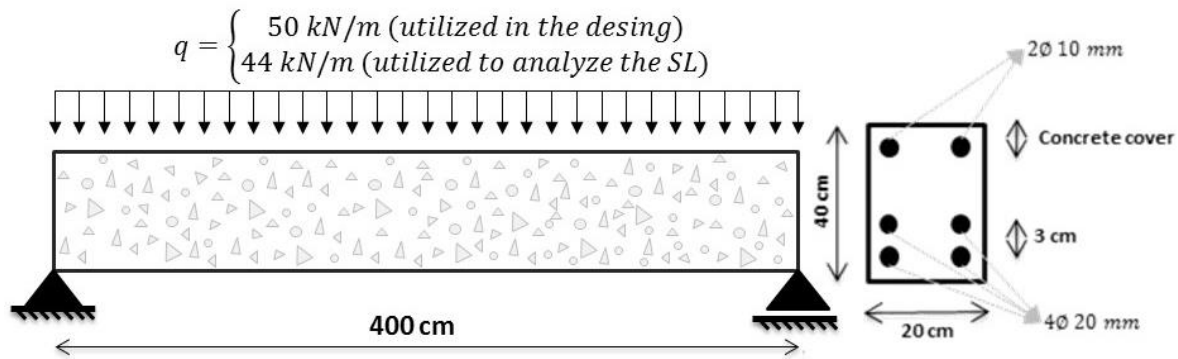
Figure 9. Simplified detailing of the reinforced concrete beam.

The structure analyzed in this work consists of a reinforced concrete beam dimensioned according to the procedures of NBR 6118 (ABNT, 2014). The Figure 9 present the values of the loads utilized to design the reinforced concrete beam and analyze the service life. In the Figure 9 the construction and geometric details have also shown. In order to analyze the concrete structure durability exposed to a moderately aggressiveness environment, the structure was dimensioned with three different concrete cover (i.e., 20, 25 and 30 mm).

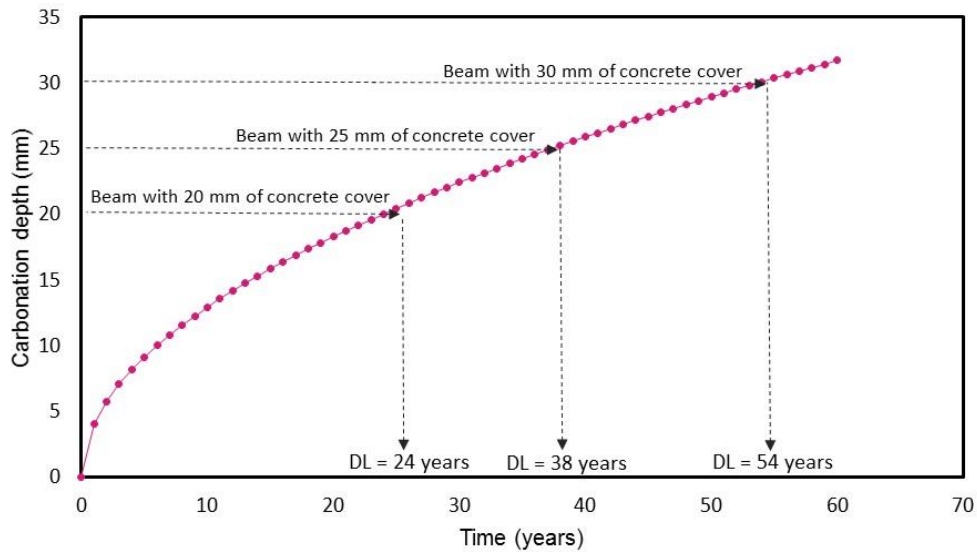
Figure 10. Carbonation advance and the DL of the beams with different concrete cover.

Initially, the concrete carbonation depth advance and the design life (DL) of the beams with different cover thicknesses (20, 25 e 30 mm) are presented in Figure 10. It is immediately noticeable the importance of using an adequate concrete cover due to the aggressiveness of the

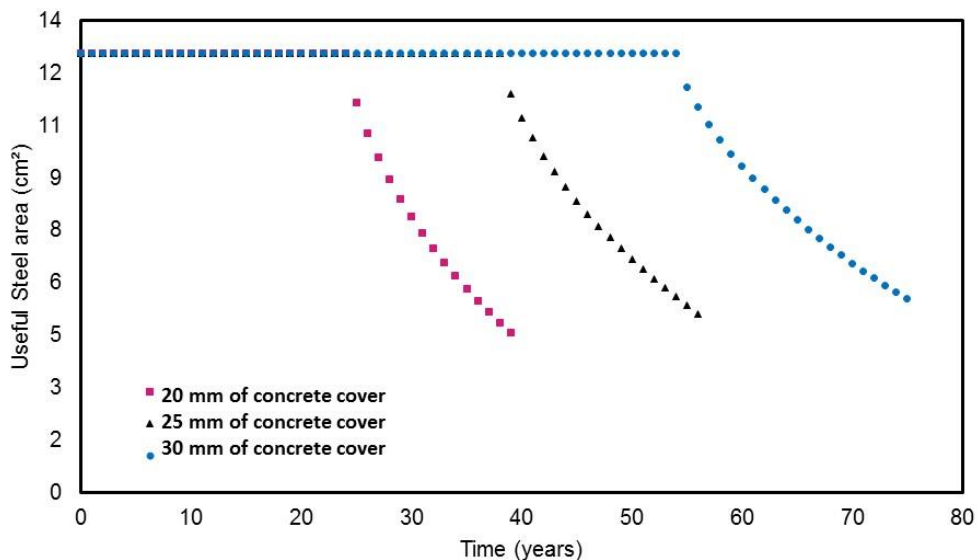
Figure 11. Loss of steel area on concrete beams under corrosion.

In Figure 11 it is possible to analyze the advance of the degradation of the reinforcement due to the action of corrosion (the graph shows the steel area of the longitudinal reinforcement). It is observed that during the corrosion initiation phase (DL) the steel area of the reinforcement is not reduced, and the section loss is more pronounced in the early years of the corrosion propagation period, in agreement with the study of Vu et al. (2000). The authors report that there is a tendency of greater loss of steel area in the initial period of corrosion because the corrosion rate of the reinforcement is higher during this period, decreasing over time with an exponential behavior.

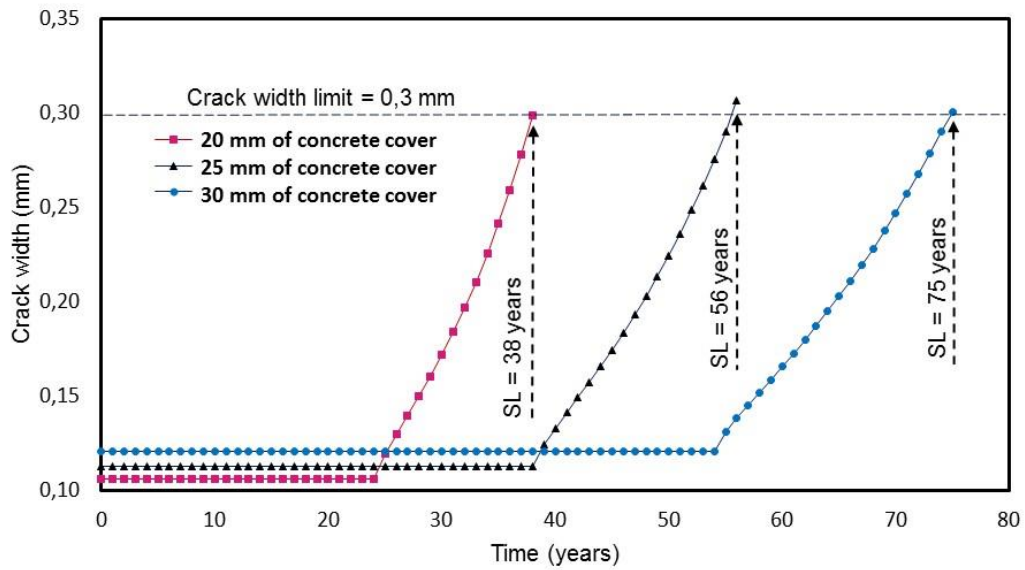
Figure 12. Progress of crack opening and the DL of the concrete beams.

Figure 12 shows the DL of the reinforced concrete beams analyzed in this work. The crack width limit adopted was $w_{lim} = 0.3$ mm, as prescribed by NBR 6118 (ABNT, 2014) for concrete structures with class II of environmental aggression (moderate).

It is observed that the slope of the crack opening curve decreases with the increase of the concrete cover, increasing the time required for the reinforced concrete structure to reach the cracking-opening limit state (relative to the SL).

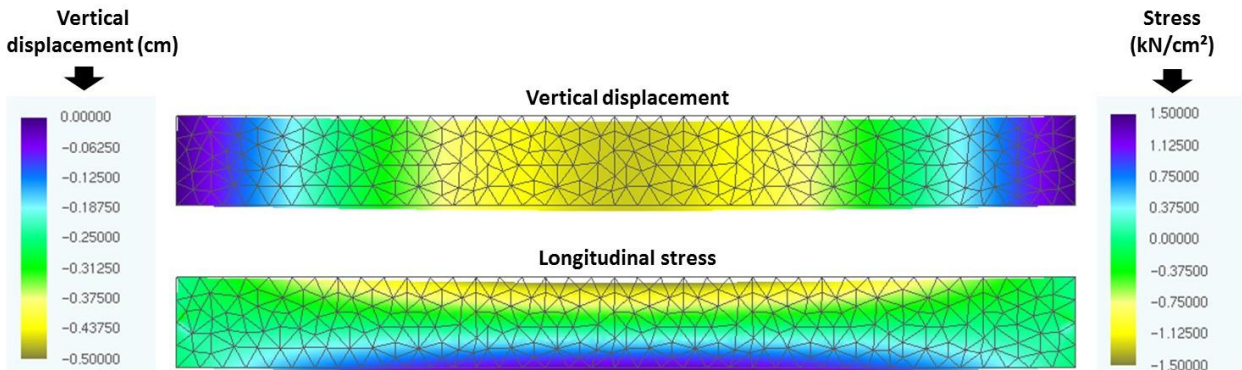
Figure 13. Deformed configuration of the beam with 20 mm of concrete cover at the end of the DL.

Finally, Figures 13, 14 and 15 show the longitudinal tensions and vertical displacements of the reinforced concrete beam with 20, 25 and 30 mm of concrete cover, at the moment the cracks reach their limit value (DL).

Thought the color maps presented in Figures 13, 14 and 15 it is possible to observe that the displacements of the beam decrease with the increase of the concrete cover because of the fact that there is a greater layer of concrete for the diffusion of CO_2 , delaying the corrosion beginning and, consequently, the degradation of the reinforcement, responsible for giving greater rigidity to the concrete beam. This result demonstrates the need to know correctly the environment to which the structure will be exposed, since the concrete elements will be designed with the required durability, guaranteeing the design life of the structures and the safety of their users.

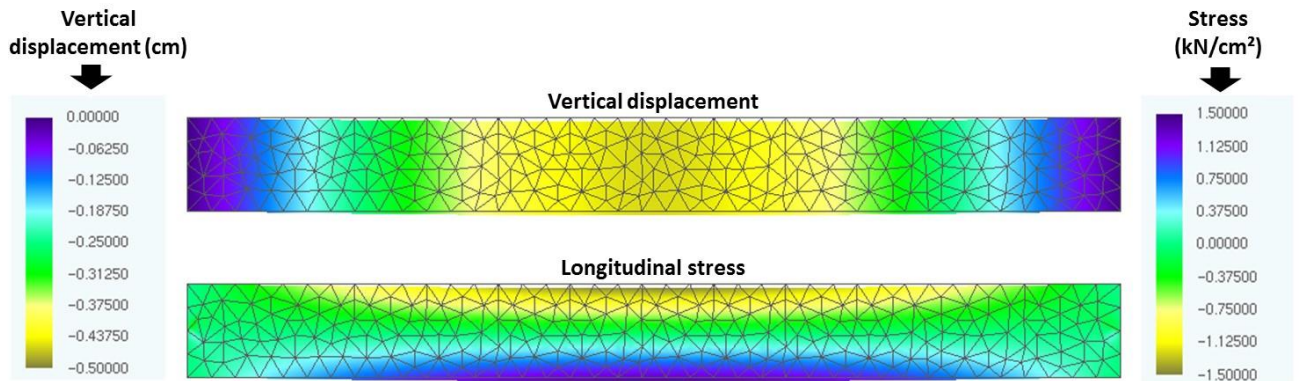
Figure 14. Deformed configuration of the beam with 25 mm of concrete cover at the end of the DL.

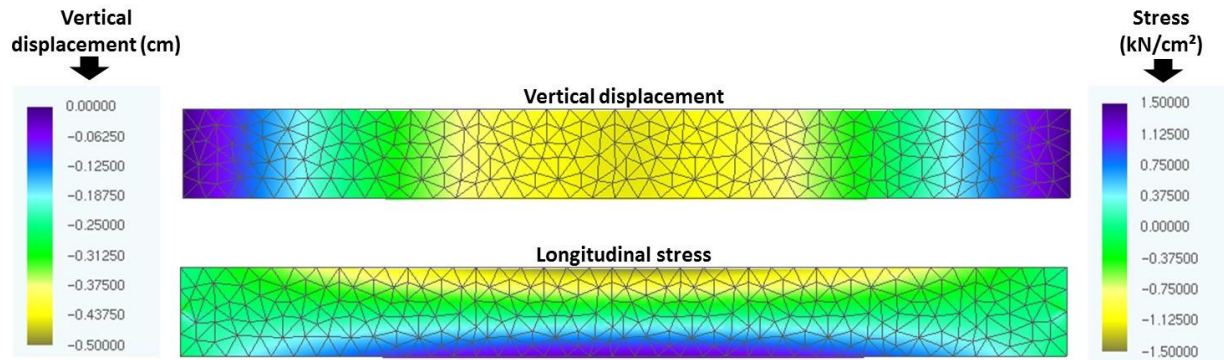
Figure 15. Deformed configuration of the beam with 30 mm of concrete cover at the end of the DL.

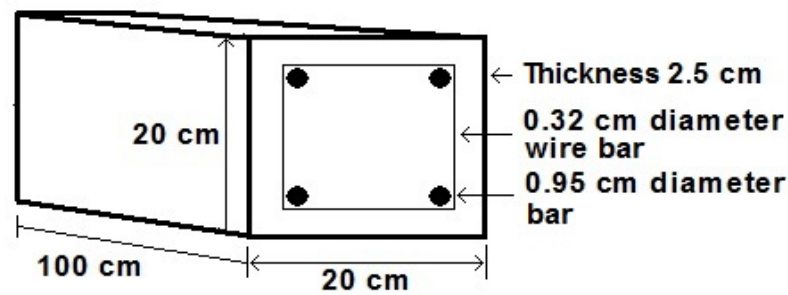
Figure 1. Specimen diagram.

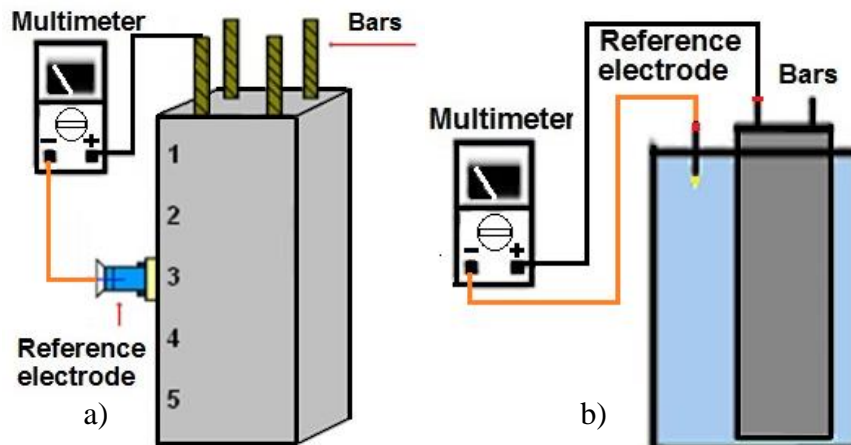
Figure 2. Diagram of the corrosion potential measurements: a) to ATM; b) to INM.

The corrosion potential measurement was made according to the ASTM C876 standard. Figure 2a shows the way in which the corrosion potential in the structures exposed to the ATM was measured, taken from five points of the specimens at different heights of the concrete surface, using a saturated copper/copper-sulphate reference electrode, ($\text{Cu}/\text{CuSO}_{4\text{sat}}$). The measurement of the corrosion potential in the specimens exposed in INM was made using a silver-saturated silver chloride reference electrode ($\text{Ag}/\text{AgCl}_{\text{sat}}$) immersed in the seawater on one side of the sample, see Figure 2b.

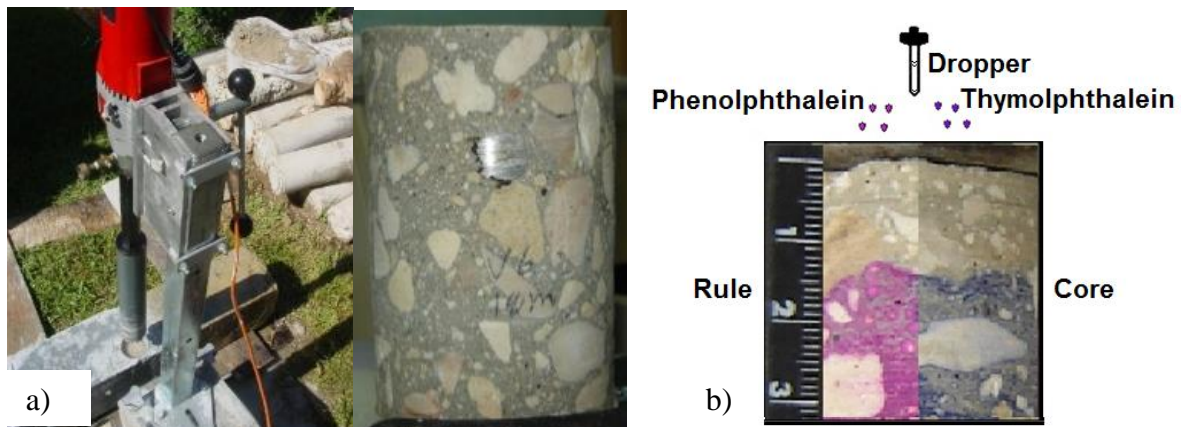
Figure 3. Carbonation front: a) Core extraction and b) Application of acid-base indicator.

The acid-base indicators were applied up to 1 cm below the level of the reinforcing steel in equal parts, see Figure 3b. A photographic record of the advance of carbonation measured by a rule was taken. Concrete of good quality has a characteristic color of the indicator used and a carbonated concrete has no color. It is due to the decrease of pH resulted from the reaction of carbon dioxide (CO₂) with the alkaline components of concrete.

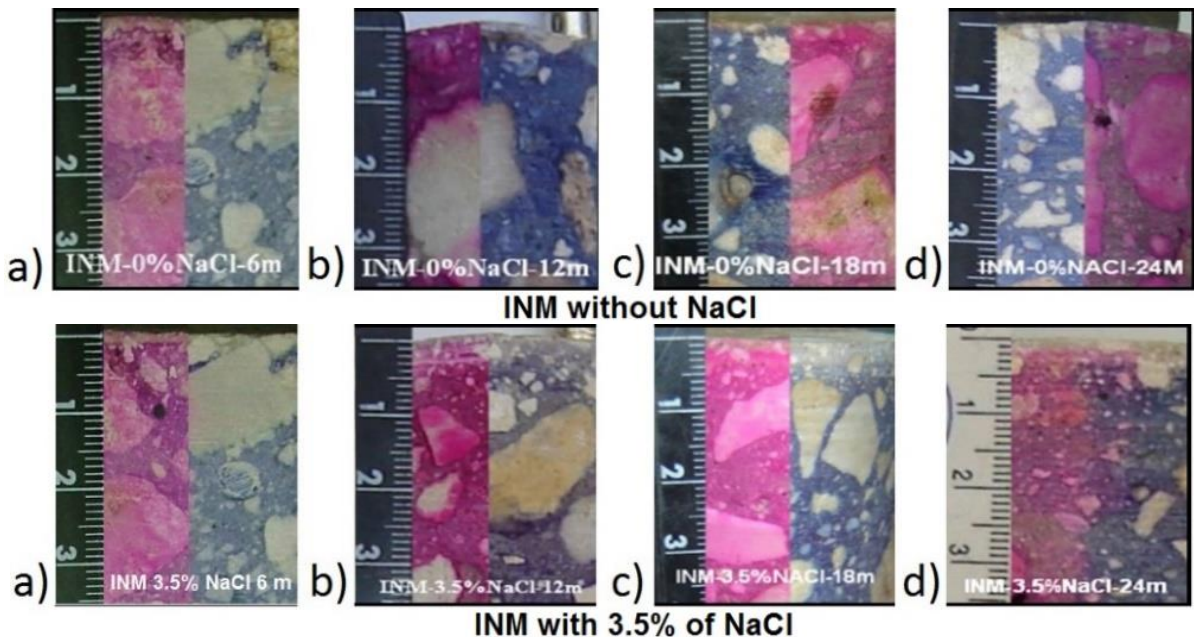
Figure 5. Carbonation front: a) 6, b) 12, c) 18 and d) 24 months, respectively, in concrete cores exposed to INM.

In the case of the structures exposed to INM, Figure 5, an insignificant advance of carbonation is observed on both manufacture conditions manufacture of reinforced concrete, reaching on average approximately 1 mm deep during the 24 months that the study lasted. The results were as expected, due to the low solubility of CO₂ in seawater, when the structures were immersed in seawater.

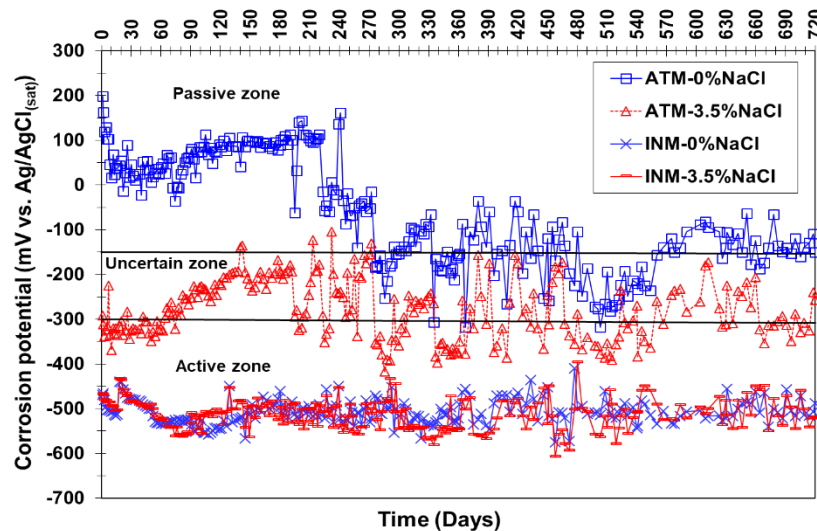
Figure 6 shows the average E_{corr} results of reinforcing steel in concrete structures made without (0%) and with 3.5% by weight of sodium chloride (NaCl) added in the mixing water during 2 years of exposure to the ATM and INM.

Figure 6. Corrosion potential of the reinforcing vs time.

The corrosion potentials of the structures prepared without additional NaCl exposed to the ATM (ATM-0% NaCl), according to the criterion of Table 2, showed a passive behavior until day 270; later the potentials became more negative with variations between the passive and uncertain zone. Such behavior that prevailed until the end of the experiment. In the case of those samples made with additional NaCl exposed to the same condition (ATM-3.5% NaCl), the reinforcing steel started with a high probability of corrosion of the steel (active zone) during the first 40 days, reducing its activity and remaining within the uncertain zone approximately until day 200 and later presenting a variable behavior until the end of the study, between the active and uncertain zones. The E_{corr} instability is due to variations in meteorological conditions such as temperature and relative humidity, as well as the rainy season.

Regarding the structures exposed to INM, both series, without and with 3.5% NaCl (INM-0% NaCl and INM-3.5% NaCl), remained within the range between -400 and -500 mV vs electrode Ag/AgCl that corresponds to a behavior of high probability of corrosion of reinforcement steel (active zone), during the 720 days of exposure that lasted the experiment. These values belong to the area of active corrosion that indicates a high probability of corrosion in the reinforcing steel. This behavior is due to the polarization induced by the lack of oxygen in the concrete-rod interface that produces the displacement of E_{corr} to more negative values [Ávila, et al., 1994]. This condition predominates over the presence of chloride in the water used for the mixture. In the case of the series exposed to INM, the attack by carbonation is practically null, leaving as the main cause of corrosion the chlorides present in seawater and the addition in the mixing water. In this sense, both series presented the same electrochemical behavior with a high probability of corrosion. Under such conditions, it is also necessary to take into account that steel under immersion is exposed to a medium poor in oxygen which makes the potentials more negative similar to those reported.

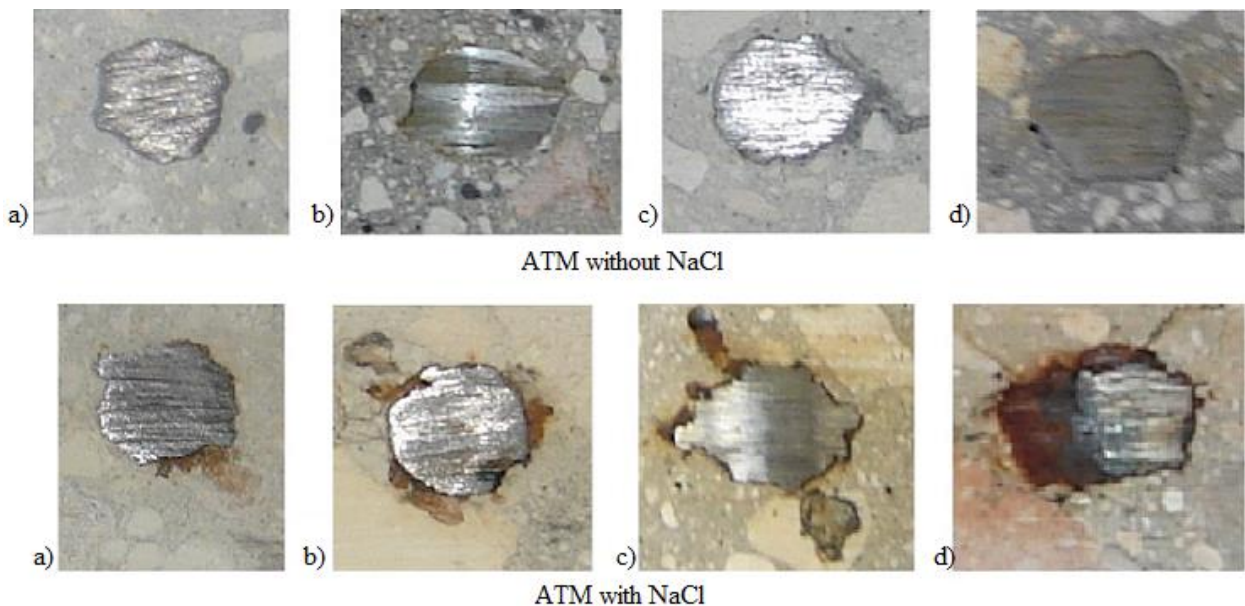
Figures 7 and 8 show the photographic record of the visual inspection of the concrete-reinforcing steel interface in concrete specimens made without (0%) and with 3.5% by weight of NaCl added in the mixing water, for 2 years of exposure to ATM and INM.

Figure 7. Photographic record of the concrete-reinforcing steel interface: a) 6, b) 12, c) 18 and d) 24 months, respectively, in structures exposed to ATM.

The structures manufactured without additional NaCl exposed to the ATM, Figure 7, do not show corrosion products on the concrete-reinforcing steel interface on any of the four periods. When comparing these results with the structures with 3.5% of additional NaCl, corrosion products are observed on the concrete-reinforcing steel interface after the first 6 months and similarly within the three subsequent periods until the end of the 24-month experiment.

The absence of corrosion products in the structures without additional NaCl, exposed to the ATM, agrees with the electrochemical behavior of steel passivity reported in the corrosion potentials during the first 270 days. However, it subsequently passes to uncertain potentials of corrosion, behavior possibly related to the variation of environmental parameters. When the action of CO_2 is ruled out as well as the presence of chlorides at the level of the rod, the uncertain potentials are attributed to variations in environmental conditions, since no corrosion products were observed during the 2 years that the study lasted. Therefore, this behavior is attributed to the relative humidity, rainfall and temperature prevailing in the southeast of Mexico, which favors and gives the conditions to take the steel to potentials at uncertain values [Pérez et al, 2010].

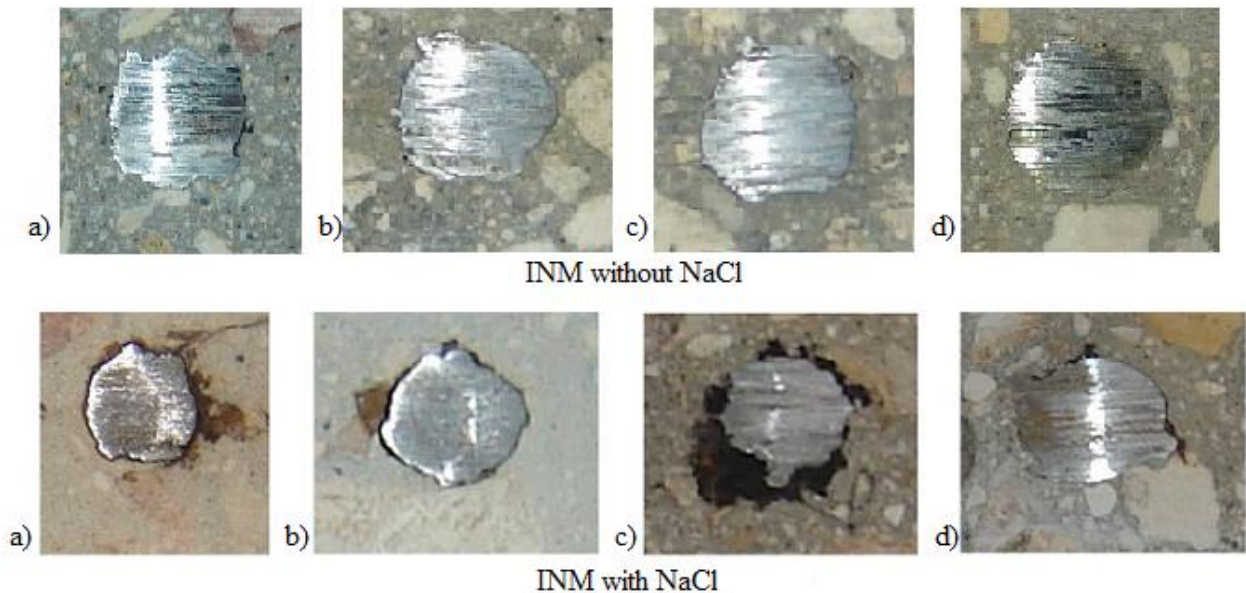
Figure 8. Photographic record of the concrete-reinforcing steel interface: a) 6, b) 12, c) 18 and d) 24 months, respectively, in structures exposed to INM.

On those exposed to INM, Figure 8, the structures without additional NaCl do not show significant corrosion product formation on the concrete-reinforcing steel interface in the four periods; while in the structures with 3.5% NaCl added in the mixing water, oxidation is detected from six months after the start of the experiment. However, corrosion is not complete on the interface, since not all the area presents corrosion products. It is proposed that the damage to the film be limited due to the lack of oxygen when immersed in seawater. So, the chloride ion is the cause of corrosion.

In the samples prepared with additional NaCl exposed to INM, the presence of oxides in the concrete-reinforcing steel interface during the four stages of the photographic record coincides with the results of corrosion potentials with high probability of corrosion obtained in the 2 years of study. This is mainly attributed to the chlorides added to the mixing water since the the manufacture of concrete structures, when CO₂ was ruled out.

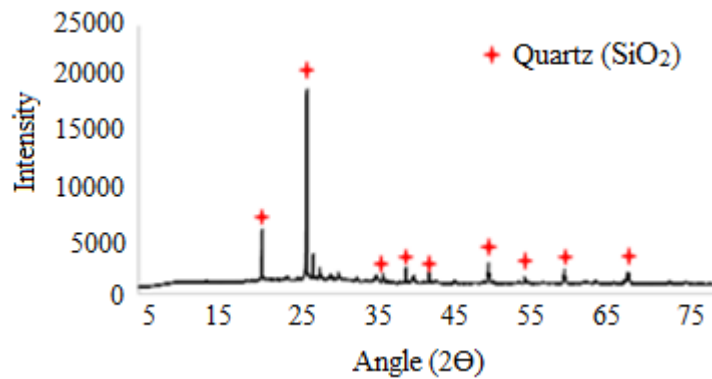
Figure 1. SCBA-Piz - XRD results. Font: Author (2016).

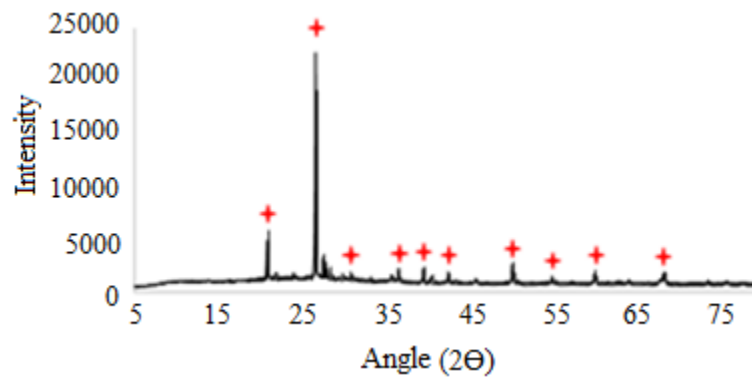
Figure 2. SCBA-Ind - XRD results. Font: Author (2016).

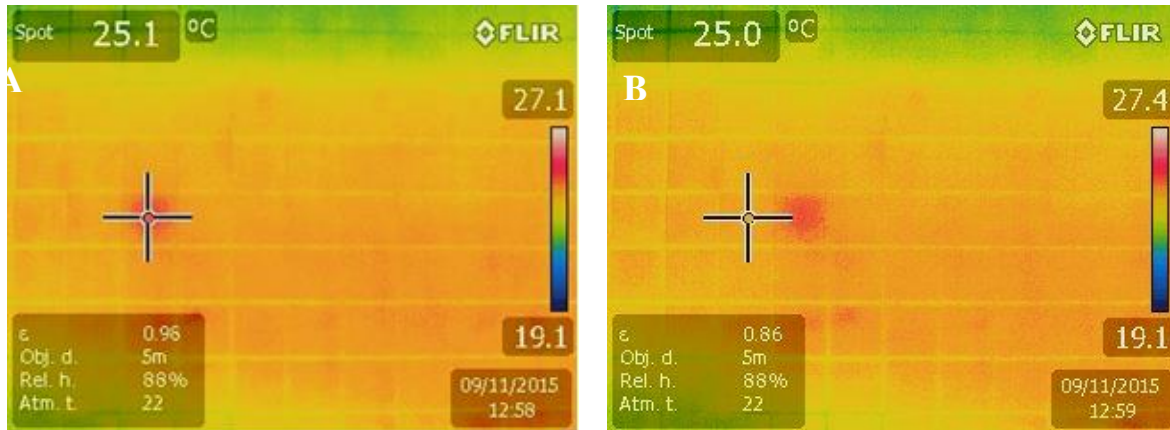
The test consisted in measuring the surface temperature of the insulation tape, thermally stable with the surface indicated by point A, followed by the measurement of temperature in the material region to be analyzed, indicated by point B, modifying the emissivity parameter of the thermal imager until the temperature indicated at point B is equal to the temperature measurement indicated on the insulating tape surface. Figure 4 shows the calibration performed on the thermal imager for a ceramic cladding.

Figure 4. Ceramic cladding emissivity determination.

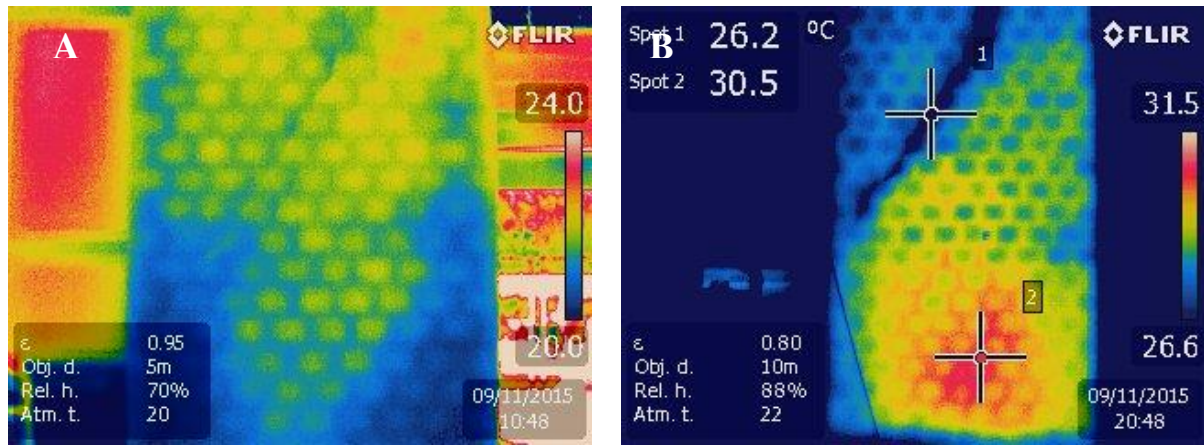
A fissure was observed in the cladding of study area 2, as presented by the thermograms shown in Figure 6.

Figure 6. A) Exploratory study thermogram.
B) Confirmatory study thermogram.

In the exploratory study thermogram, shown in Figure 6A, it is possible to observe the existence of a thermal gradient in the lower part of the façade and a diagonal line, with temperatures lower than the central part of the façade. In the confirmatory study thermogram, illustrated in Figure 6B, it is possible to verify the existence of the diagonal fissure, marked by point 1, and the region with mortar plaster detachment together with moisture presence marked by point 2, with a higher temperature due to the ability water has of retaining heat during negative heat flow periods when compared to that of cladding materials.

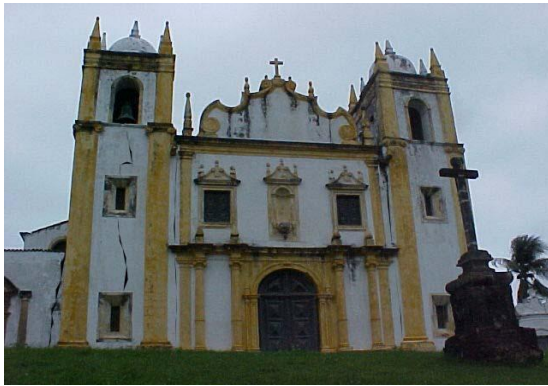
Figure 3. Structural damage to the Carmo Church in the year 2000. Source: Public Collection of Olinda.

Around the year 2000, the Carmo Church underwent several interventions, undergoing restoration and stabilization of the slopes on which the building is supported, including the need to rebuild the slopes and reinforce the foundations and the east bell tower, which had become compromised (see Figure 3). The restoration and recovery services lasted about 10 years before

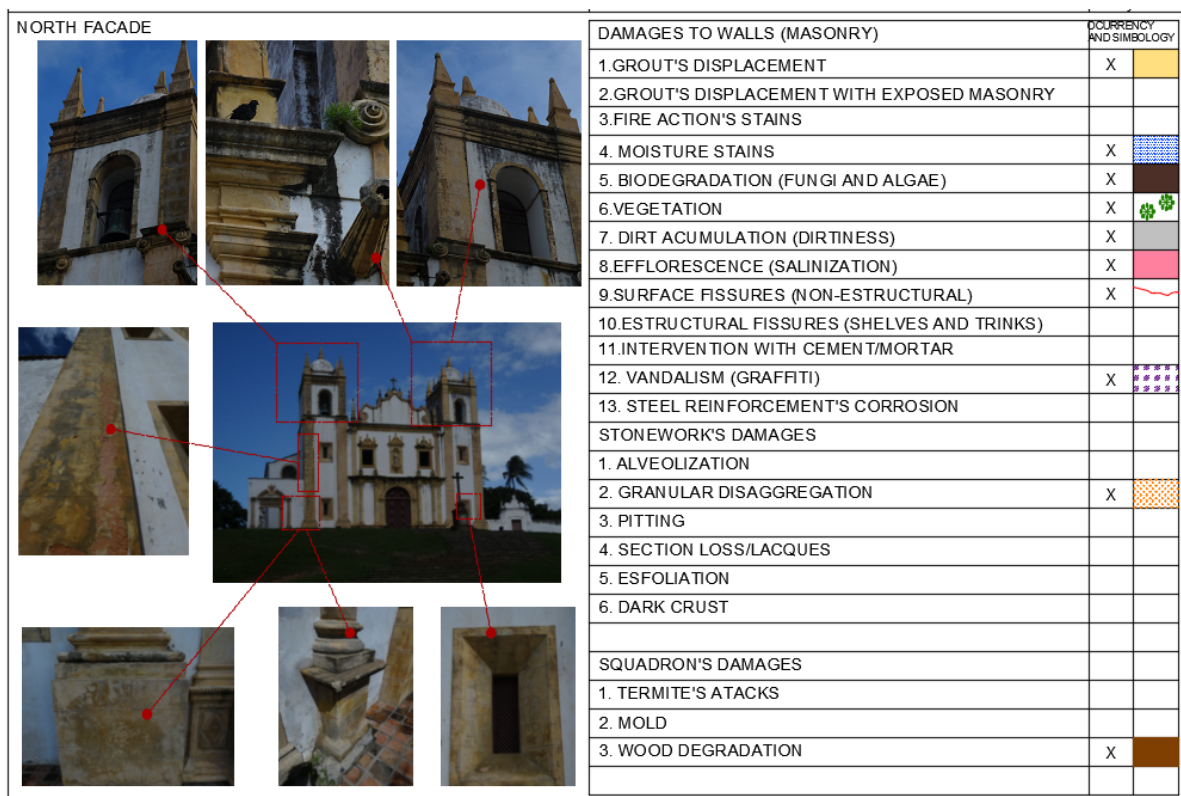
Figure 6. Damage identification form for the north façade of the Carmo Church. Source: Authors.

The DIF is organized to present, in addition to the list of damages found, some relevant photographs of the anomalies and the date on which the surveys were carried out, in order to establish a relationship between the state of degradation of the building and the time when it was inspected, as shown in Figure 6. The period in which the building was surveyed is important, in light of the possibility of the evolution of damage, as pathological manifestations tend to develop when the environment in which the building is located is conducive.

It should be noted that the damage map shown in Figure 10 was based on the information obtained by the DIF shown in Figure 6. Figure 11, in turn, considered the observations presented in the DIF of Figure 8. Figure 12 was based on information from the DIF in Figure 7 and the damage map of Figure 13 was drawn from the data contained in the DIF of Figure 9.

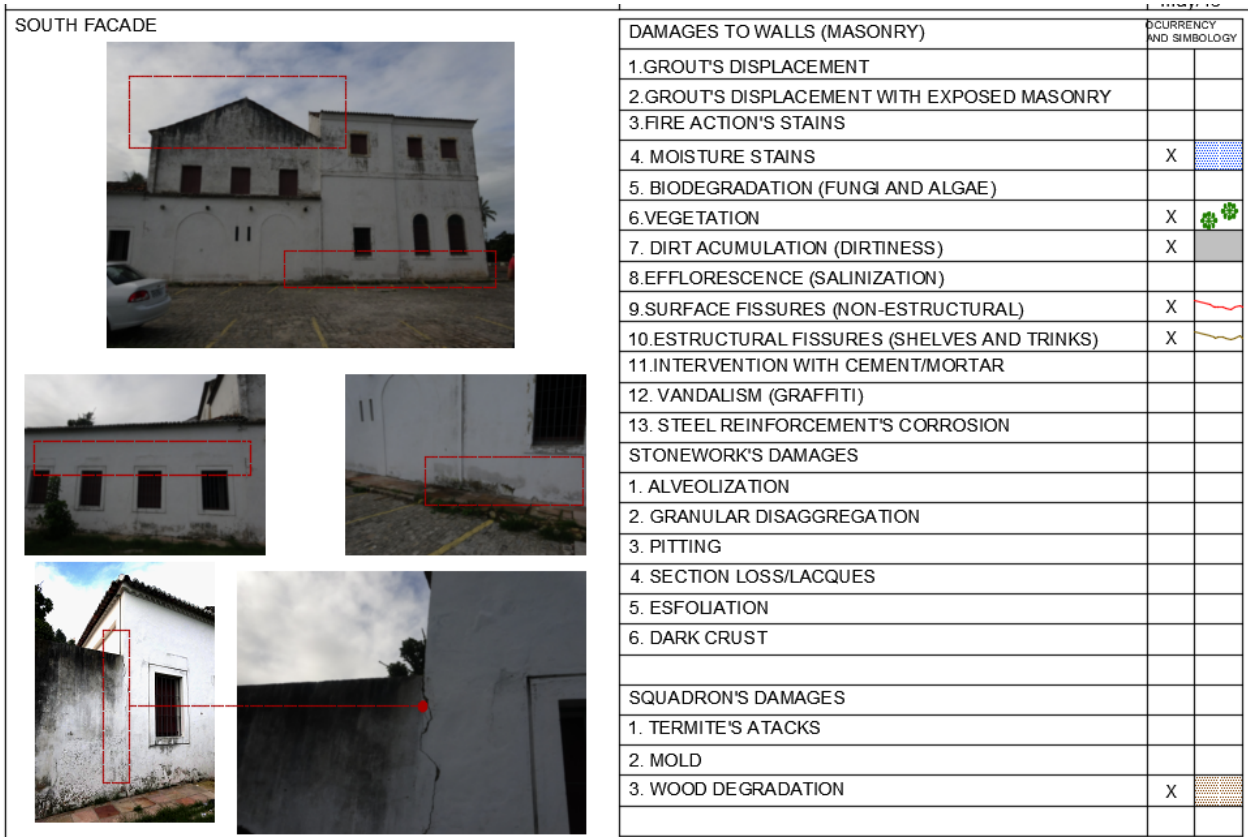
Figure 8. Damage identification form for the south façade of the Carmo Church. Source: Authors.

On the southern façade, damp spots with accumulations of dirt were also observed, including ascending moisture stains along the entire length of the façade (see Figure 8).

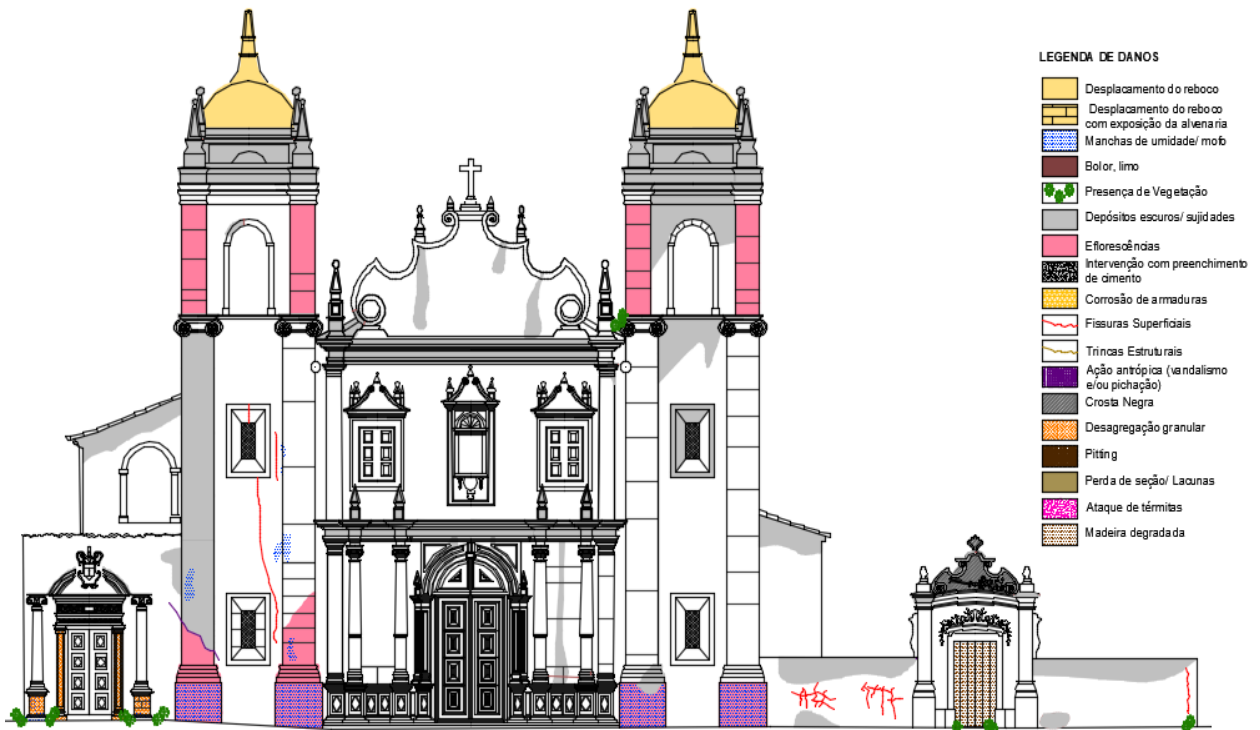
Figure 10. Damage Map of the North Façade of the Carmo Church. Source: Authors.

Figures 10, 11, 12, and 13 below show the damage maps produced for the north, east, south, and west façades, respectively, of the Carmo Church.

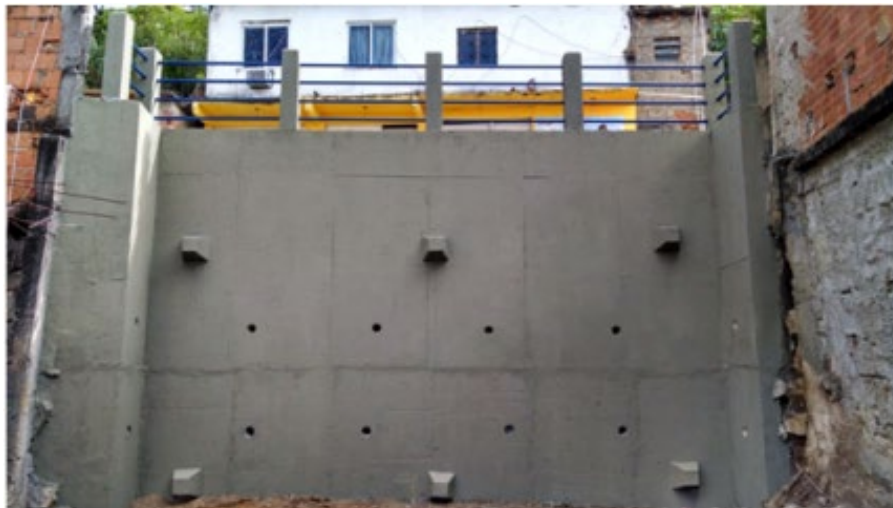
Figure 1. An anchored curtain in a geotechnical hazard area (Author)

This geotechnical solution constitutes the most adequate technical solution for containing the high horizontal forces resulting from deep excavations with minimum displacements of soil mass and structures located in the vicinity.

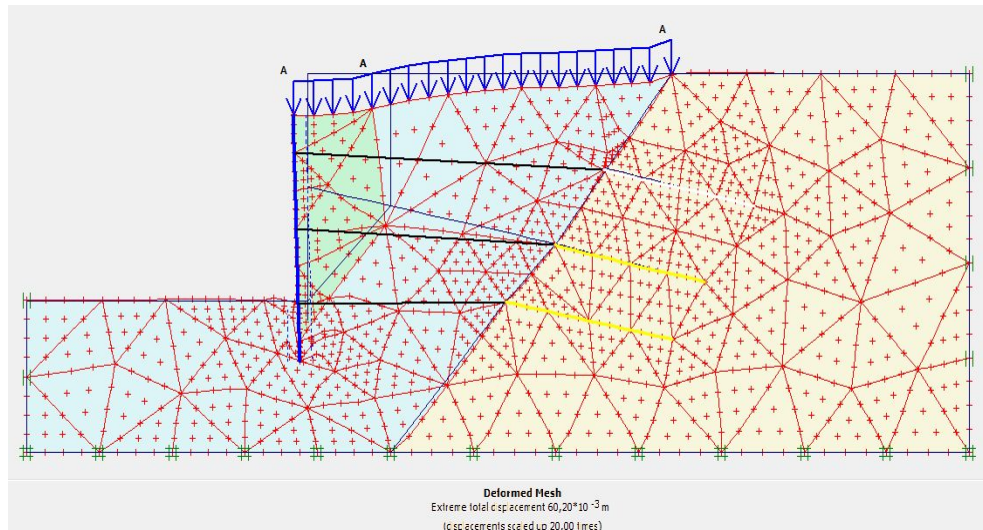
Soil strains or displacements (see Figure 6), which can occur between the anchor lines in the direction normal to the plane of the problem, are ignored in the two-dimensional situation. For that reason, the actual force applied on the rods is divided by the spacings between the rods in the normal direction.

Figure 6. Displacement of the anchored curtain after 50 years (Plaxis).

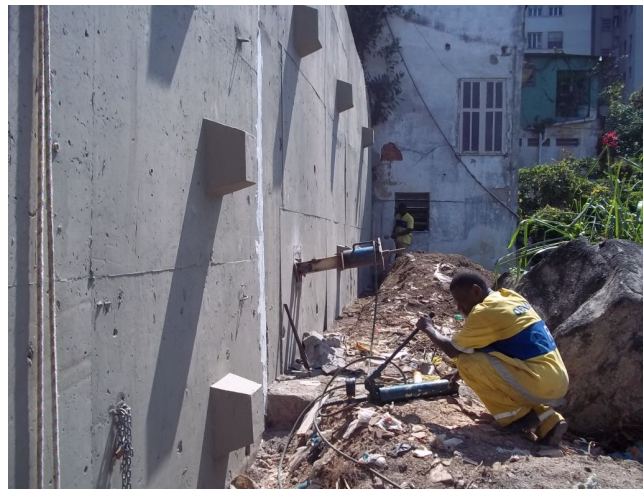
The execution of an RLVT is shown in Figure 7; the test was performed during the structural recovery of the hillside containment structure, which had already accumulated additional overloads over the 50 years since it was built.

Figure 7. Residual load verification testing underway.
