Revista **ALCONPAT**

January - April 2018

Service life analysis of reinforced concrete structure under uniform corrosion through ANN model coupled to the FEM

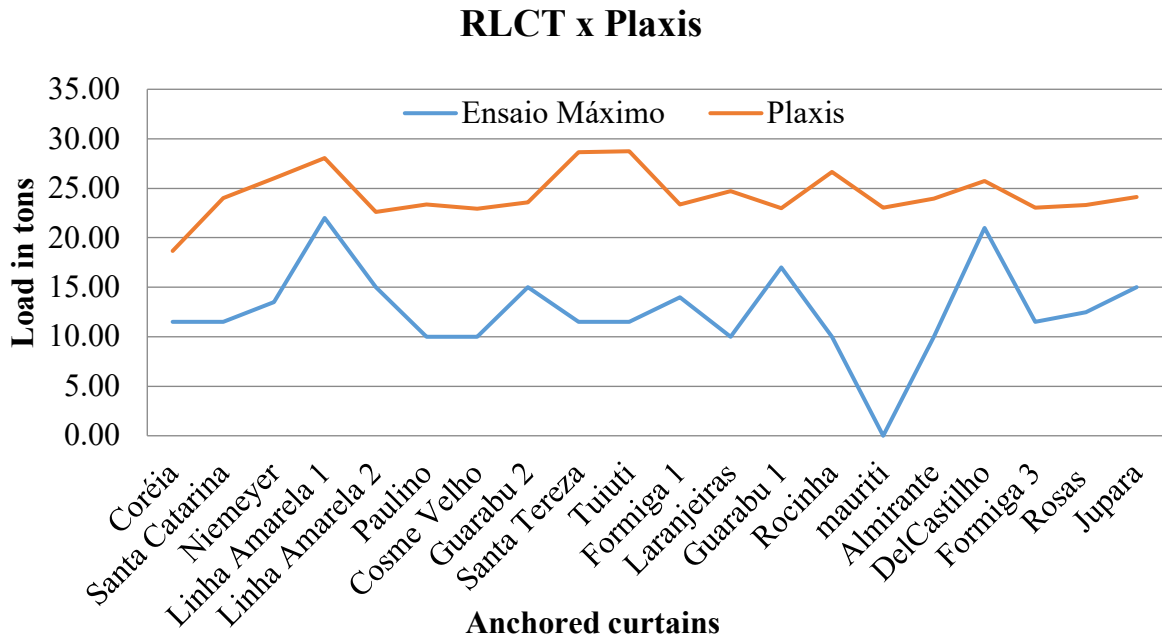
The graph in Figure 8 shows (blue line) the maximum RLVT results for all of the 20 anchored curtains surveyed over a period of 5 years. To obtain conservative values for the residual loads, the maximum residual load in tons for each anchored curtain was considered.

The maximum value of residual load for the tie rods was 22 tons for the curtain located near the Linha Amarela expressway in the suburbs of Rio de Janeiro, and the lowest value of ZERO tons was obtained for the curtain on Mauriti Street in the burrow of Santa Tereza.

The simulated residual loads on the tie rods after 50 years for the same anchored curtains are shown in Figure 8 (blue line). The values of the residual load changed over time from a maximum value of 28 tons for two curtains located in Saint Tereza and in the Tuiuti community to a minimum value of 18 tons for a curtain located in the Coréia community.

Figure 8. Graph of the RLVT and Plaxis results (Author).

It can be seen that the two lines that represent the tests simulated using the Plaxis computational system (blue line) and residual load verification test (red line) do not meet for any of the 20 anchored curtains surveyed over five years during this research.

After comparing the results of the practical tests and the theoretical tests developed using the Plaxis 8.2 2D computational tool (Figure 8), it was found that the results of the residual load verification tests did not show increases in load over time.

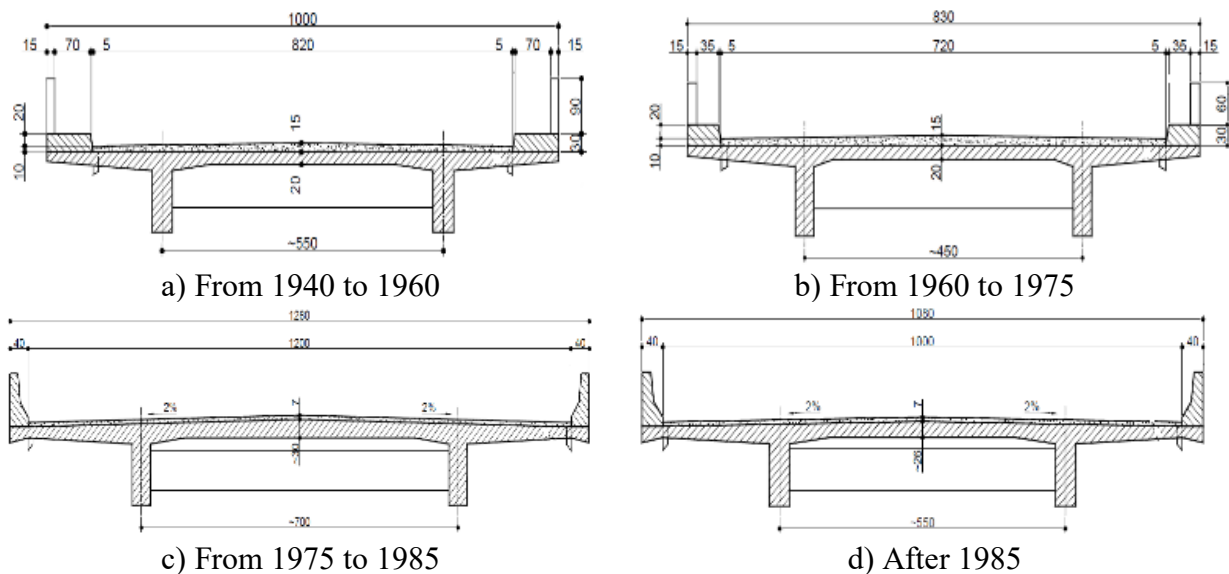
A survey was also carried out to identify the construction periods and the typical mobile loads of each structure. Failure to supply most of the original designs meant that much of this information was obtained by comparing the evolution of the bridge cross-sections of federal highways over time with the mobile loads that were used on bridges built in the respective periods, as shown in Figure 1.

Figure 1. Evolution of the transverse cross-section of federal road bridges (Measurements in cm)

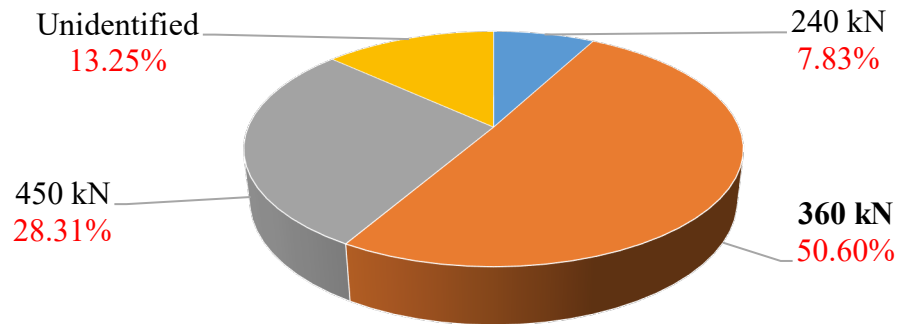
Regarding the project model load, Figure 2 shows that 50.60% of the structures were qualified with 360 kN loading. The mobile loads of 450 kN, currently used, represent 28.31% and those of 240 kN represent 7.83% of the total sample. There were also 13.25% of structures whose project model loads were not possible to identify.

Figure 2. Project model load of bridges evaluated

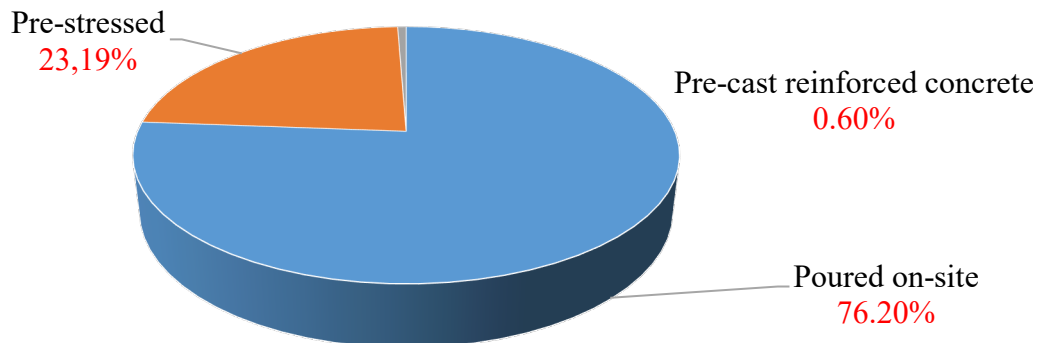
Regarding the constructive system, it was verified that reinforced concrete poured on-site was predominant, used in 76.20% of the bridges and viaducts. The second most prominent system was prestressed concrete, adopted in 23.19% of the structures. Pre-cast reinforced concrete accounted for 0.60%. These data are shown in Figure 3.

Figure 3. Constructive systems used on evaluated bridges

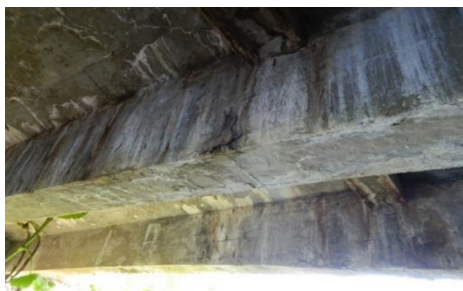
Figure 4. Presence of efflorescence, displacement of concrete coating, and reddish-brown spots due to the corrosion of reinforcement

In order to identify pathological manifestations, observations were made at each site during the inspections and the SGO survey reports were analyzed. The major pathological problems identified are illustrated in Figures 4 to 7.

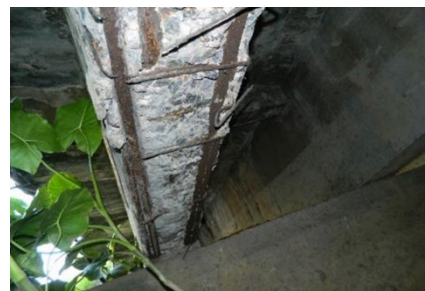
Figure 5. Exposed and rusty reinforcement on beams, some with broken strips

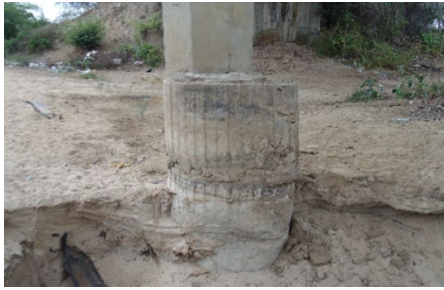
Figure 6. Erosion of the foundation and misalignment of the pillar in relation to the pipe

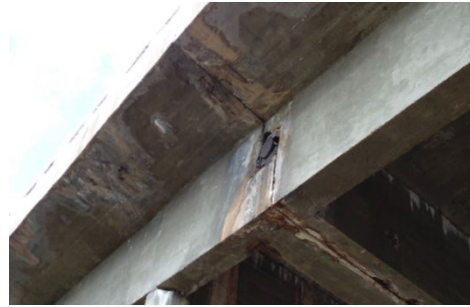
Figure 7. Metal bearing on a Gerber tooth with visible damage and infiltration

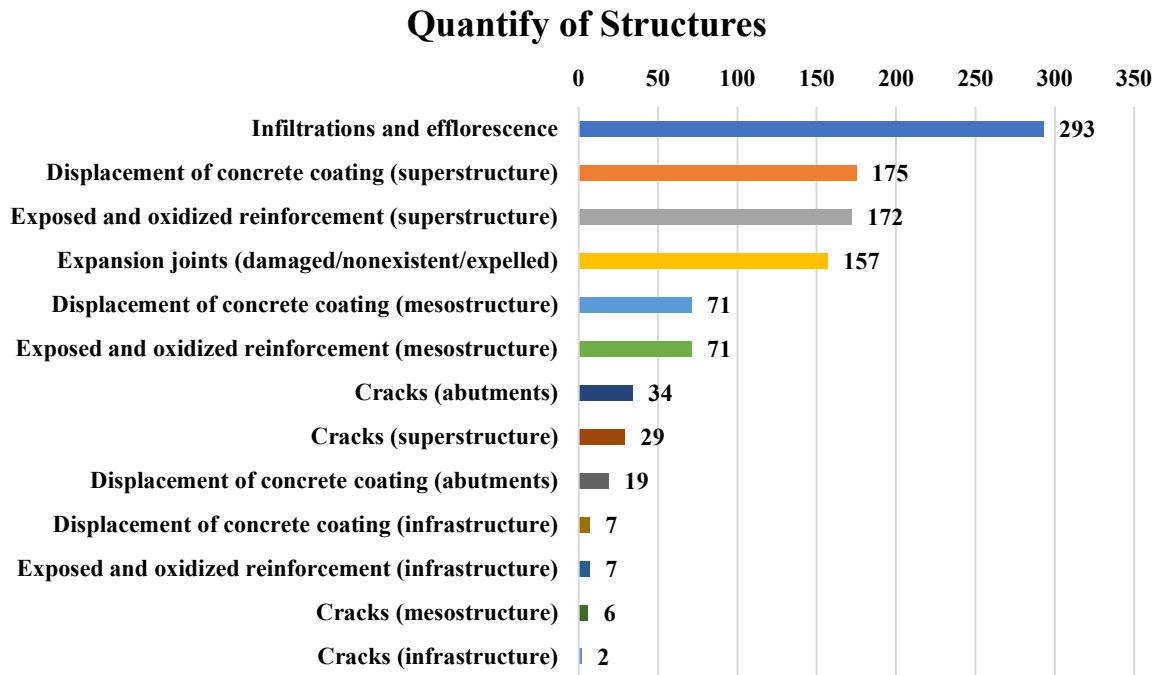
Figure 8. Occurrences of pathological manifestations in the analyzed structures

Figure 8 synthesizes the highest incidences of pathological manifestations for the evaluated set, showing the predominance of infiltrations and efflorescence, present in 293 SES. The following anomalies are also worth mentioning: displacement of the concrete (of the superstructure) in 175 structures, exposed and oxidized reinforcement (of the superstructure) in 172 structures, and damaged and/or nonexistent expansion joints in 157 SES.

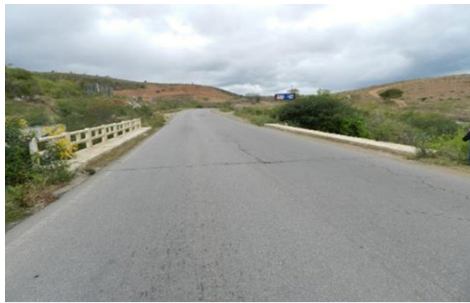
Figure 9. Absence of lateral guard-rail

Similar to the pathological manifestations, some of the main types of damage observed in the bridges and viaducts of this study are illustrated in Figures 9 to 12.

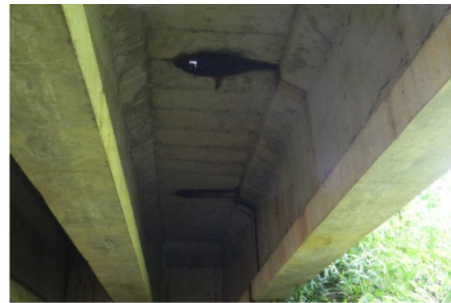
Figure 10. Damaged drain causing infiltration and moisture spots between the beams

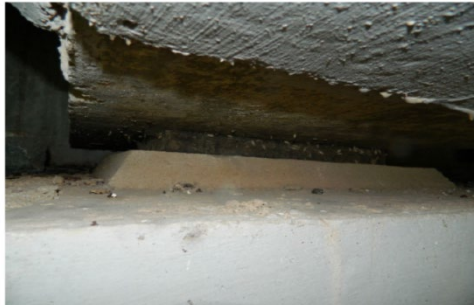
Figure 11. Deformed elastomeric bearing

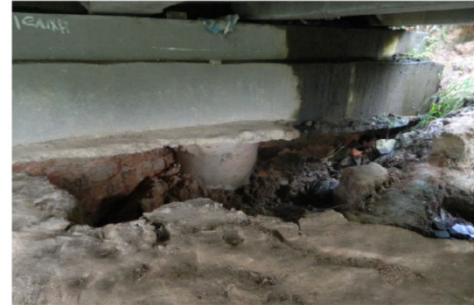
Figure 12. Extreme erosion around the foundation

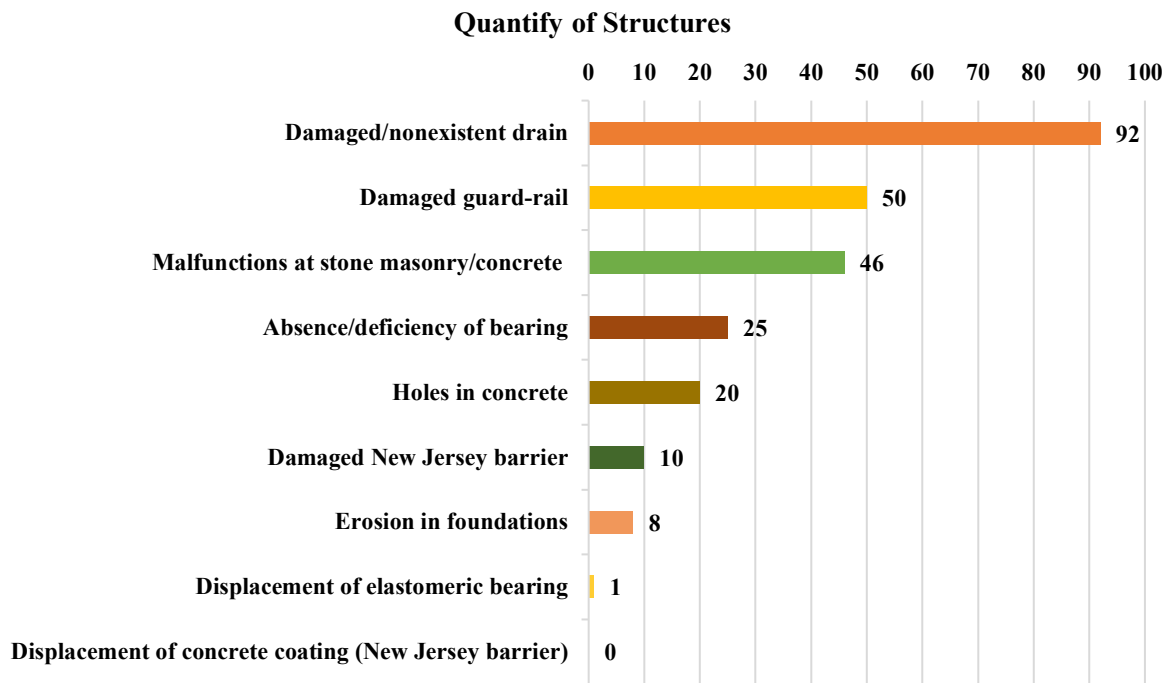
Figure 13 quantifies the principal damage types found in the analyzed set of structures. It was verified that 92 bridges had damaged and/or nonexistent drains. Next most prevalent were damaged guardrails (50 SES), followed by breakdowns in stone/concrete masonry (46 SES), as well as the lack or deficiency of bearings (25 SES), and holes in the concrete (20 SES). Other types of damage occurred less frequently.

Figure 13. Principal types of structural damage found in the set of structures analyzed

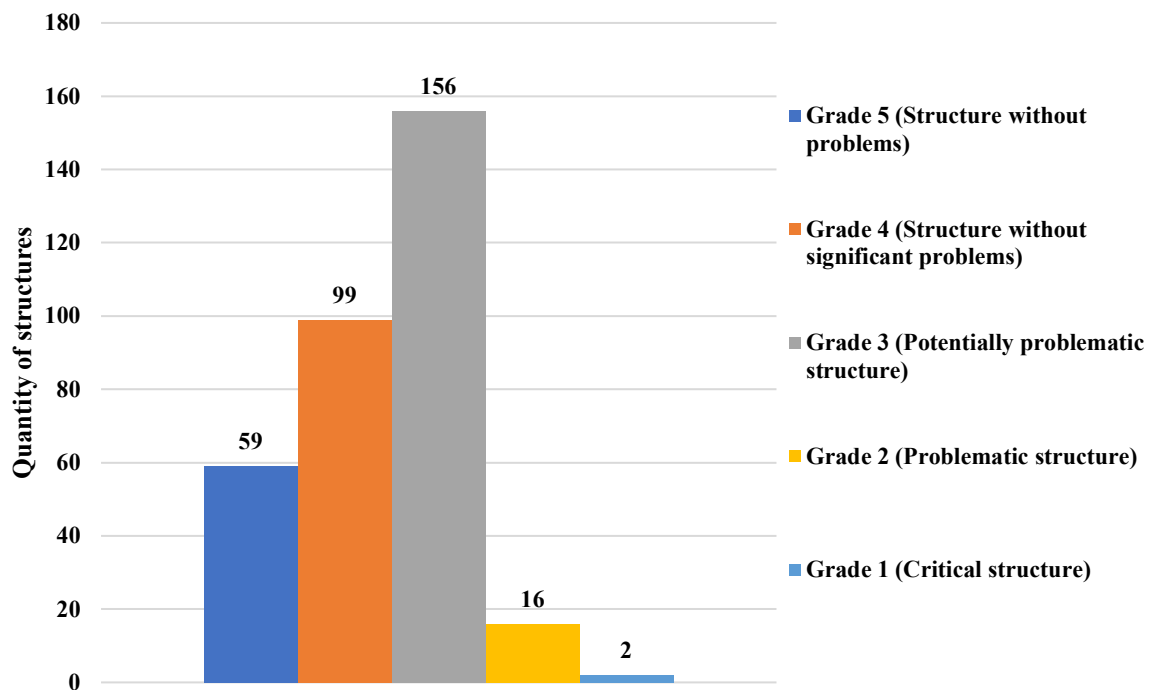
The application of these criteria to the sample studied is shown in Figure 14, which indicates that 156 SES can be classified as potentially problematic (grade 3), or 46.99%. It is important to note that 174 structures were evaluated as having grades between 1 and 3 (critical to potentially problematic), which is equivalent to 52.41% of the sample studied. Only 59 structures (17.77%) received a grade of 5.

Figure 14. Stability conditions according to DNIT 010/2004-PRO

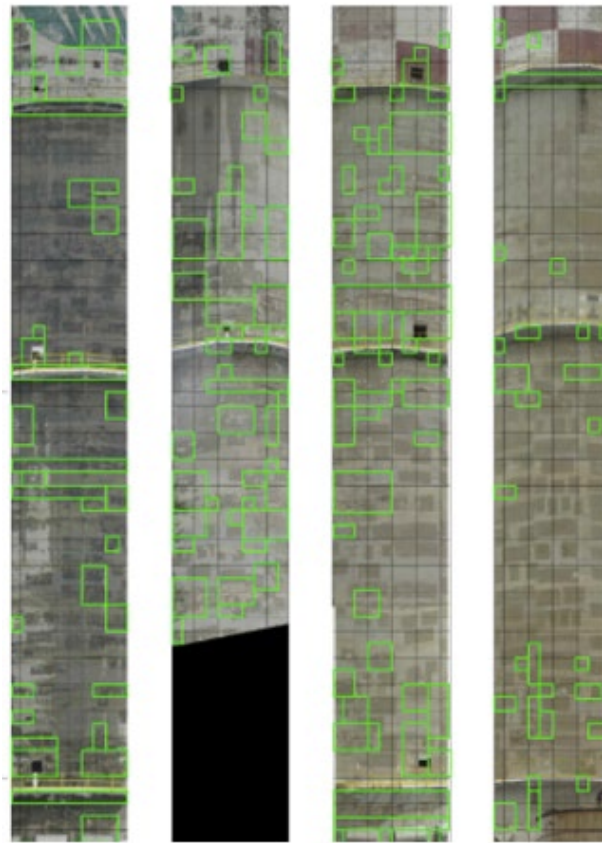
An aerial drone was used to facilitate damage survey due to structural complexity, limited access to high areas and time concerns. An autonomous mission was designed using a flight plan based on sequential GPS points along the tower’s four vertical surfaces (north, east, south and west). Drone cruise speed was controlled such that high quality images were taken in areas with visible structural damage. These were converted into two-dimensional maps and areas with the greatest visible damage marked (Figure 2).

Figure 2. Two-dimensional map of drone images. Areas of major visible damage delimited by green lines.

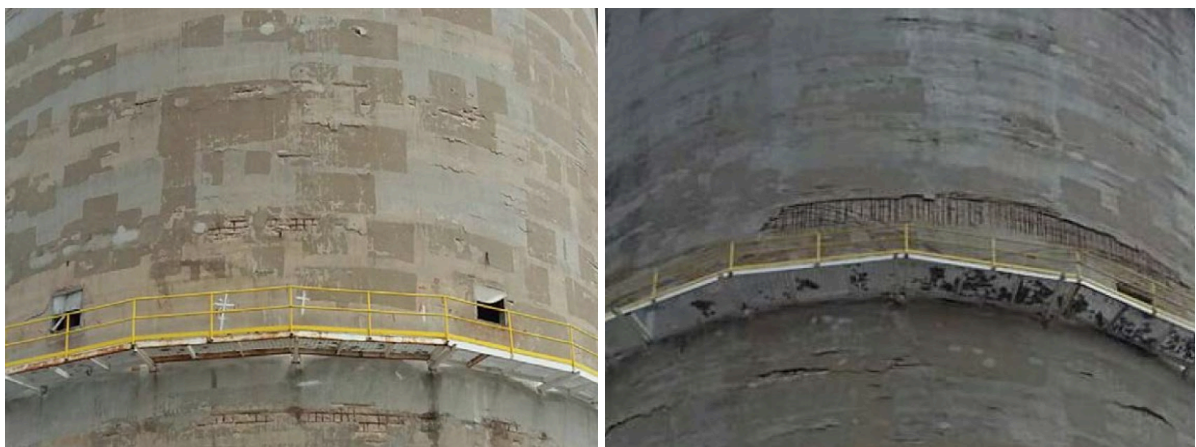
Previous, localized repairs are clearly visible in the images. Since these were probably not done adequately, they may have accelerated deterioration processes in the concrete-steel system (Figure 3 and 4). There are also areas of concrete detachment and spalling, exposed steel reinforcement, diminished section of the reinforcement and cracks ranging in length from approximately 0.50 m to 5.00 m and in width from 3 mm and up.

Figure 3. Exposed steel reinforcement, corrosion, concrete spalling and multiple rectangles indicating the sites of previous localized repairs.

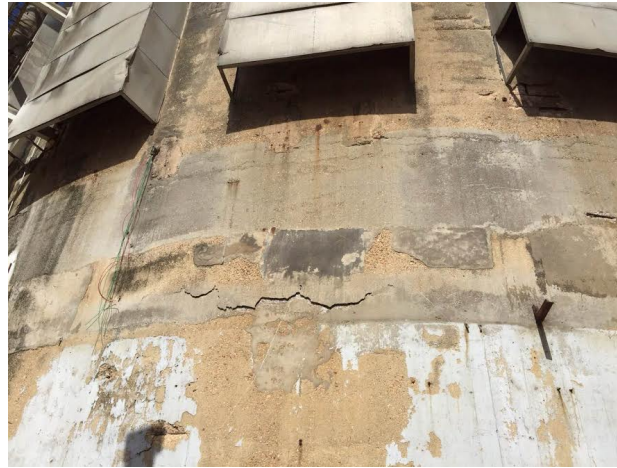
Figure 4. Detail of localized repairs in which the more recent concrete has separated from the original concrete, causing occasional spalling and anodic zones favoring formation of corrosion cells.

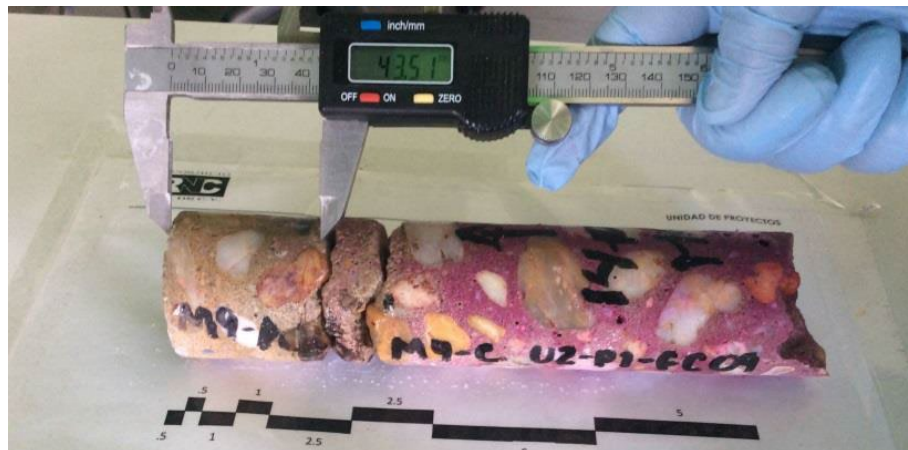
In some samples the depth of carbonation was notable. For example, in U2-P1-P04 a clear colorless zone was visible after phenolphthalein application (Figure 5). This indicates a considerable drop in concrete pH that extends to the depth of the rebar (Table 2). Severe damage is also present from cracks running parallel to the wall surface.

Figure 5. Depth of carbonation in U2-P1-P04. Note depth of damage and cracks parallel to the surface.

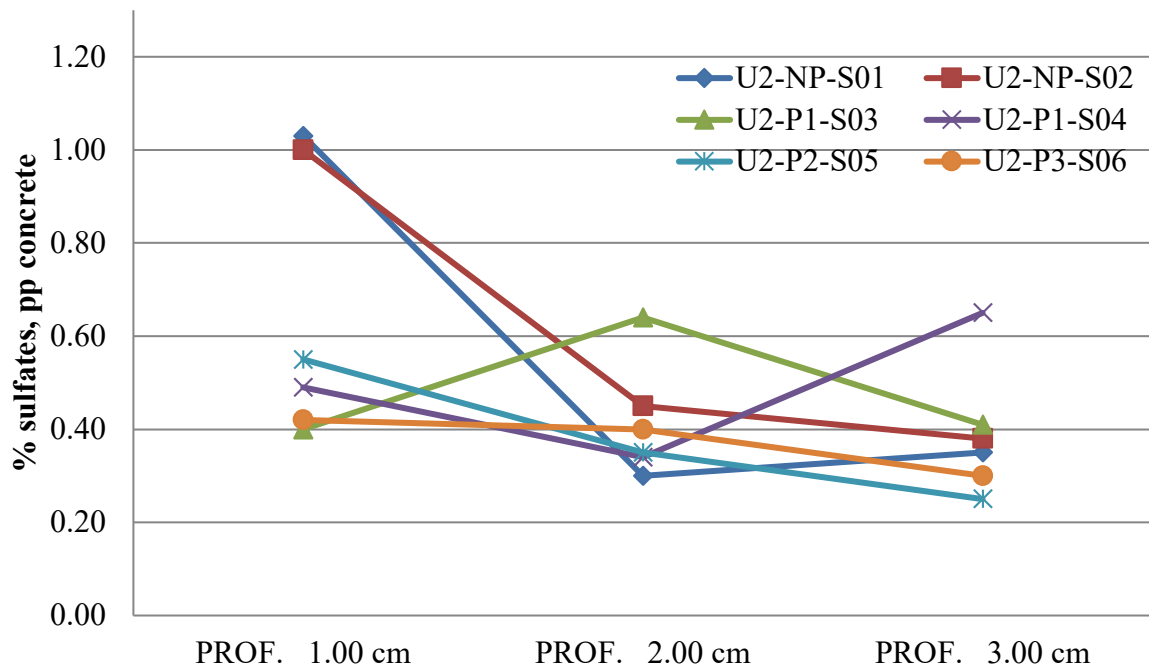
At the concrete surface, this parameter varied from 0.25 to 1.0% pp concrete content, and at 3 cm depth it varied from 0.50 to 0.80% pp concrete content (Figure 6). These are considered high values since the limit is 0.40% pp concrete content. Nearby sources of high sulfate levels include marine waters, industrial gases and the water in adjacent cooling towers. Sulfate attack of concrete components can cause formation of ettringite and plaster.

Figure 6. Sulfate concentration in concrete samples by depth. All tested areas exceeded the 0.40% pp concrete threshold, indicating sulfates damage. (PROF = DEPTH)

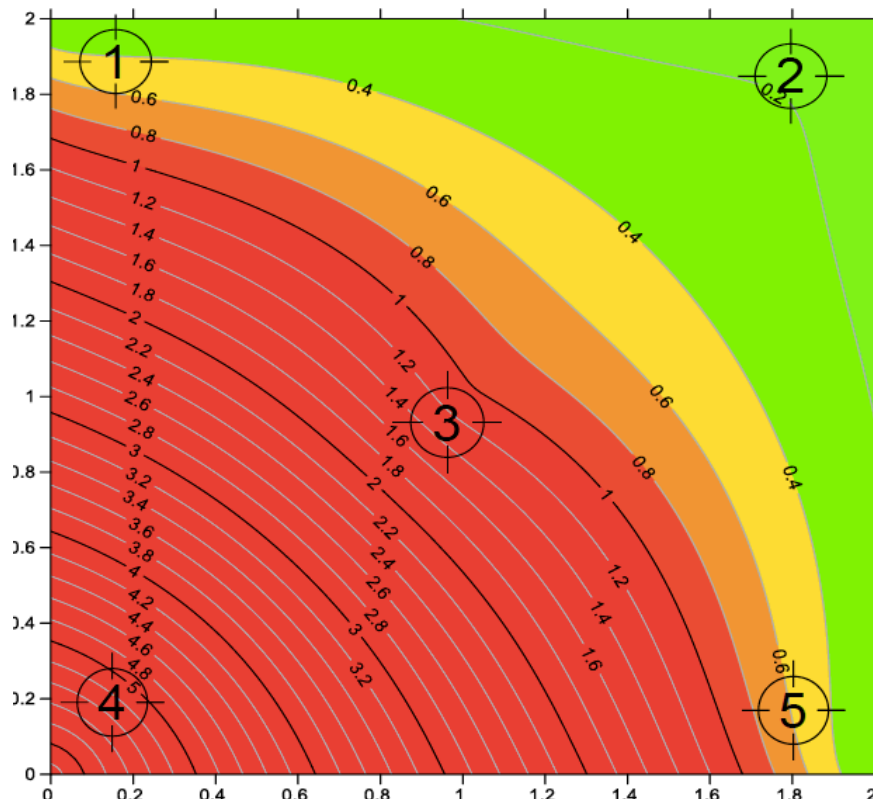
Non-destructive tests of corrosion rate were run even though areas of exposed steel were quite evident and rebar corrosion was obvious. Values for this parameter were moderate to very high in most cases (Table 2), with values near $5 \mu\text{A}/\text{cm}^2$ (Figure 7).

Figure 7. Corrosion rate isovalues for study zone U2-P1-P04; most values are very high.

The very high corrosion rate values may have been caused by localized repairs done with uncompacted materials, which cause cracks and spalling between the new and pre-existing concrete. This is a very common effect at the concrete-steel interface in real structures. It arises from the “top-bar” effect in which adherence to the steel reinforcement decreases in the cover, particularly in thick concrete with inadequate compaction (P.R. Jeanty et al., 1988; A. Castel, 2006). It can also result from corrosion caused by galvanic current within the macrocell. This is caused by an electric connection between rebar exposed to different electrochemical surroundings, that is, passive steel in recently repaired zones and active steel in carbonated zones (J. Gulikers and M. Raupach, 2006; J. Warkus and M. Raupach, 2006). High galvanic currents result which lead to high corrosion levels according to RILEM recommended levels (A. Nasser et al., 2010).
