## **ALCONPAT International**

## **Revista ALCONPAT**

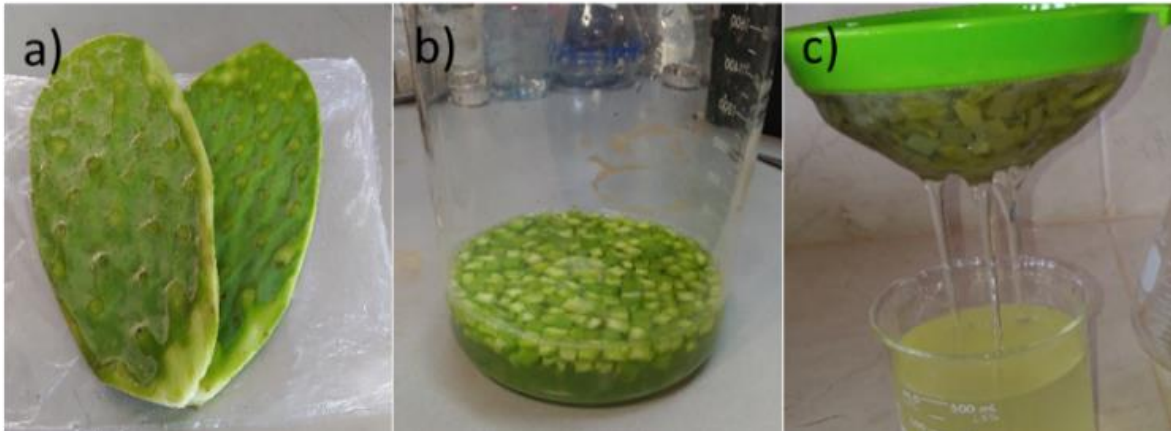
Figure 1. a) Fresh cactus leaves, b) Prickly pear cactus mixed with water y c) Filtration process of Nopal mucilage.

The cactus leaves that were used had a fresh state of preservation and were free of spines. To proceed with the extraction of the Nopal mucilage, the following procedure was carried out: i) the cleaning of the leaves was carried out to eliminate traces of dust and other residues, ii) the leaves were cut into pieces of 1cm x 1cm to extract the gel as much as possible and iii) the pieces were mixed with water to obtain three concentrations of mucilage in a Nopal-water weight ratio of 1: 1, 1: 2 and 1: 3, seen on Figure 1.

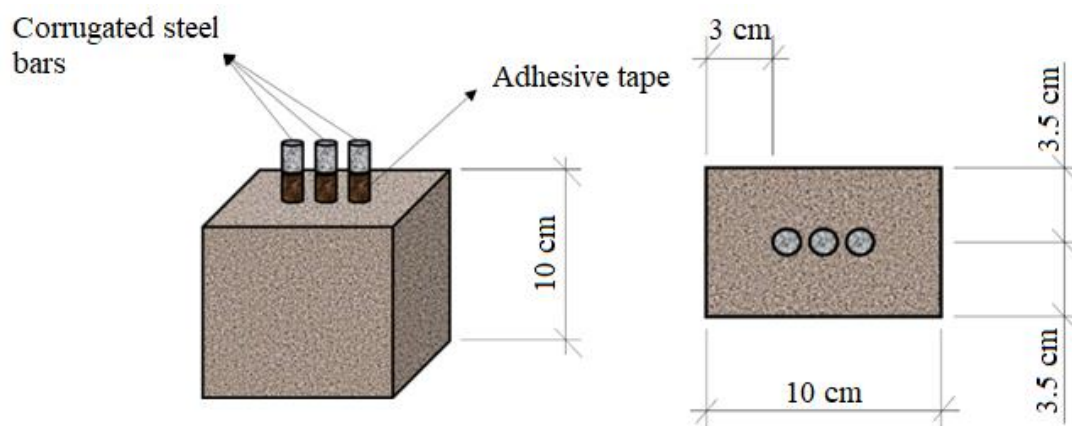
Figure 2. Dimensions of concrete samples.

The specimens were designed with a 30 mm of concrete cover between the edge of the bars and the sides of the cube. Therefore, the specimens were 7 cm wide, 10 cm long and 10 cm high, and the exposed area of the steel bars in contact with the concrete was 18 cm<sup>2</sup>, as seen in Figure 2. Each steel bar was coated with adhesive tape on the mortar-air interface as described by other authors (González et. al., 2004; Caré and Raharinaivo, 2007; Poursaee, 2010).

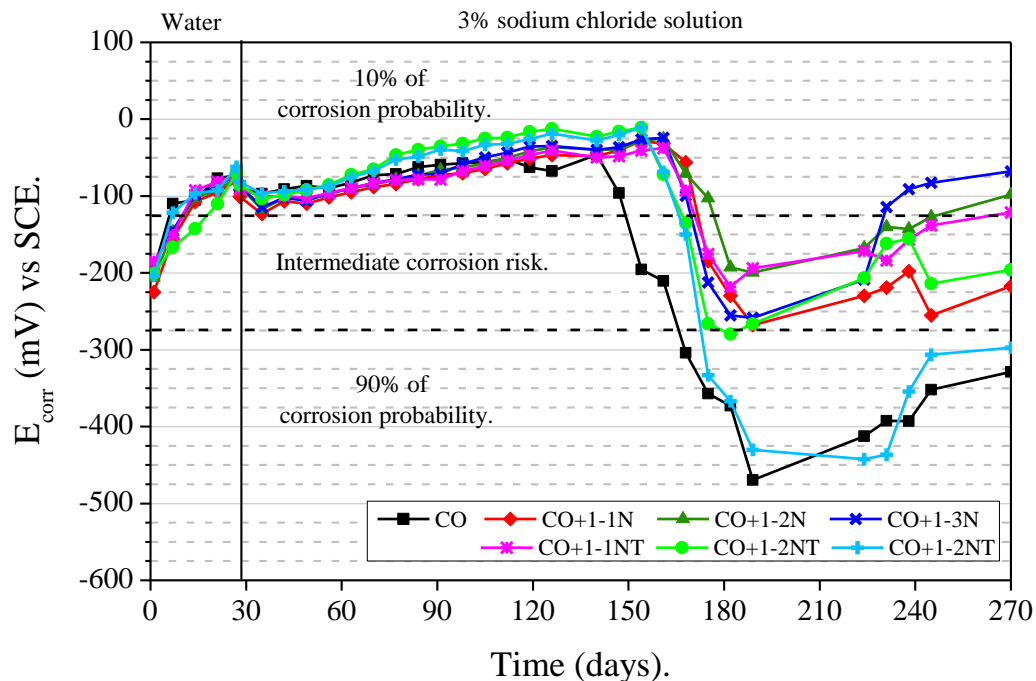
Figure 3. Behavior of corrosion potential values ( $E_{\text{corr}}$ ) with time.

The corrosion potential values for all samples with Nopal mucilage are detailed in Figure 3.

During the concrete curing process, it is clear that the potential of all samples acquires very noble values, between -90 and -50 mV. These values remain in the range of a 10% probability of corrosion (Pérez-Quiroz et. al., 2008). The high alkalinity, as well as the presence of moisture and oxygen in the concrete pore network, are factors that influence these potential values. Under these conditions, the steel develops an oxides passive layer of compact and waterproof (Hansson, 1984). All samples with Nopal mucilage, have a drop in their values and reach the range of intermediate corrosion risk. Possibly, due to the presence of chloride ions on the surface of the steel, localized corrosion occurs and consequently the breakdown of the passive layer (Caré and Raharinaivo, 2007). Although with the advance of the exposure period, the ideal conditions of the concrete seem to be maintained and the potential values are gradually recovered, approaching more noble potential values, between -210 and -60 mV. Unlike the control sample that reaches values close to -500 mV with a probability of corrosion of 90%. The CO+1-3N sample showed the best behavior with very noble values of potential, around 60 mV at 270 days of testing.

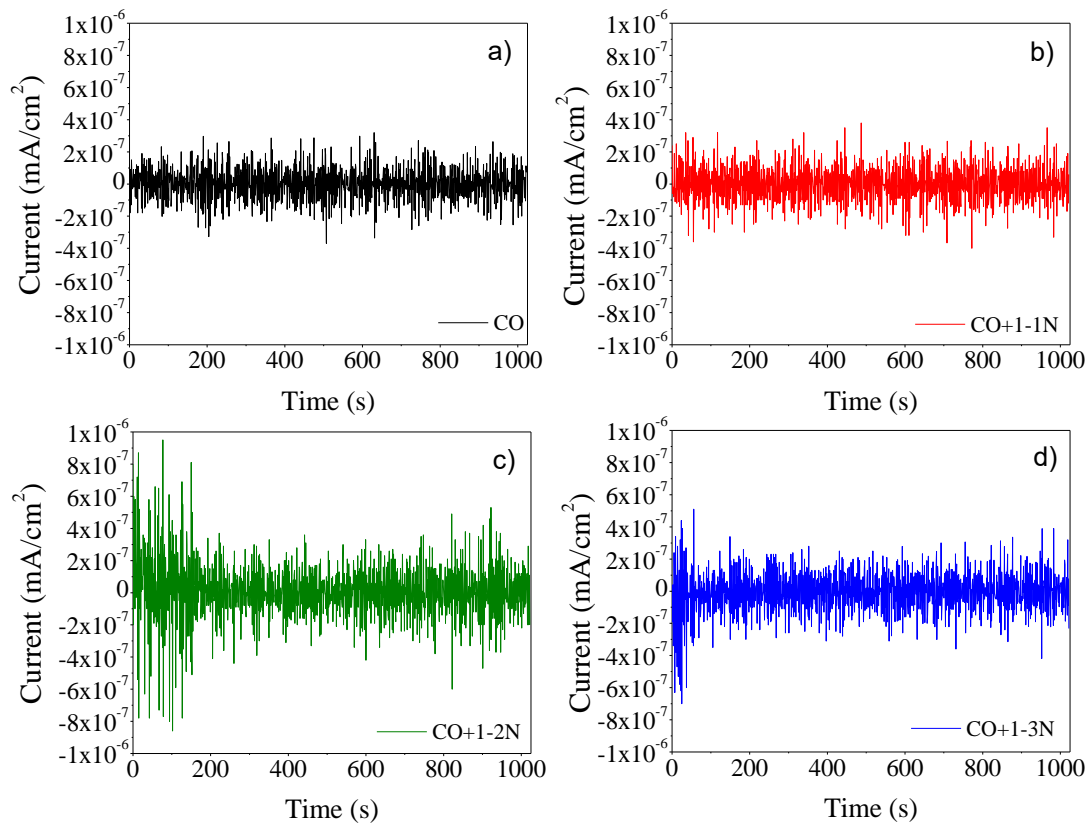
Figure 4. Time series of current at 28 days of concrete curing for the following samples: a) CO, b) CO+1-1N, c) CO+1-2N and d) CO+1-3N.

As an example, the following time series shows the current fluctuations of the samples with Nopal mucilage obtained by maceration at room temperature, see Figure 4 and Figure 5.

After 28 days of concrete curing, all current time series show a similar behavior with fluctuations that reach values of up to  $2 \times 10^{-7}$  mA/cm<sup>2</sup>. These low current values are indicative of a passivation state in the reinforcing steel. The passive layer of steel evolves over time (Hansson, 1984) and through this technique these small changes in current values can be detected (Gusmano et al., 1997; Cottis, 2001). Only CO+1-3N sample has some transients with values of up to  $8 \times 10^{-7}$  mA/cm<sup>2</sup>. With the advance of the exposure time to the aggressive environment, a significant change in the behavior of the time series for the CO sample can be seen. In general, a change in the values of current time series of up to an order of magnitude is observed, with some transients reaching values of up to  $8 \times 10^{-6}$  mA/cm<sup>2</sup>. This behavior can be associated to the presence of chloride ions on the surface of the steel, which cause the rupture of the oxide layer (Hansson, 1984). On the other hand, the samples with Nopal mucilage for day 161 show a decrease in the current values, and no abrupt changes are observed. This is an indication that the steel passivation steel is maintained as well as the conditions for it to remain in that state.

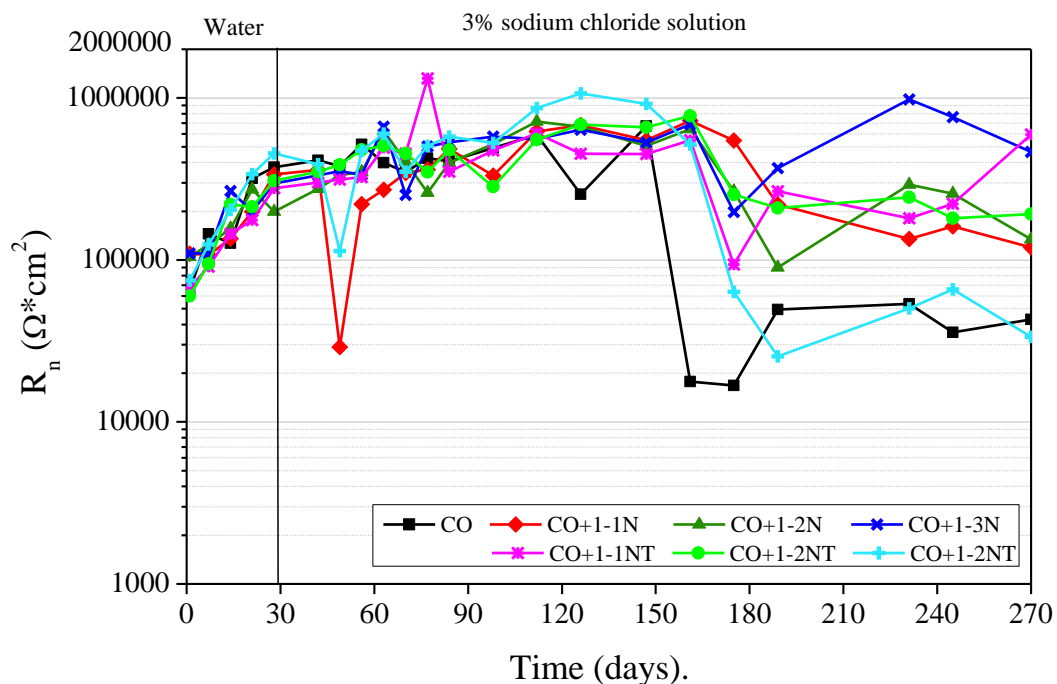
Figure 6. Behavior of noise resistance ( $R_n$ ) values with time.

At the beginning of the tests, a progressive increase in  $R_n$  is observed. These results show that the cactus mucilage does not adversely affect the curing process of concrete and guarantees the conditions for the reinforcing steel to develop a passive film. After 150 days of testing, the control sample shows a fall in  $R_n$  values close to  $2 \times 10^4 \Omega \cdot \text{cm}^2$ , with significant fluctuations in their values. This behavior indicates that the onset of corrosion consists of a series of severe localized events (Legat et. al., 2004).

At the end of the test period all samples with Nopal, keep values greater than  $1 \times 10^5 \Omega \cdot \text{cm}^2$ , with the exception of the CO+1-3NT sample, which maintained a slightly higher performance respect to the control sample. In contrast, the CO+1-3N sample reached values greater than  $4 \times 10^5 \Omega \cdot \text{cm}^2$  significantly improving the electrochemical properties of reinforced concrete. This response evidences part of the advantages offered by this Nopal gel, as it not only acts as a retarder of setting concrete, but also as an additive that can improve the electrochemical response of reinforcing steel, delay the onset and active spread of corrosion in reinforcing steel (Martinez-Molina et. al., 2015).

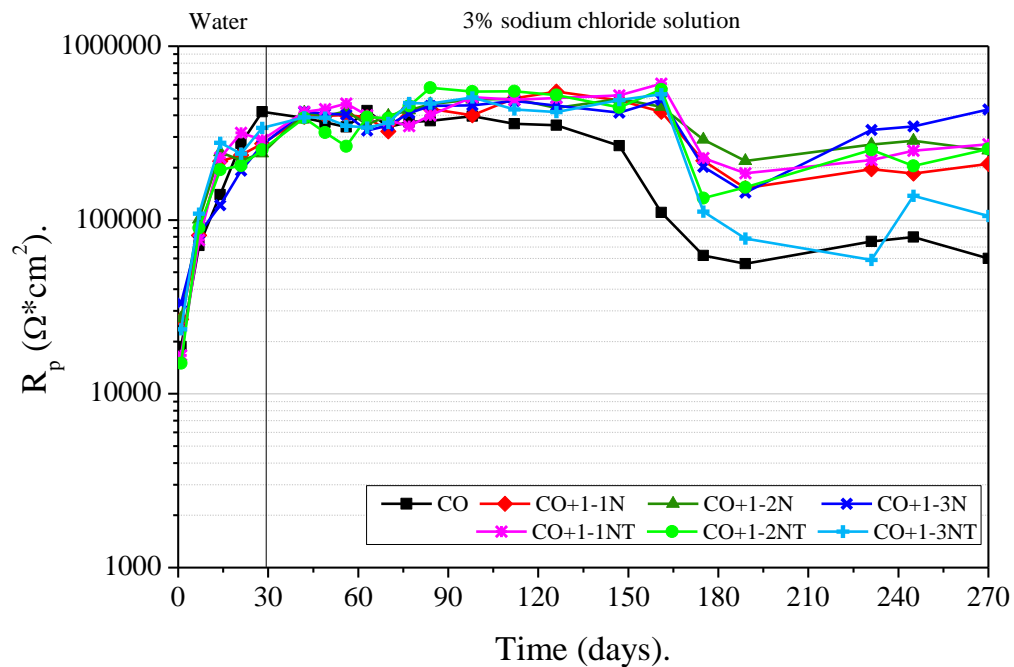
Figure 7. Behavior of polarization resistance ( $R_p$ ) values with time.

In Figure 7 it can be observe the  $R_p$  values obtained from linear polarization resistance technique.

In general, it can be seen that these results show a similar trend to noise resistance values. The good performance of the Nopal mucilage within the concrete matrix is evident, because despite presenting a drop in  $R_p$  values after 150 days of exposure to the aggressive environment, progressively the resistance of all samples increases at the end of the trial period.

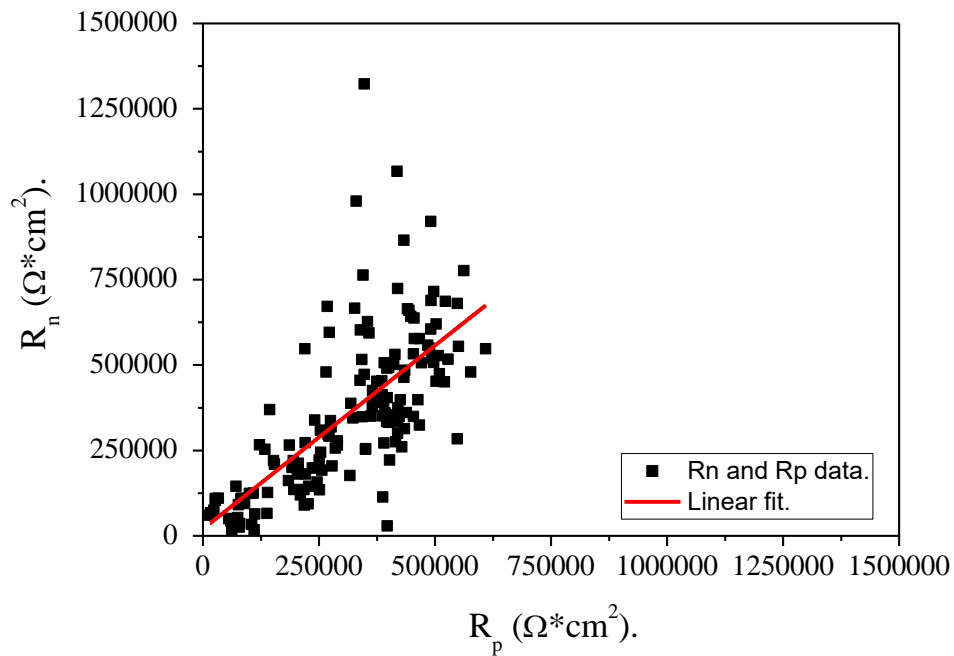
Figure 8. Correlation between the  $R_n$  and  $R_p$  values of all samples.

A linear correlation was made from the  $R_n$  and  $R_p$  results of all samples, as shown in Figure 8.

From this analysis a correlation coefficient with a value of 0.695 was obtained. This value indicates a reasonable correlation between the results of both electrochemical techniques (Kearns et al., 1996), taking into account that a value of zero indicates that there is no correlation and a value of one indicates a very good correlation. This result confirming that both techniques are equivalent and suitable for the electrochemical study of reinforcing steel in concrete. In fact, many studies of the electrochemical behavior of reinforcing steel in particular with the use of these techniques have been reported in the literature (Andrade et. al., 2004; Legat et. al., 2004; Bing et. al., 2007; Poursaee, 2010).

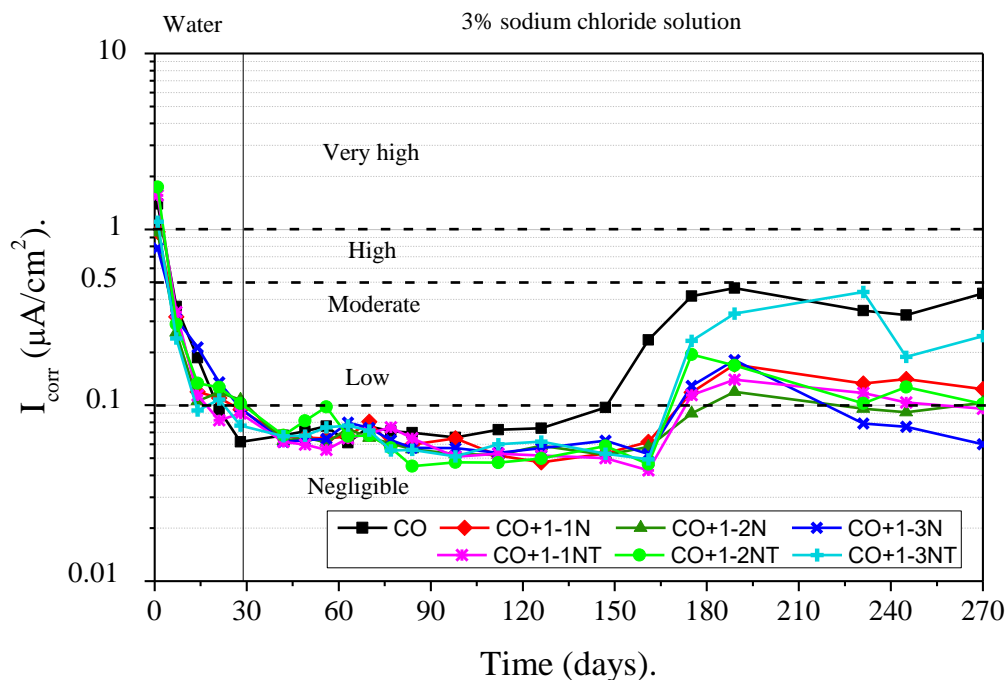
Figure 9. Behavior of corrosion rate ( $I_{corr}$ ) values with time.

The corrosion rate is inversely proportional to the Linear Polarization Resistance values from which the  $I_{\text{corr}}$  was determined for all samples (Andrade and Buják, 2013). According to some researches the proportionality factor (constant B) varies from 13 to 52 mV. In this study on the analysis of the corrosion rate of the reinforcing steel in concrete, a value of  $B = 26$  mV was applied (Andrade et. al., 2004). All corrosion rate values in terms of current density are shown in Figure 8. During the curing process of concrete, a rapid decrease in  $I_{\text{corr}}$  values can be observed until values below  $0.1 \mu\text{A}/\text{cm}^2$  are reached in the negligible corrosion speed range (Andrade and Alonso, 1996). At these values, steel possibly already developed a state of passivity due to the presence of oxygen, moisture and a highly alkaline medium (Hansson, 1984). With the advance of the exposure time to the aggressive medium all samples with mucilage maintain very low  $I_{\text{corr}}$  values. This behavior, as stated by other studies, is possibly due to the fact that this natural additive is capable of reducing the diffusion coefficient of chlorides, caused by an increase in the viscosity of the solution of the concrete pores (Ramírez-Arellanes et. al., 2012).

At the end of the test period, samples with Nopal mucilage maintained corrosion rate values between  $0.1$  and  $0.2 \mu\text{A}/\text{cm}^2$ , except for the CO+1-3N sample, which maintained values lower than  $0.08 \mu\text{A}/\text{cm}^2$  in the range of negligible corrosion rate (Andrade and Alonso, 1996) These indicated that the Nopal mucilage not only improves the electrochemical properties of steel, but also that in the presence of chlorides it can keep the reinforcing steel protected for a longer time (Martinez-Molina et. al., 2015). On the contrary, the control sample is maintained in the range of moderate corrosion rate.

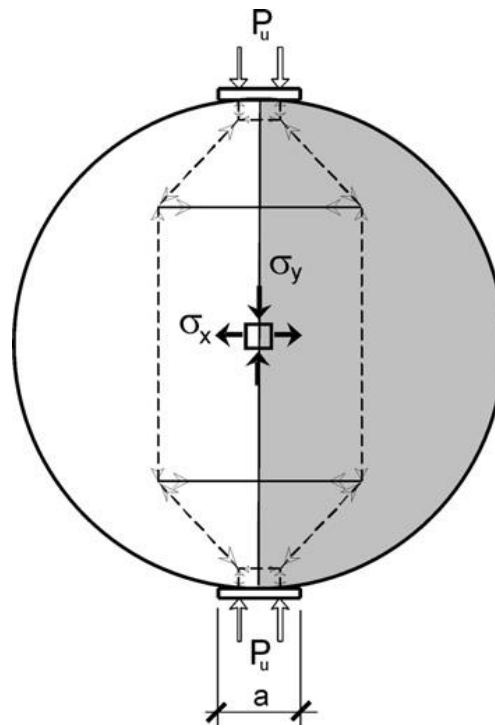
Figure 1. Representation of loading and stress distribution in the determination of traction by diametral compression.

This same method was used for the analysis of binding between new materials and old materials, and a study for recovery of structures (Espeche and León, 2011). Figure 1 illustrates the assay performed.  $P_u$  represents the load applied linearly on the test body, and  $\sigma_x$  and  $\sigma_y$  represent the tensions on the horizontal (x) and vertical (y) axisaxes, respectively.

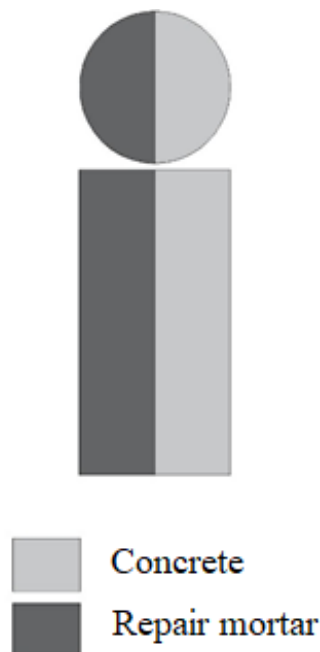
Figure 2. Test specimen to evaluate adhesion between concrete and repair mortar.

The mortar characterization was performed by molding cylindrical specimens measuring 5 cm in diameter and 10 cm in height. These specimens were tested for compression and diametral compression traction. In addition to these mechanical properties, the bond strengths of these materials to concrete were verified through test bodies composed of concrete and mortar of 10 cm in diameter and 20 cm in height. In this way, diametral compression tensile tests of cylindrical test specimens composed of concrete and mortar were carried out, as shown in Figure 2. The guidelines of ABNT NBR 7222 of 2011 were followed to evaluate the adhesion between different materials, as used by Espeche and León (2011), Alanazi et al. (2016), and Radhakrishna et al. (2012).

The adhesion between the parts of the specimen (Figure 2) was evaluated in two ways. The first method was to evaluate the adhesion of the new material to the old one only with the saturation of the bonding surface between the materials. The other method sought to evaluate the bond between the materials in the presence of an epoxy-based adhesion bridge. This application has the function of improving the adhesion between the concrete material, as well as the saturation of the surface with water.

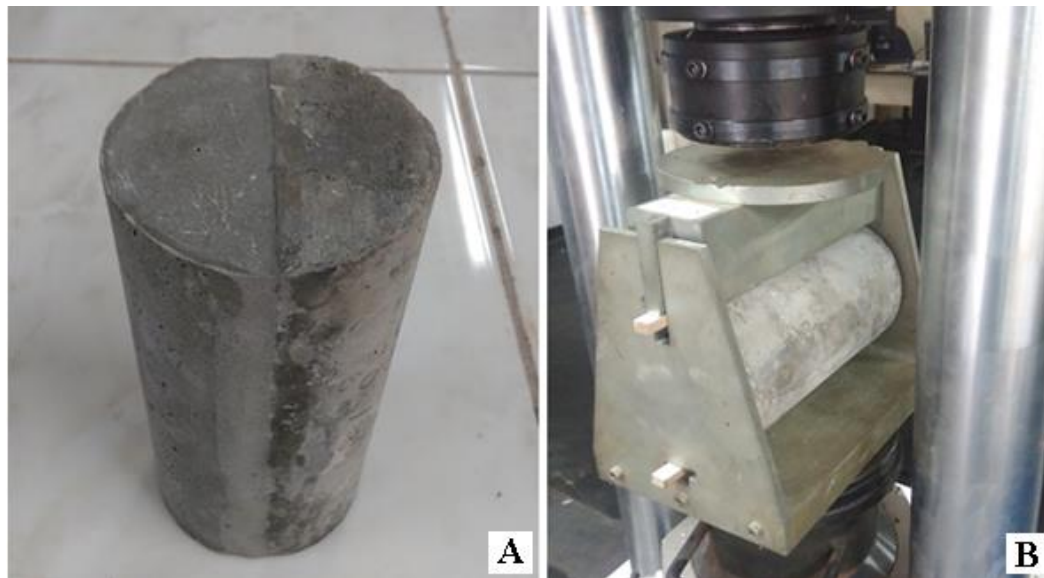
Figure 3. (A) Test body used to determine the adhesion between the repair and the concrete; (B) Test to determine the adhesion between the repair and concrete by diametral compression.

The verification of the adherent strength was performed by means of diametrical compression (Figure 3 - B), which was performed in diametrically opposite lines, in the specimen (Figure 3 - A). By obtaining the breaking load, it was possible to calculate the bond strength between concrete and mortars by means of ABNT NBR 7222 of 2011.

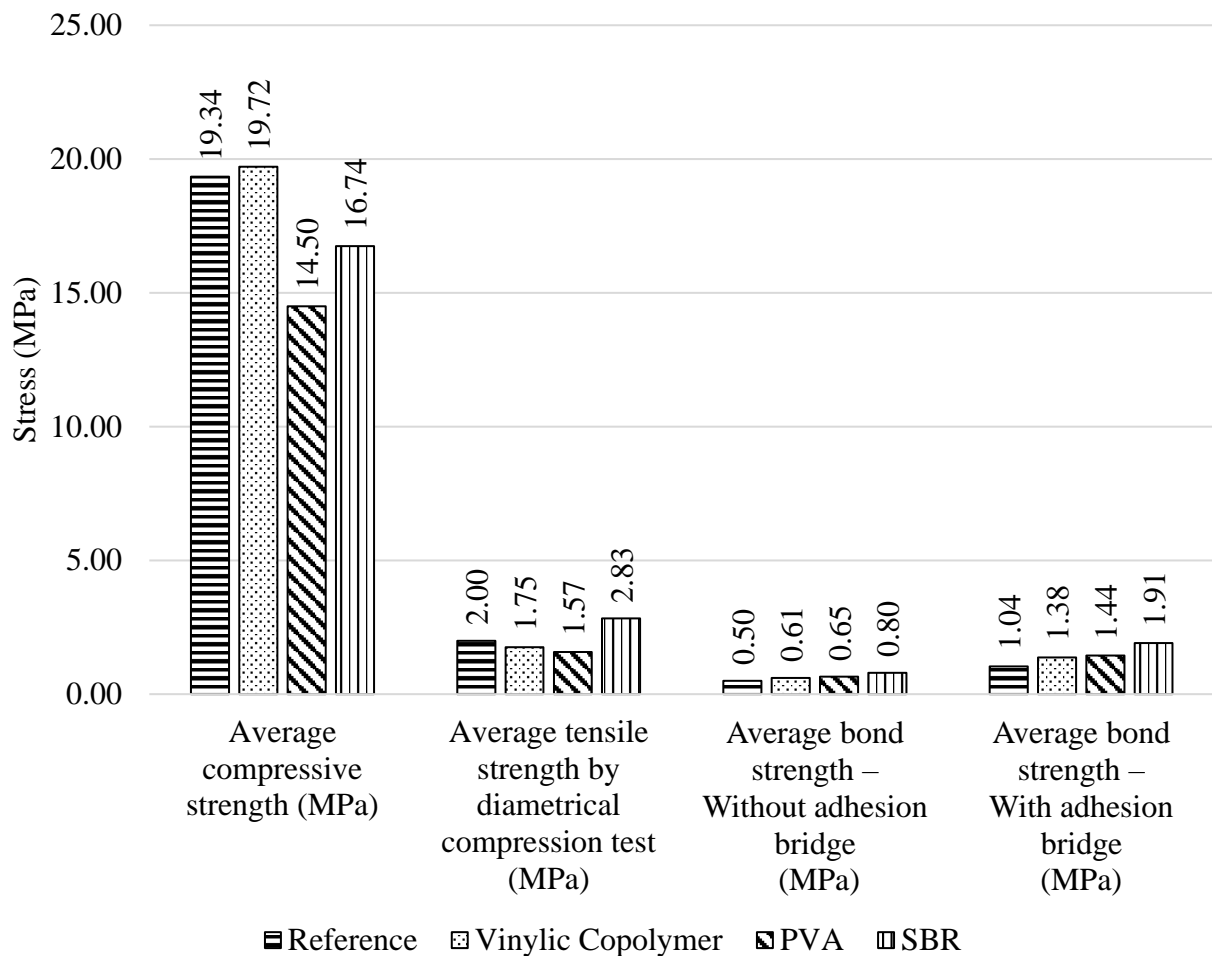
Figure 4. Mechanical resistance of repair and reference mortars.

When analyzing the results presented in Table 3, it can be observed that the polymer mortars tested in this work present improvements over the reference mortar in some properties, while in other properties they show lower values than the reference mortar. The results are presented graphically in Figure 4.

The results obtained for compression show that the mortar modified with vinylic copolymer has a small increase in the resistance compared to the reference, as shown in Figure 4. Among the other polymeric materials, a reduction of the average resistance for the SBR-modified mortar is observed, as predicted in the literature (Ukrainczyk and Rogina, 2013). The lowest results for compressive strength were recorded for mortar composed of PVA.

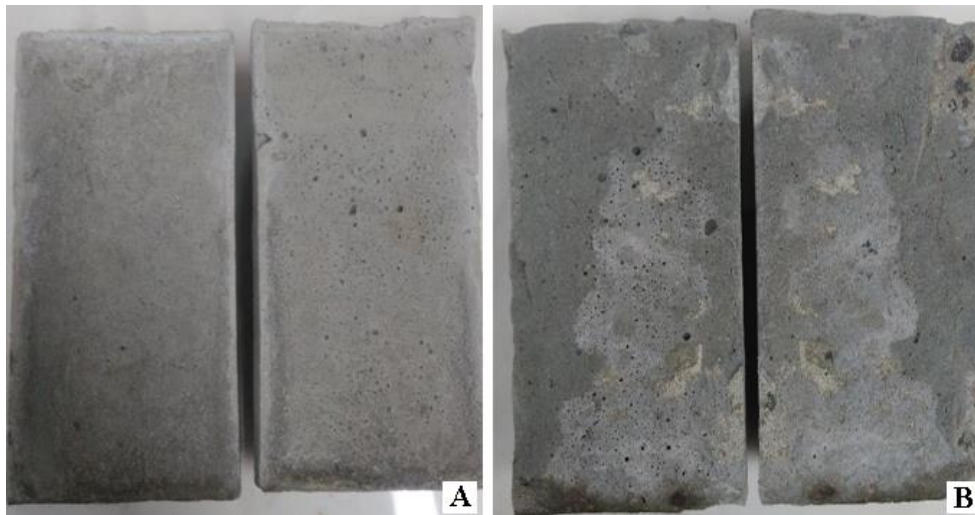
Figure 5. (A) Plan of rupture of a test specimen tested in adhesion without an adhesion bridge; (B) Plan of rupture of a test specimen tested in adhesion with an adhesion bridge.

After verification of the rupture planes between the concrete and the repair material, as shown in Figure 5, it can be observed that the loading may have obeyed the plane of union between both materials.

In the first situation, without the adhesion bridge (Figure 5 - A), it was observed that the two halves separated perfectly. In other words, there was no presence of mortar in the concrete half or the presence of concrete in the middle of the mortar. This is an indication that the plane of rupture is more brittle than the resistances of the two materials. This assertion is corroborated by the values of the results, presented in Table 3. In other words, the properties of the polymeric materials do not confer great adhesion resistance between cementitious materials.

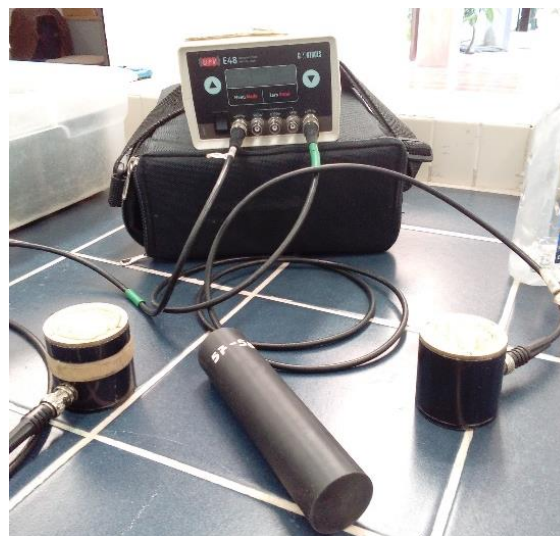
The UPV technique, an indirect method to determine the homogeneity of cement based materials, was used to estimate another physical property of the mortar cubes (Troconis et. al., 1997). In this method, an emitter sends an ultrasonic pulse that travels through the material until reaching a receptor. The distance between the emitter to the receiver was divided by the elapsed time for which the wave travelled from both transducers is known as UPV. After performing the electrical resistance testing, the same specimens were used to carry out the UPV technique. The UPV was measured by using a commercial ultrasonic pulse velocity tester. The procedure followed was in accordance to ASTM C597 - 2002 and project DURAR (Troconis et. al., 1997). Figure 2 represents this test.

Figure 2. Equipment used for UPV test

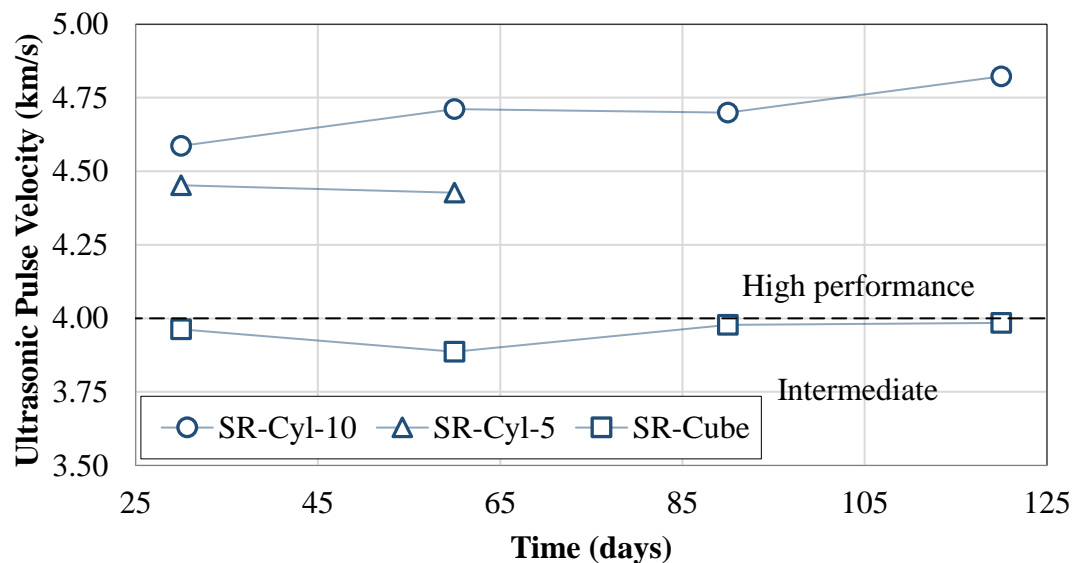
The UPV index performance vs. time is observed in Figure 4. For this performance index the material evaluated was only the high performance mortar SR. This was because the other mortars were not considered for this index evaluation due to a specimen shortage.

Figure 4. Average UPV vs. time experimental values for high performance mortar (SR)

As observed, UPV index maintained almost constant during the experimental time (from 25 to 120 days). But the UPV values for the three different dimensions were different between them, showing smaller values when 5 cm cubes were used as specimens (~3.95 km/s), followed by the values obtained with 5 x 10 cm cylinders (~4.44 km/s), and finally by the 10 x 20 cm UPV results (~4.70 km/s).

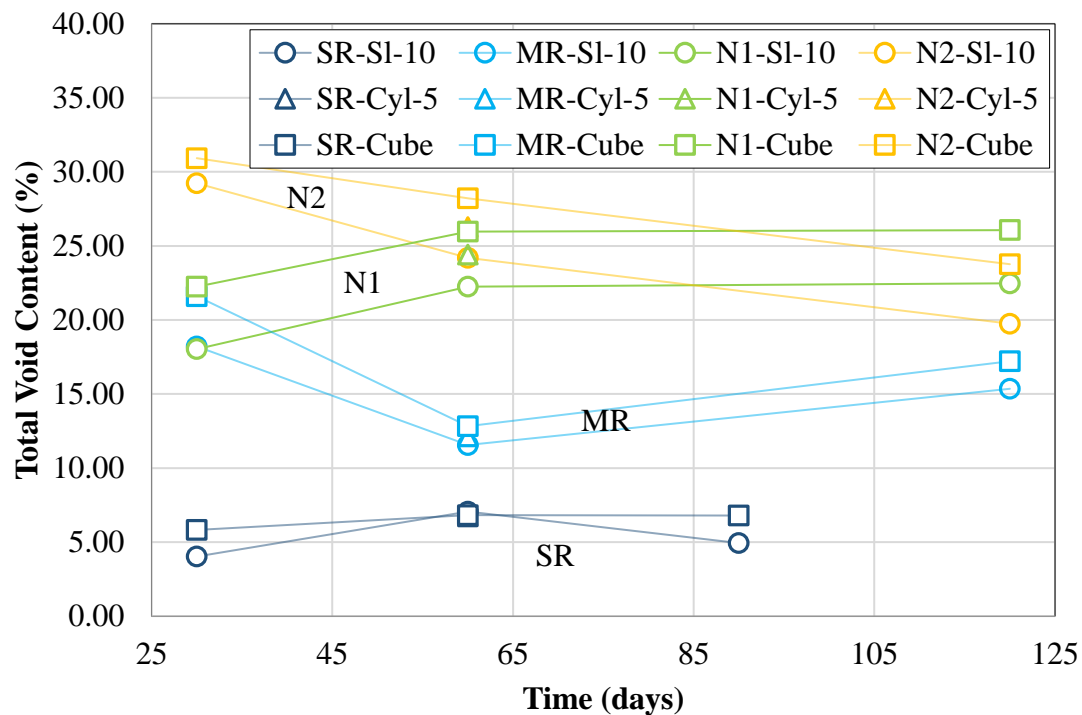
Figure 5 presents the results obtained of TVC vs. time for the three different specimen geometries used. For TVC index, the specimens used were full size cubes and small cylinders. The third specimen shapes and dimensions used were 5 cm in height and slices cut from the 10 x 20 cm cylinders (SI-10).

Figure 5. Average TVC index vs. time experimental values for low (N2), intermediate (N1, MR) and high performance (SR) mortars

As observed from Figure 5, low performance mortar N2 average TVC index was similar regardless of specimen shape (cube, cylinder or slice) and dimension, giving after 60 days and up to 120 days experimentation period values of 24.4 % in SI-10, 26.3 % in small cylinders 5 x 10 cm and 27.6 %

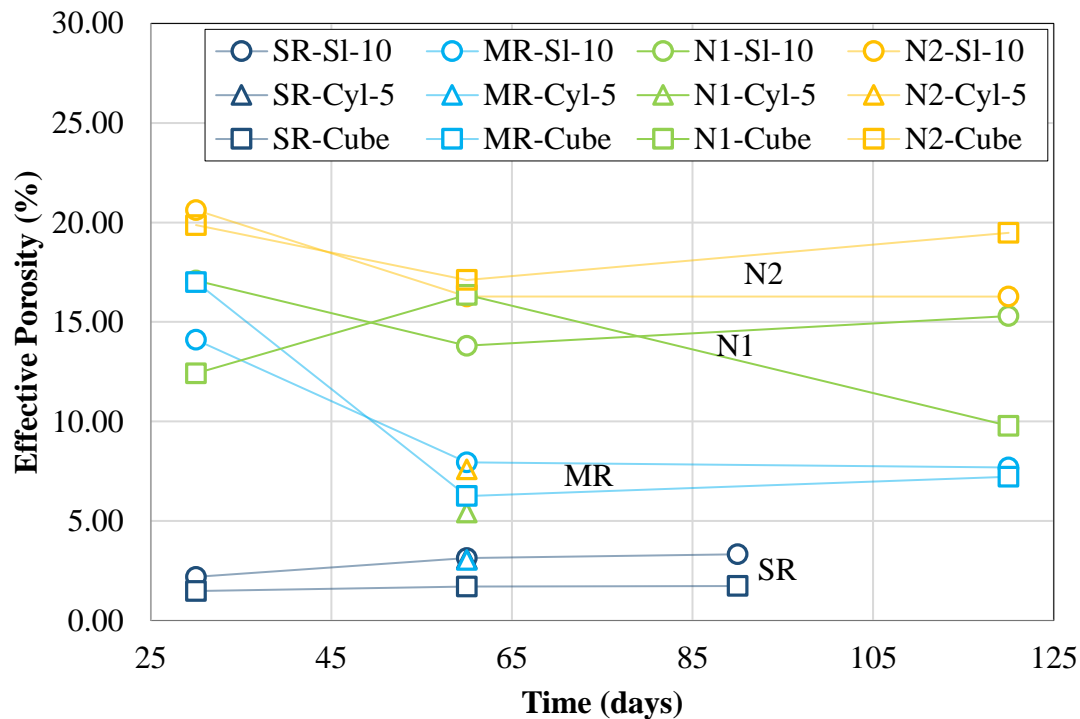
The effective porosity performance in time is shown in Figure 6 as per effective porosity average values,  $\epsilon_{eff}$ . Average  $\epsilon_{eff}$  index with time for all mortar tested agreed with typical mortar performance: as curing time increase,  $\epsilon_{eff}$  decreases due to higher hydration degree of the cement paste in the mortar.

Figure 6. Average  $\epsilon_{eff}$  index vs. time experimental values for low (N2), intermediate (N1, MR) and the high performance (SR) mortars

Figure 6 also shows that the  $\epsilon_{eff}$  value differences between mortar type at 120 days of age: N2's  $\epsilon_{eff}$  between 16 % - 20 %, N1's  $\epsilon_{eff}$  of between 10 % - 16 %, MR's  $\epsilon_{eff}$  of about 7.5 %, and SR's  $\epsilon_{eff}$  of about 2.5 %. Therefore, it was observed that there was no difference on  $\epsilon_{eff}$  index values between N1 and N2, which supports TVC index values obtained (Figure 5). Compared against Table 1 the performance value ranges for this  $\epsilon_{eff}$  index, N1 and N2 index values obtained correspond to a low

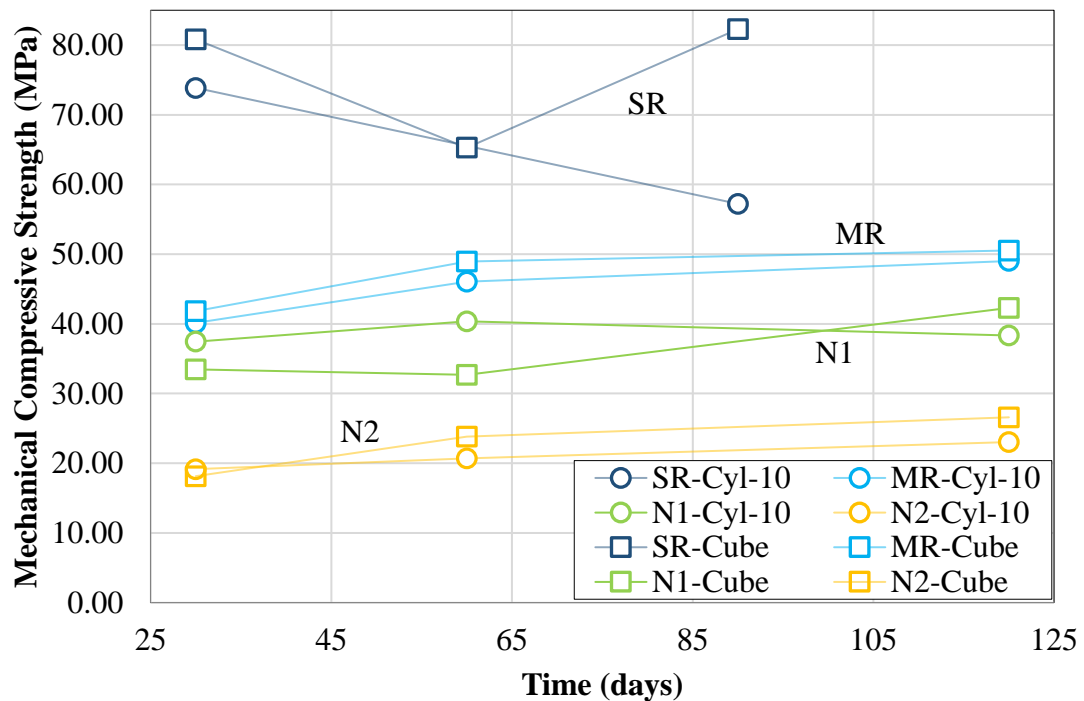
The SR mortar presented an erratic performance of CS index values, as observed in Figure 7. This performance should be investigated in the near future, perhaps it is due to an apparent deficiency on the specimen preparation when the dimensions are large, such as the 10 x 20 cm.

Figure 7. Average CS index vs. time experimental values for low (N2), intermediate (N1, MR) and high performance (SR) mortars

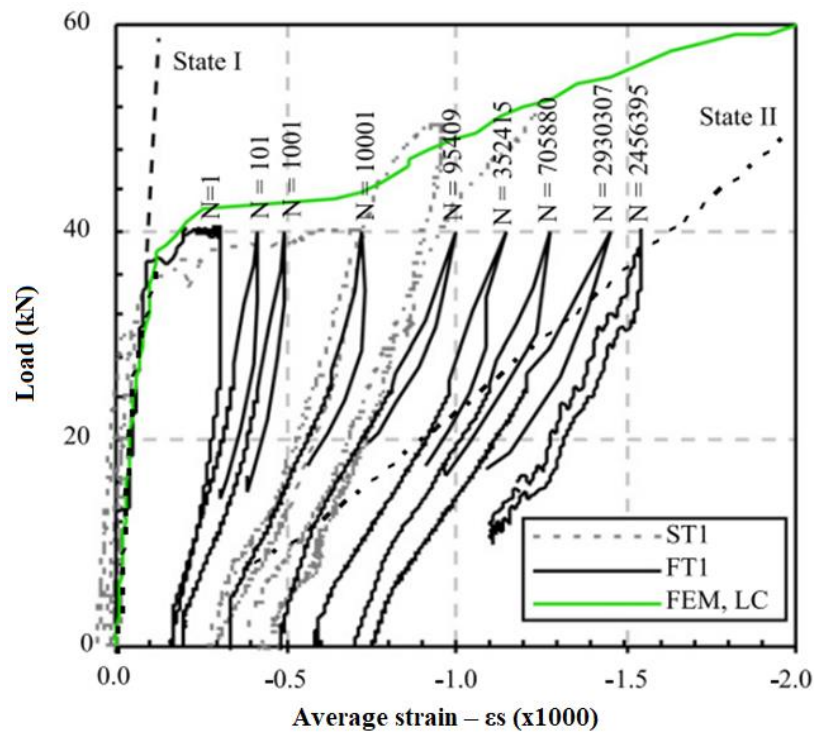
The figure 1 presents the reduction of the tension stiffening as the number of cycles increases, based on tests made by Zanuy et al. (2011). Analyzing this figure, it is possible to highlight two important aspects: as the number of cycles increases, it gets closer to the pure State II; and the gradual reduction of the tension stiffening is due to the loss of adhesion between steel bars and concrete.

Figure 1. Fatigue failure in a reinforced concrete element (Zanuy et al., 2011)

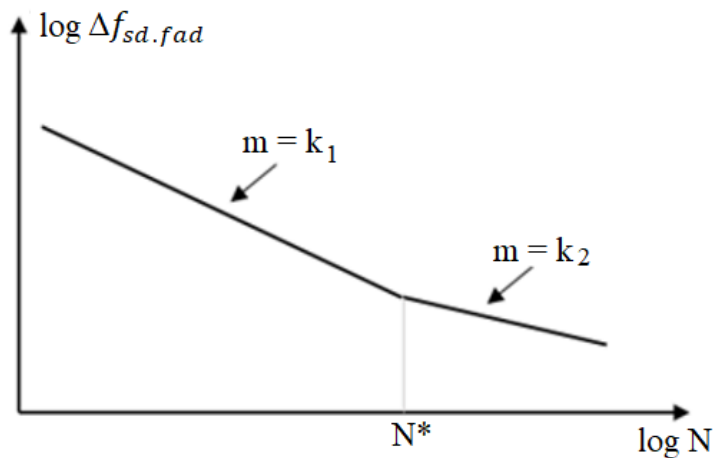
Figure 2. Fatigue characteristic resistance curves (S-N curves) for steel (Junges, 2017)

In this research it will be used passive reinforcement bars, the S-N curves can present two values,  $k_1 = 9$  e  $k_2 = 5$ . From this, the constants  $Const_1$  and  $Const_2$  can be determined for both curves through the following equations

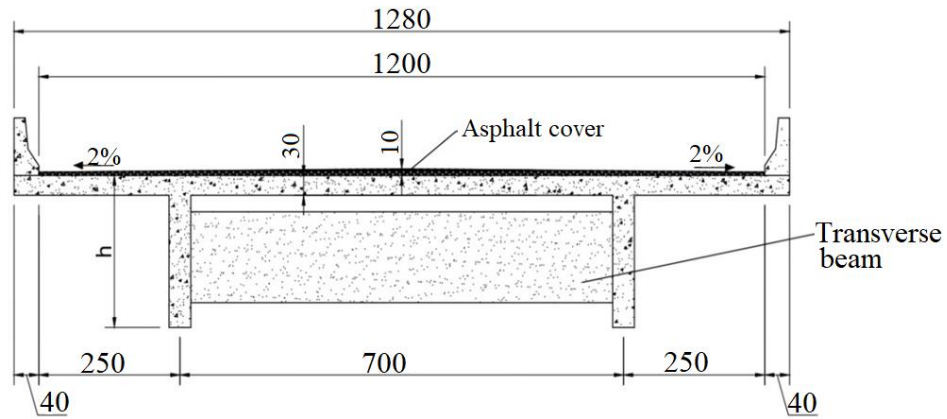
Two single carriageways are assumed for all analyzed bridges. Moreover, following the guidelines from “Manual de Projeto de Obras-de-Arte Especiais” (DNER, 1996), each carriageway will have adopted dimension of 3.60 m, totalizing 7.20 m of width, and 2.40 m to each shoulder. The figure 3 demonstrates the transverse cross section of the three bridges.

Figure 3. Cross section of the bridge (dimensions in centimeters) (Own Author, 2019).

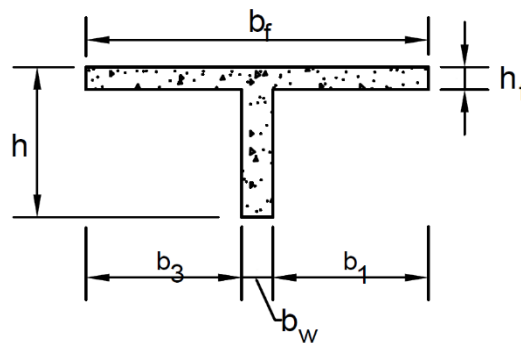
There are intermediate transverse beams placed in each 5 m with constant width of 0.30 m and high of 0.80 m. The transverse beams are not connected to the slabs, so they have the locking function only. Due to the simplification of the calculations, the following hypotheses are adopted: the bridge slab is not usually of constant thickness, but in this research the slab thickness is adopted as constant; constant thickness is adopted for the 10 cm asphalt cover. The “T” section of the beams used is shown in figure 4.

Figure 4. Cross section of the beams (Own Author, 2019).

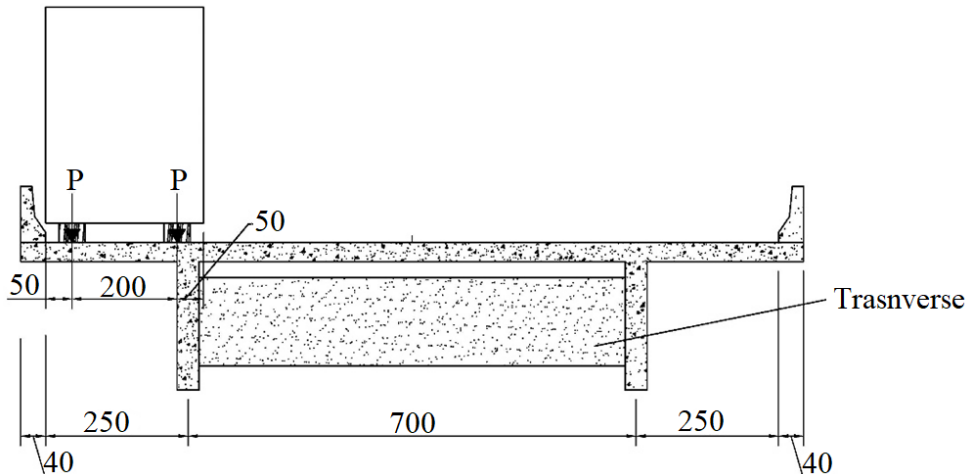
Regarding the positioning of the Brazilian load train, TB 450, the Brazilian Code NBR 7188:2013 clarifies that it can assume any position along the entire cross section of the bridge where there is a road lane, provided the wheels are in the most unfavorable position, “including shoulder and safety bands”. The distributed load must also be applied in the most unfavorable position, “regardless of the road lanes” (ABNT, 2013, p. 4). Figure 5 shows the TB 450 vehicle positioned in the most unfavorable section of the bridge cross section. The same position is assumed for the three bridges studied in the paper.

Figure 5. Load train vehicle TB 450 in cross-sectional for maximum stress on the left beam of the figure (dimensions in centimeters) (Own Author, 2019).

This critical position is determined using the technique of influence lines, and a simplified model already established that can be seen in numerous publications such as Carvalho (2017). In this case, the support reaction line of influence is used, thus, considering the load train (TB 450) in the position that leads to the greatest reaction of the studied beam, it is possible to determine the set of loads named longitudinal load train (“trem tipo longitudinal”, the original name is Brazilian Portuguese, TTL), which the bending moment forces of the beams will be determined with.

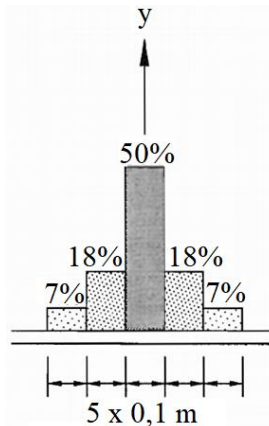
travel centered on the traffic lane and the others are distributed symmetrically along the lane, as shown by the frequency distribution of vehicle transverse positioning in a bridge shown in figure 6 (EUROCODE 1, 2002).

Figure 6. Frequency distribution of vehicle transverse positioning in the bridge

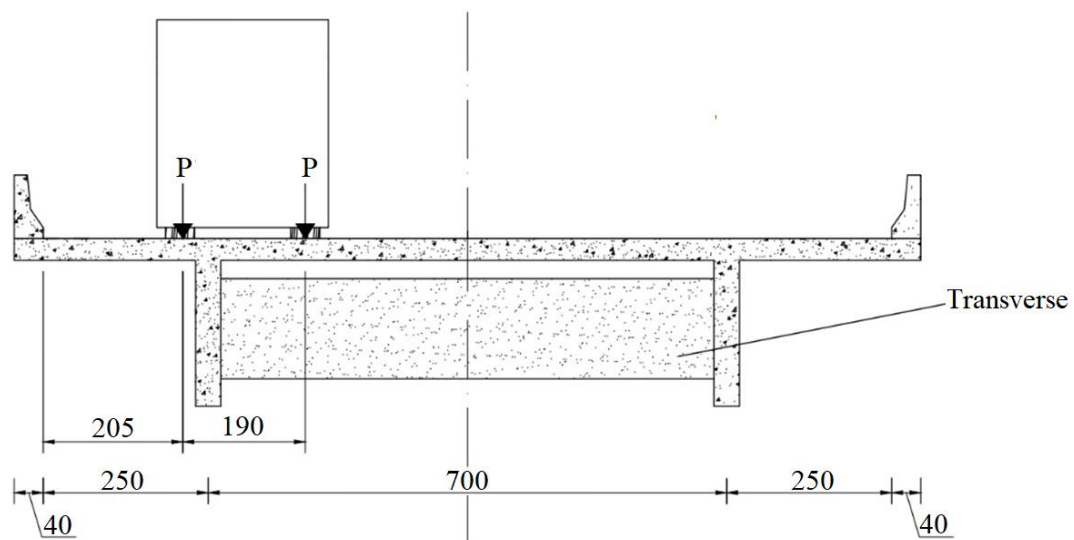
Figure 7. Transverse position adopted for the actual freight vehicles (dimensions in centimeters) (Own Author, 2019).

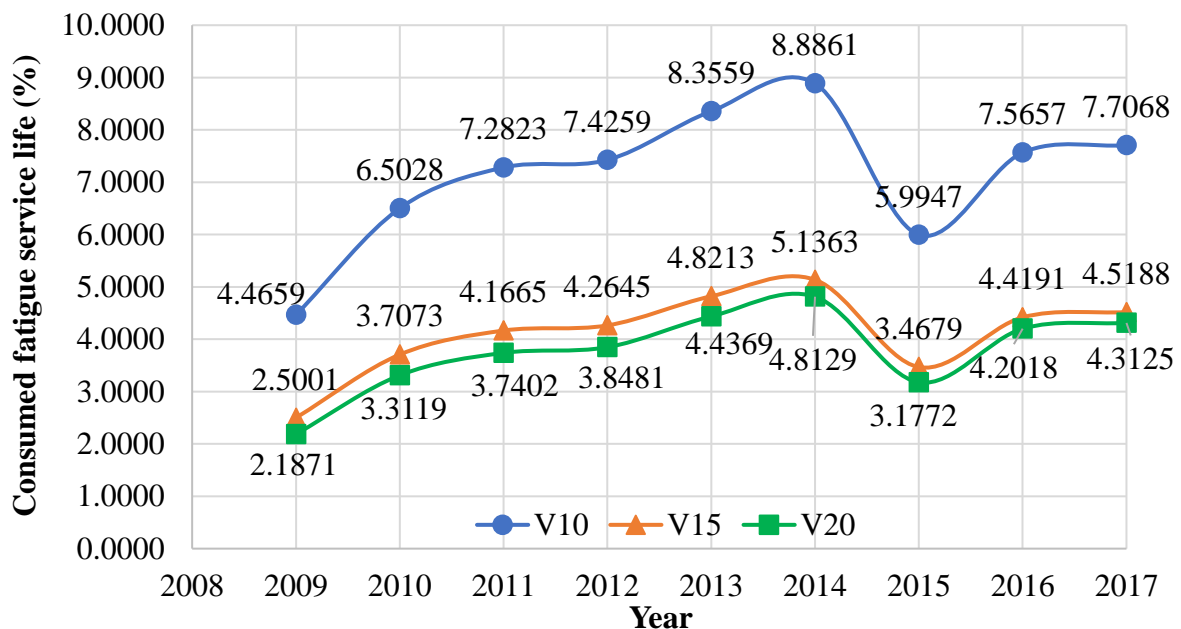
The figure 8 presents the consumed life of each respective year analyzed for each bridge. In addition, in table 6 are presented the estimated fatigue service life of the longitudinal reinforcement steel bars, showing the consumption of fatigue resistance over the nine years considered, and the time required to reach 100% of consumption.

Figure 8. Consumption of longitudinal reinforcement fatigue service life (Own Author, 2019).

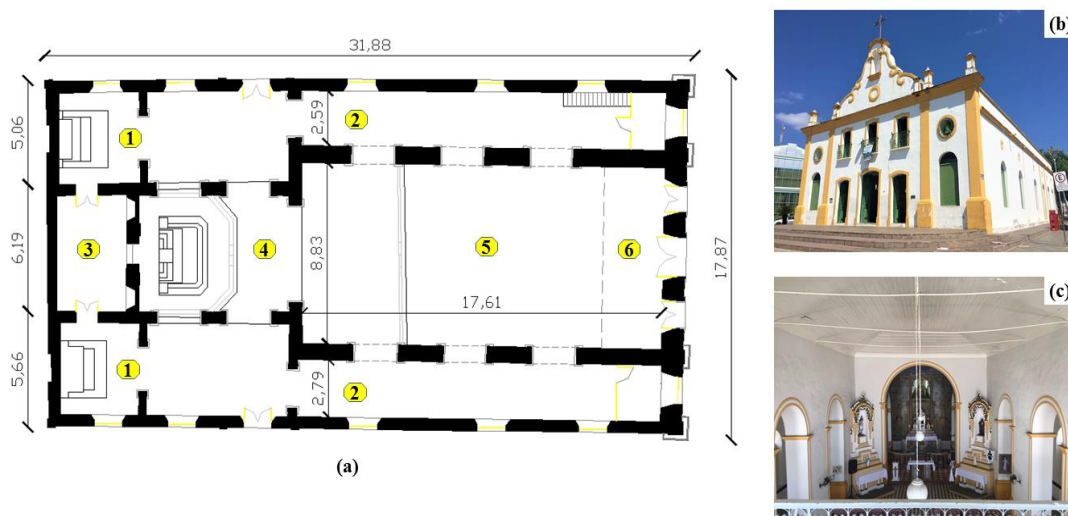
The Nossa Senhora do Rosário Church, shown in Figure 1, is the oldest church of the historic center of Sobral and therefore it has a very important role in the historical-social context of this city. Its construction, in vernacular masonry, occurred in the first half of 18<sup>th</sup> Century, approximately in the year of 1740. In the year of 1777, the church originated the “Pretinhos Church” and its architectural structure tending to baroque. This denomination was given by the Nossa Senhora do Rosário dos Homens Pretos de Sobral Brotherhood, founders of the church. In 1914, by request of Dom José, priest and later bishop of Sobral, a lateral expansion of the building was done. Later, in 1926, the floor (done of solid bricks) was changed for hydraulic ceramic floors.

Its floor plan, shown in Figure 1 (a), has two lateral naves and one main nave. In the same axis of the main nave, there is a main and two other secondary altars, and the sacristy can be seen in the middle of the main altar. The main entrance is in the main facade where, few meters from the main entrance, there is a metallic gate characterizing the environment as an anteroom that provides access to the sanctuary. There is also a coro-alto just behind the main facade, from which the altars can be seen, as shown by the Figure 1 (c).

Figure 1. View of the Nossa Senhora do Rosário Church: (a) floor plan where (1) indicates the secondary altar, (2) lateral nave, (3) sacristy, (4) main altar, (5) central nave and (6) coro-alto; (b) main facade and (c) internal view of the central nave.

As highlighted by Santos et al. (2016) in Figure 1 (b), one of its most expressive characteristics is the pediment, which in much resembles baroque features, due to its curvilinear movements, creating an aperture in arc format, centrally arranged and enriched by the insertion of a cross.

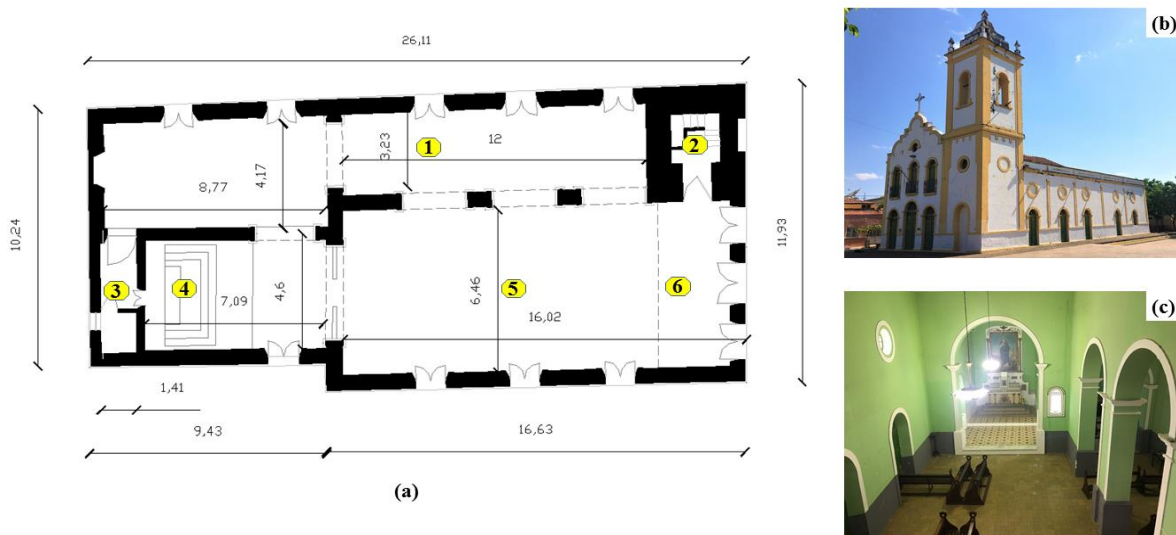
Considered one of the oldest churches in Sobral, the Nossa Senhora das Dores Church (Figure 2) was built near the Acaraú River, one of the few churches in the city which faces partially the river. The church, according to Pinto (2009), was built in 1818, although the date is not accurate. It has a neoclassical architecture, however, it has a single lateral tower, as shown in Figure 1 (b), posteriorly built, according to Mesquita et al. (2017) around 1924, not following the neoclassical rule. To build the church, constructive techniques of the period are used, being totally constructed in solid masonry bricks.

Figure 2. View of the Nossa Senhora das Dores Church: (a) Floor plan where (1) indicates the aisle, (2) lateral tower, (3) sacristy, (4) main altar, (5) central nave and (6) coro-alto; (b) main facade and (c) superior view of the main nave.

Its geometry is shown in Figure 2 (a), where can be observed that the church has a main nave, an aisle, a single lateral tower, a coro-alto, a single altar and, in the back of the main altar, a sacristy. Figure 1 (c) illustrates the interior view of the building, where it is observed that the church is little ornamented with only one picture located at the bottom of altar representing the image of Nossa Senhora das Dores, a wall with a large lateral arches separating the naves and a large arch located in front of altar.
