## **ALCONPAT International**

## **Revista ALCONPAT**

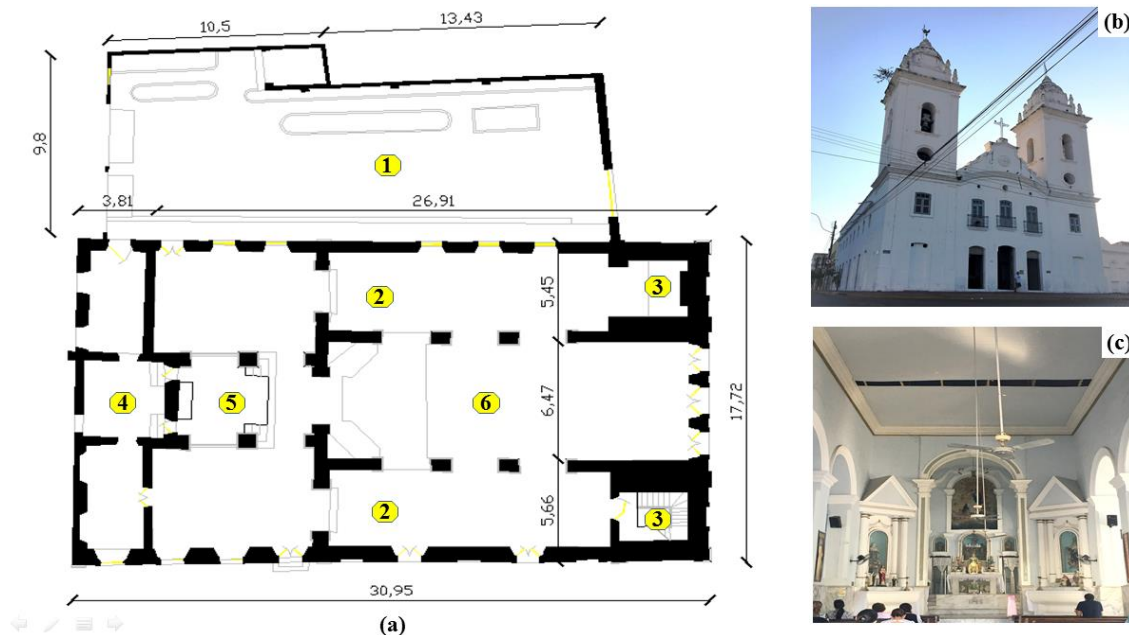
Figure 3. View of the Menino Deus Church: (a) Floor plan where (1) indicates the lateral courtyard, (2) aisles, (3) towers, (4) sacristy, (5) main altar and (6) central nave; (b) main facade and (c) internal view of the main nave.

Figure 3 (a) represents the floor plan of the church and shows that its geometry is divided in many parts, where in the side there is a large courtyard, in the internal part there are two aisles, each one in front of each tower, a large central nave that is located in front of the main altar and just behind this, the sacristy. In Figure 3 (c), it is observed that the degree of ornamentation of the church is also low.

The Menino Deus Church (Figure 3), had its construction process started around the 1810 through the idea of two Carmelitas sisters arrived in Sobral in this same year with the nuns of the third order of the Carmelitas Emerenciana de Sant'Ana and Teresa de Jesus. According to the Inventário de Bens Arquitetônicos-IBA (IPHAN, 2005), a document that catalogs all the heritage constructions listed in Sobral, it is estimated that in 1820 the central part of the church was built. The towers were only got completed in 1940. The design clearly shows a correlation with the city's Cathedral, adopting the standard of the second half of the 18<sup>th</sup> century, with a distinctive characteristic of the cornice, which are elements constituents of facades of the period, generally located above the windows or main oculus of the building.

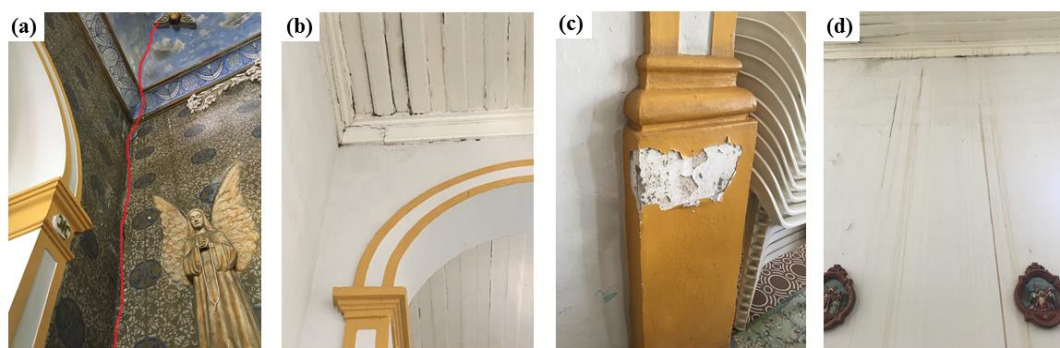
Figure 5. Internal pathological manifestations of the Nossa Senhora do Rosário Church: (a) crack, (b) disintegration of lining elements, (c) detachment and (d) humidity stains.

In the internal part of the church the main, the following pathological manifestations were observed: crack, disintegration of lining elements, detachments and humidity stains, as illustrated by the Figure 5. The most serious situation was the crack located near the altar (Figure 5 (a)), because its presence may be associated with the movements adjacent to the building and new constructions in the vicinity of the sanctuary. These movements occasionally cause sinking of the soil and cracks and fissures in

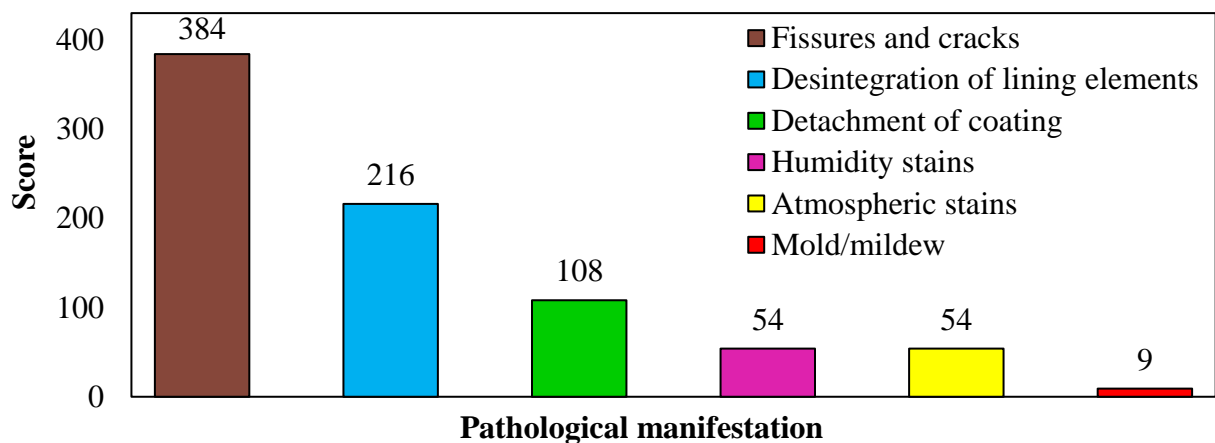
From the application of the checklist of the GUT Matrix in this building it was possible to elaborate the graph of priorities, which is represented by Figure 6, where it is possible to verify that priority pathological manifestations, that must be treated first, are fissures and cracks, in this case, in the main altar of the church, because it presents the highest scores, 384 scores, and represents a high priority damage, according to the descriptions in Tables 1, 2 and 3 of Section 2.

Second, in the order of priorities, it is the disintegration of lining elements with a total of 216 scores, being framed as an average damage. In the third position are the detachments of coating with 108 scores, being also framed in the degree of average damage. Humidity stains and atmospheric stains, both with 54 scores, are also identified as average damage. The damage with lowest severity, which is in the last position of the order of priorities, is mold /mildew, with 9 scores and low damage.

Figure 6. Priority graphic of the Nossa Senhora do Rosário Church.

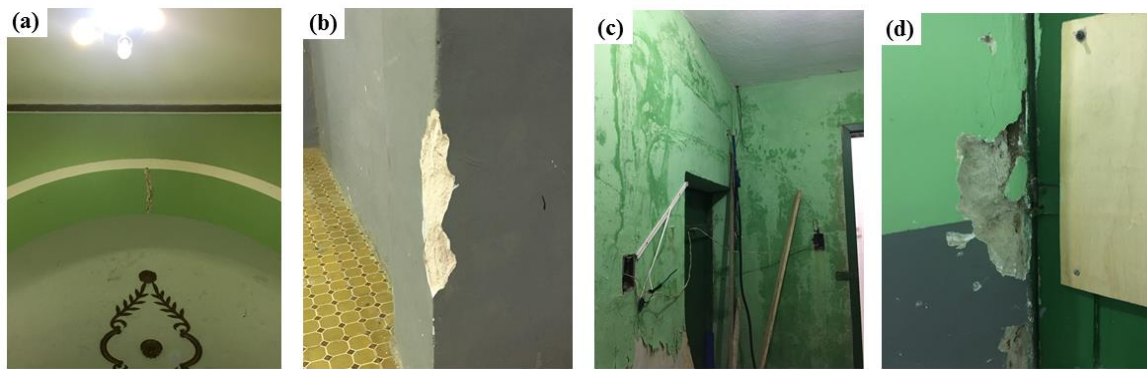
The main pathological manifestations observed in the internal part of the structure were: fissures and cracks, detachment of coating, humidity stains and detachment of coating with exposure of parts of the frame, which are illustrated in Figure 8. In Figure 8 (a), there is the most severe pathological manifestation for this building: a crack located in the central arch of the main nave. This anomaly is in a very aggravated situation, being its occurrence related to the incidence of soil movement of the foundation and to a possible overload in the arch, since many interventions with an increase of load were executed over time, as for example, the exchange of a lining that was previously made of PVC by a slab of reinforced concrete. Thus, to Gravity, a score 10 was attributed, that is, the maximum score of the method here used, which causes a high impairment of the performance of the building. Regarding Urgency, a score 10 was also inserted, due to the large area of commitment of this manifestation, requiring urgent intervention. And for Tendency it was also chosen a score 10, corresponding to the large possibility of evolution of the situation.

Figure 8. Internal pathological manifestations of the Nossa Senhora das Dores Church: (a) crack in the central arch, (b) detachment of coating, (c) humidity stains and (d) detachment of coating with exposure of the frame parts.

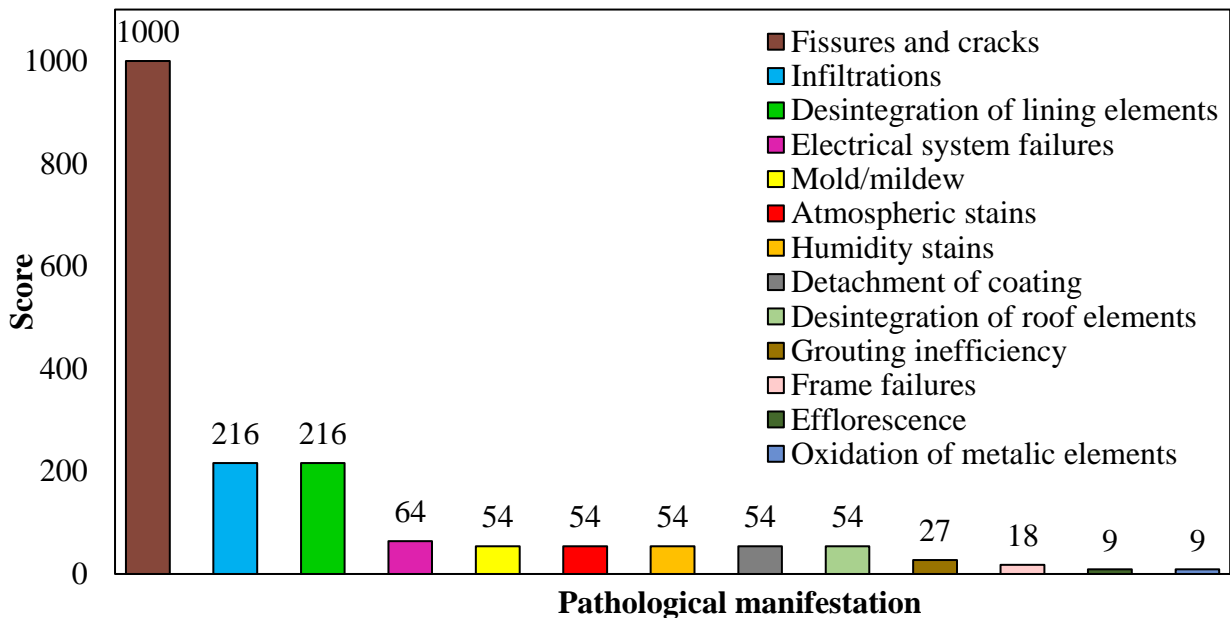
The data obtained from the application of the GUT Matrix in this building were organized in the priority graph shown in Figure 9, where it is verified that the pathological manifestation of highest priority is the crack in the central arch of the main nave, with a total of 1000 scores, which classifies it as a total damage, that is, of extreme gravity, urgency of solution and fast tendency of evolution. In addition, the difference between this damage and the two other (infiltration and disintegration of lining elements, both with 216 scores each) is very high, that corresponds to 784 scores, which show the severity of this crack.

Figure 9. Priority graphic of the Nossa Senhora das Dores Church.

Four pathological manifestations presented the same scores (54 scores): mold/ mildew, atmospheric stains, humidity stains, detachment of coating, which evidences pathological manifestations of average damage. The damages: grouting inefficiency (27 scores), frame failure (18 scores), efflorescence (9 scores) and oxidation of metallic elements (9 scores) correspond to category of low potential damages, the latter two occupying the final position of the order of prioritization. This building presented the largest number of pathological manifestations and this fact is connected to the lack of maintenance of the structure, moreover this church is now interdicted. The existing

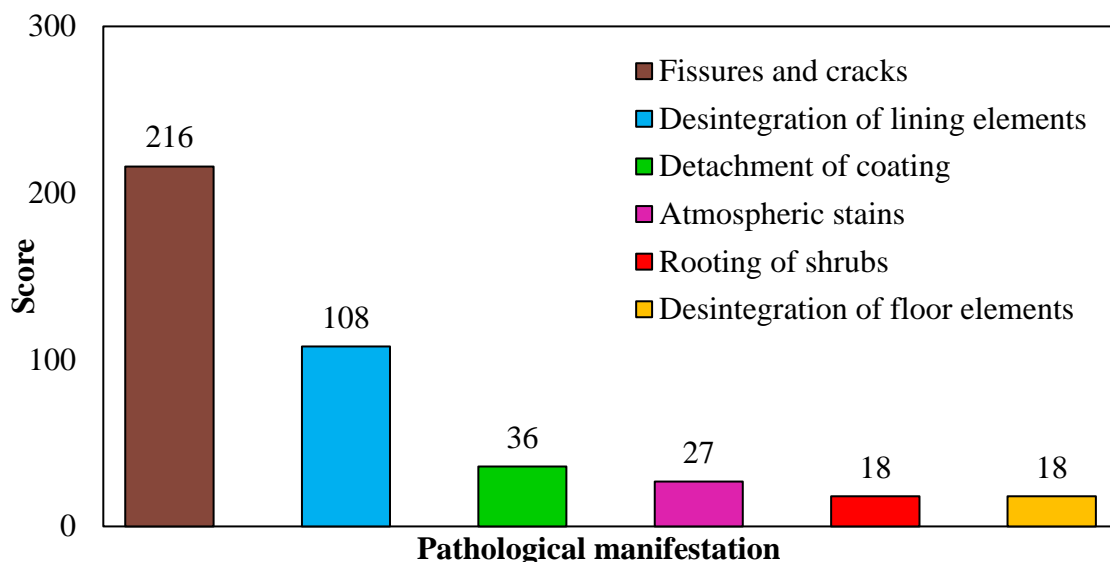
With the results of the checklist of GUT Matrix applied in this building, the graph of priorities was constructed and it is illustrated in Figure 12, where it is verified that the most prioritized pathological manifestation are the fissures, which can be observed in the upper opening of the front facade door (Figure 10) and also in an internal wall of the left lateral facade (Figure 11 (a)). The scores of this anomaly corresponds to 216 and are obtained by applying to the Severity, Urgency and Tendency 6 scores per each one, being therefore an average priority damage. In second position is the detachment of coating that presents a total of 108 scores, being also an average damage. In third and fourth positions are the disaggregation of lining elements and atmospheric stains, with 36 and 27 scores each one, being classified as average and low damage, respectively. In the final positions in the order of priorities, are the rooting of shrubs and the disintegration of floor elements, with 18 scores each, classified as low damage.

Figure 12. Priority graphic of the Menino Deus Church.

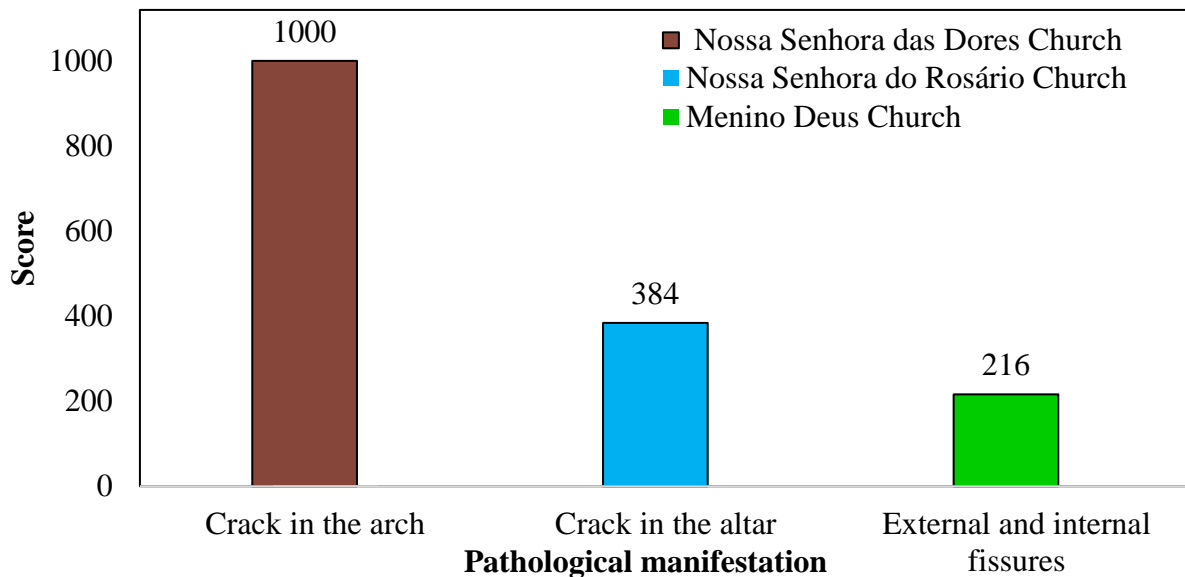
By the comparative analysis of the pathological manifestations listed in first position for each church and having as parameter its total score, among the three buildings studied, the Nossa Senhora das Dores Church presented the most severe damage with a total of 1000 scores for the crack in the central arch of the main nave. The second most severe was the Nossa Senhora do Rosário Church with a total of 384 scores also for a crack in the main altar. And finally, the third most severe damages were the fissures present in the main facade near the opening of the upper window, in the lower part of one of the columns of a tower and in walls of the internal part of the Menino Deus Church with a total of 216 scores. Figure 13 shows the comparison between the most severe damages of these churches.

Figure 13. Comparative graphic between the most severe pathological manifestations for each church.

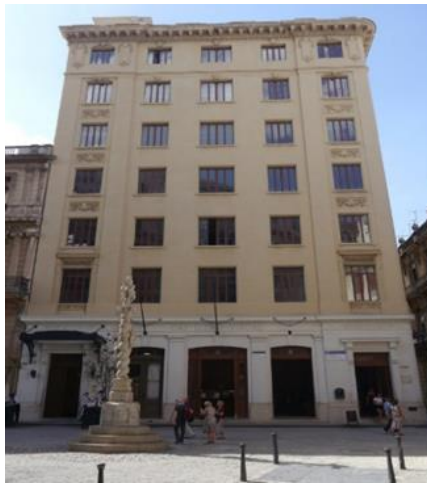
This paper aims to discuss the results of the diagnosis made to a reinforced concrete building erected between 1900 and 1906 for the firm Casteleiro & Vizoso (Figure 1). Eclectic style and seven levels high, it was projected so that all levels had 4 m high struts, except for the ground floor with 6.3 m. The building was erected on a steel structure, covered in hydraulic concrete with foundations and reinforced concrete roof. The foundations consisted of support rafts calculated to support an average load of 3 Kg/cm<sup>2</sup>. The concrete prepared to form all the midlevel and stairs was dosed in proportion to 1 volume of cement, 3 of sand and 5 of gravel. The calculation of the accidental load of the floors was estimated for 366 Kg/m<sup>2</sup> and a safety factor of 4 was applied to the metal structure.

Figure 1. Studied building

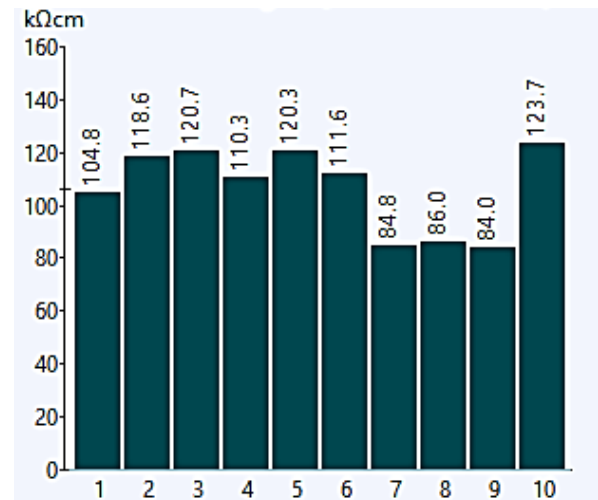
Figure 6. livingroom, axis 2-5:A-C

Figure 5 and figure 6. Results of the apparent resistivity on the reinforced concrete slabs of the third level

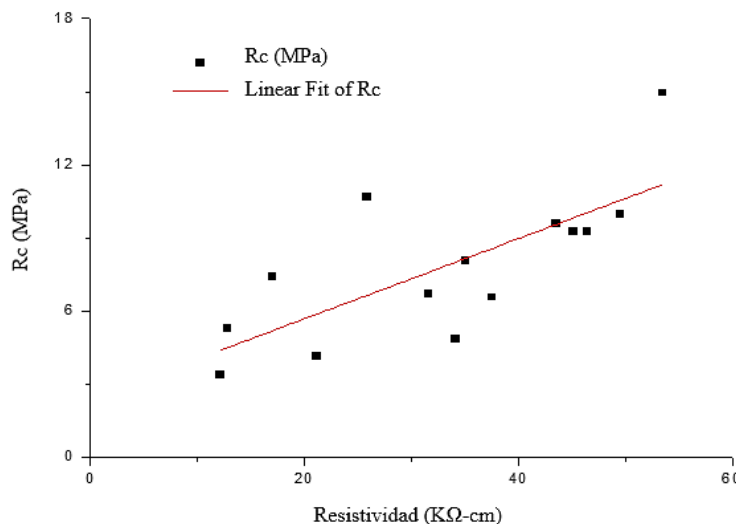
Other authors (Ramezaniapour et al., 2011) demonstrated that for the same cement mix design, there is a linear relationship between compressive strength and  $\rho$  due to the chemical similarity of the pore solution. To assess the correspondence between the concrete permeability of reinforced concrete slabs and the  $\rho$  measured directly on the slabs, both results were correlated based on the strengths of the extracted probes. Figure 7 shows the graph obtained regarding the correlation between the  $R_c$  and  $\rho$  for the mid-level slabs of the studied property.

<b>Rc</b>	<b>Intercept</b>	Value 2,38046	Error 1,56301
	<b>Slope</b>	0,16484	0,04373
	<b>Statistics R-Square</b>	R <sup>2</sup> 0,50396

Figure 7. Relationship obtained between  $R_c$  and  $\rho$  of the slabs

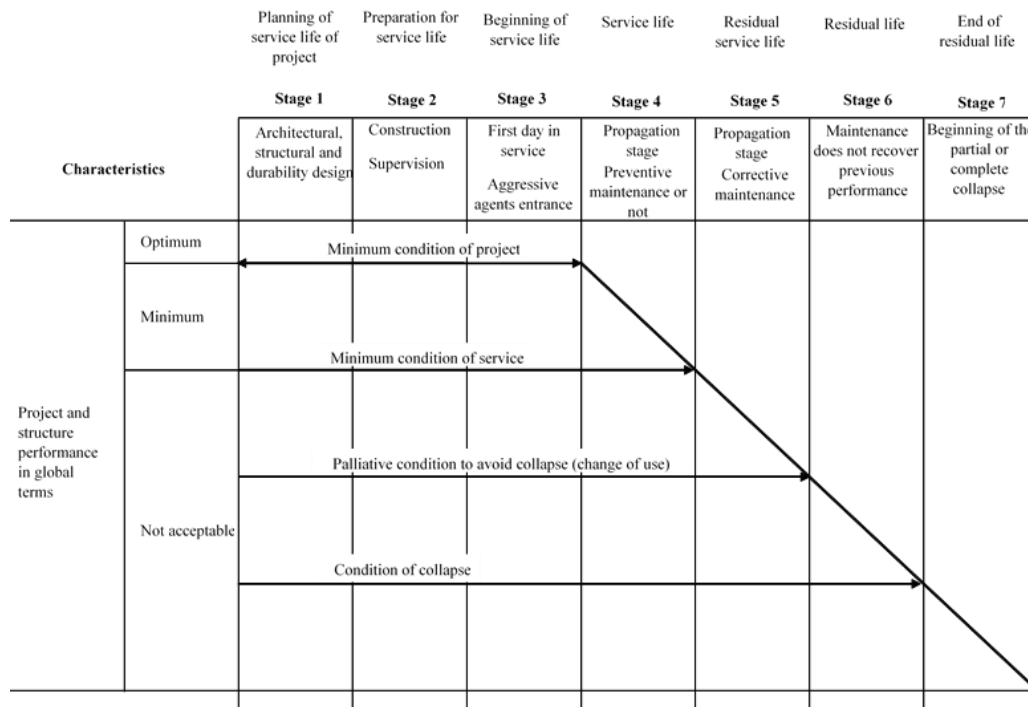
Figure 12 shows a graphical representation of the service life of a structure proposed by (Castro-Borges and Helene, 2007).

Figure 12. Conceptual model of the service life of a structure (Castro-Borges and Helene, 2018)

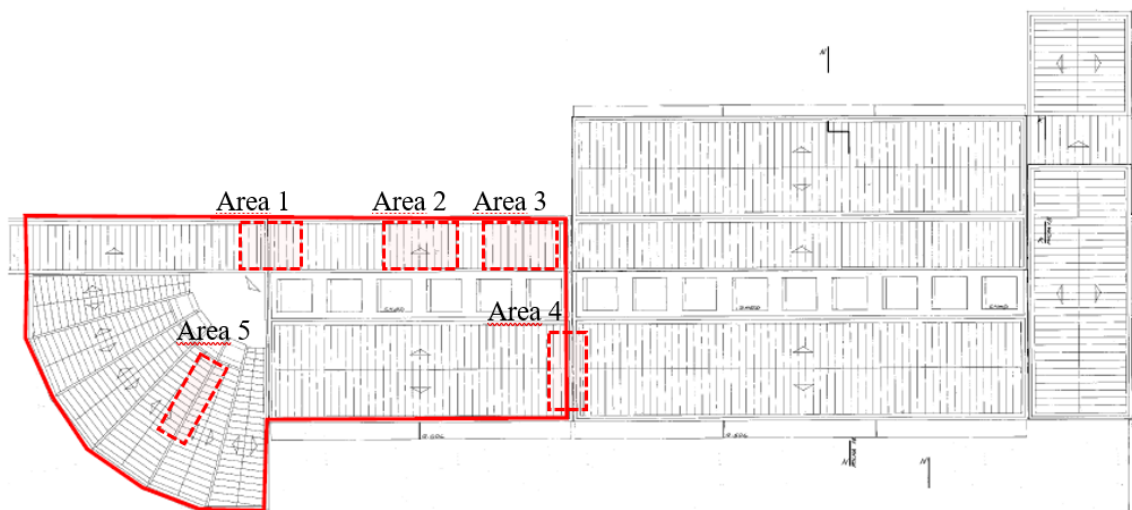
Based on the projects provided by the Oscar Niemeyer Planning Center (CEPLAN), the current Building C roofing system is highlighted in Figure 2, the Department of Civil and Environmental Engineering - ENC, and the focus areas represented.

Figure 2. Highlight in the site plan for the built area (Adapted from CEPLAN, 1973).

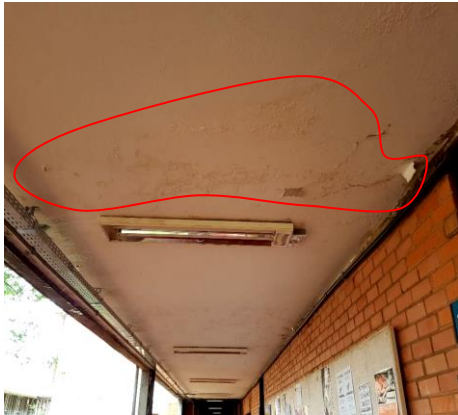
In the internal visit held on 10/30/2018 in the morning, after a rainy season, leaks were observed in the ceiling of the classroom corridor (area 1, 2 and 3), even after rain had ceased, as shown in Figure 3 and Figure 4. The gutters are multiple and are spread over a wide area of the ceiling.

Figure 3. Gutters in the ceiling of the hallway with mold, humidity stains, and peeling of the coating.

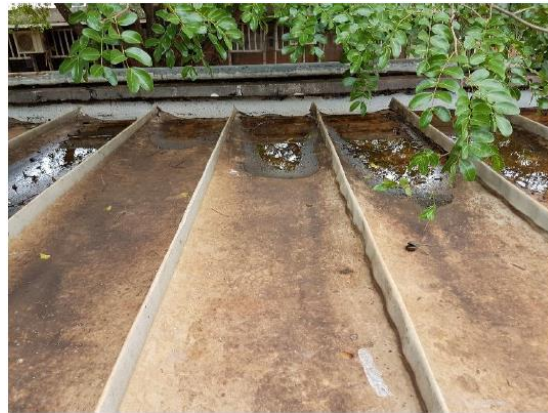
Figure 4. Deformed roof with water accumulation and debris.

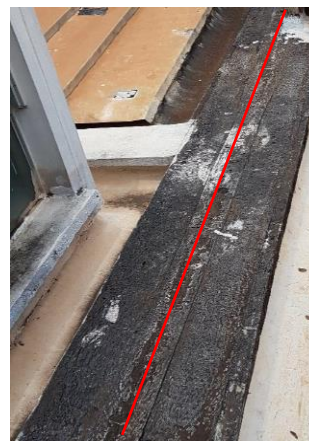
Figure 6. Structural joint without sealant

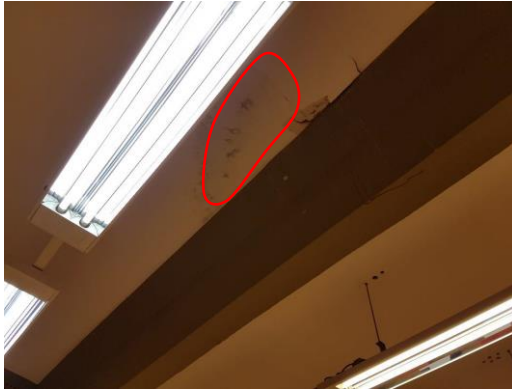
reported infiltrations. In the auditorium ceiling, it is possible to see marks of freshly dried gutters near a beam, including the puddles on the floor. Figure 7 and Figure 8 below illustrate such spots that indicate the water path and the formation of puddles.

Figure 7. Spotlight humidity on ceiling

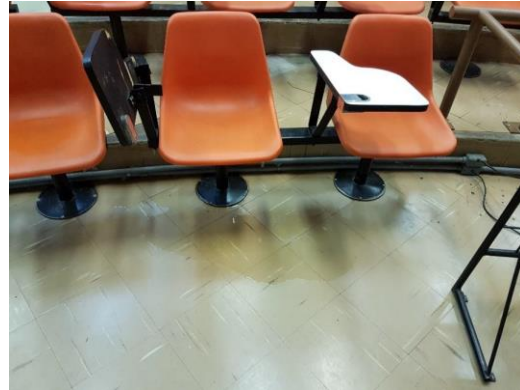
Figure 8. Water puddles formed by dripping

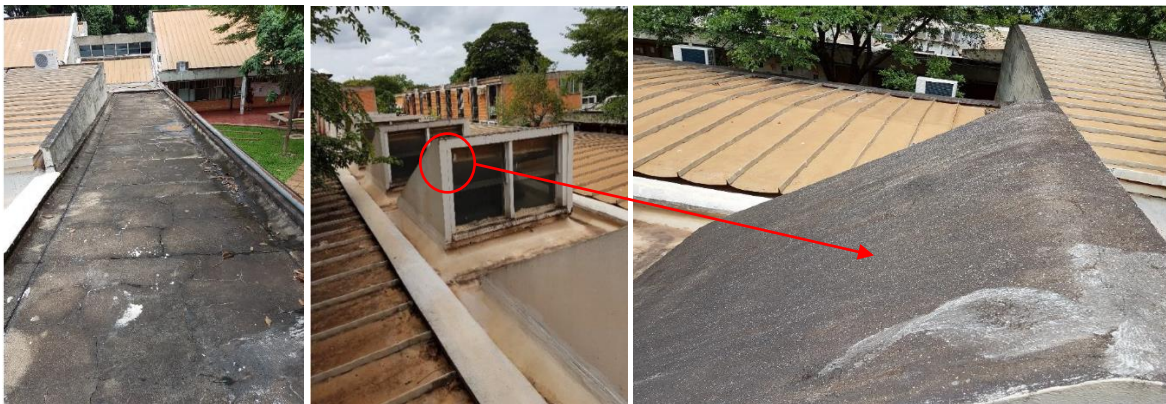
In the support structure, there are no signs that indicate waterproofing after the removal of the roof. Shrinkage cracks were found mostly throughout the slab and, in some places, there are small concrete disintegration. The joints along the length of the slab, as well as between the slabs and rails, are very degraded, with no sign of filler elements and sealant, with water accumulation.

Figure 9, Figure 10 and Figure 11. Support structure without roof/skylight.

The sheds and the covering of the auditorium entrance hall have no roof: they are made of solid waterproofed slabs, figure 9, figure 10 and figure 11. The sheds present in the roof are from a structural point of view. The performance of the roofing system elements is in good condition, with only fouled surface dirt.

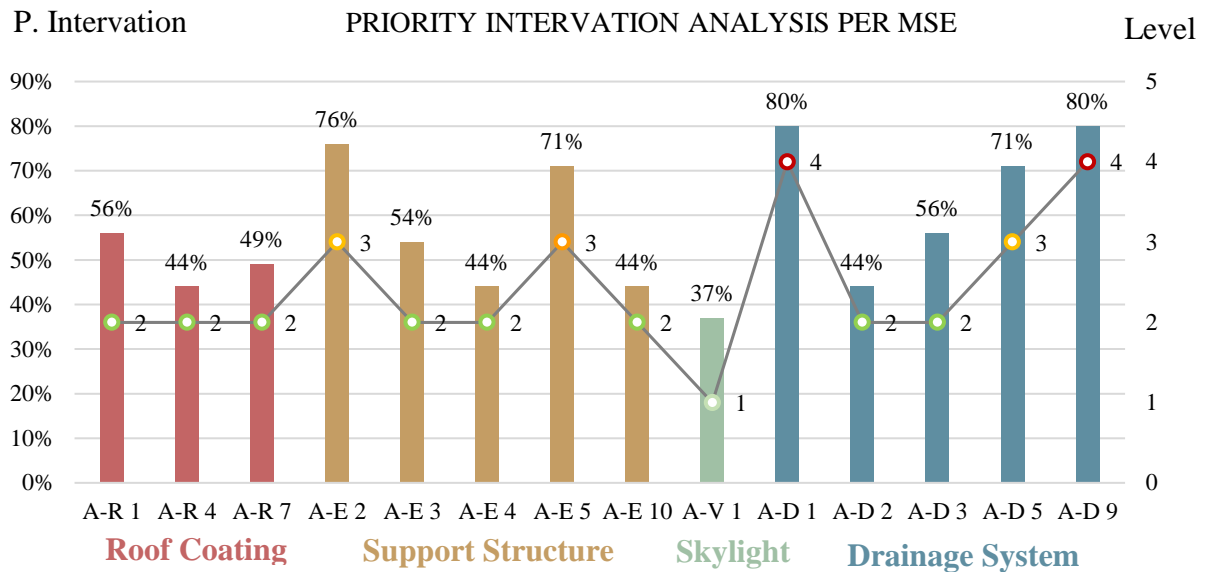
Figure 12. Intervention priority per MSE (Author, 2018).

It is noticed that the Support Structure and Drainage System obtained the highest Intervention Priority Levels. This means that for levels 3 and 4 found in the MSE resulted in an Intervention Priority in the range of 70% to 80%.

In addition to the tables and solutions presented, anomalies that obtained higher levels of intervention priority were also analyzed. Figure 12 shows the relative contribution of each anomaly to the total sample of anomalies detected in the flat cover and allows to measure the intervention priority level of the anomalies through the MSE.

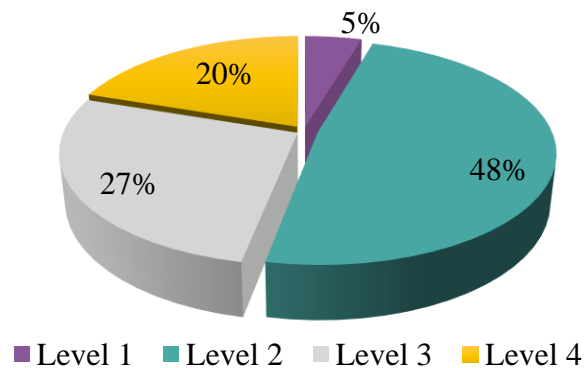
Figure 13. Distribution of priority intervention levels for detected anomalies (Author, 2018).

Figure 13 shows the distribution of intervention priority levels. It is worth noting that level 3 requires short-term actions, and concentrate a total of 27% of the anomalies, while for level 4, with an immediate priority action, a total of 20% was obtained. Thus, the priority intervention given at level 3 and level 4 corresponds to almost 50% of the total observed anomalies, concentrated in cracks, disintegration, surface dirt, and no-drain points.
