ICOMOS principles and contemporary additions: challenges to integrity in Venezuela's colonial heritage.

O. Ippolito Ojeda¹*

Cite as: Ippolito Ojeda, O. (2026), “*ICOMOS principles and contemporary additions: challenges to integrity in Venezuela's colonial heritage.*”, *Revista ALCONPAT*, 16 (2), pp. 307 – 328, DOI: <https://doi.org/10.21041/ra.v16i2.1016>

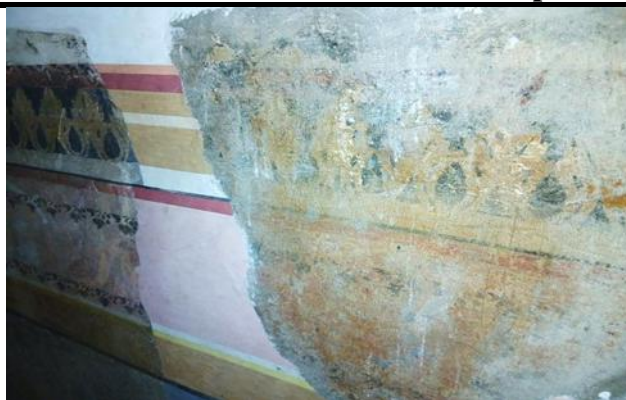
Table 1. Example of objective restoration

In the mural painting, the missing areas of the original fresco were filled only with horizontal lines without the rest of the ornaments. From a certain distance, the eye merges the missing part and it visually disappears, but from up close, the stroke of the reintegration is obvious, differentiating it from the original. The aesthetic reading is restored without falling into falsification and respecting the historical instance of the loss.
Photo of the Casa de la Estrella Museum.

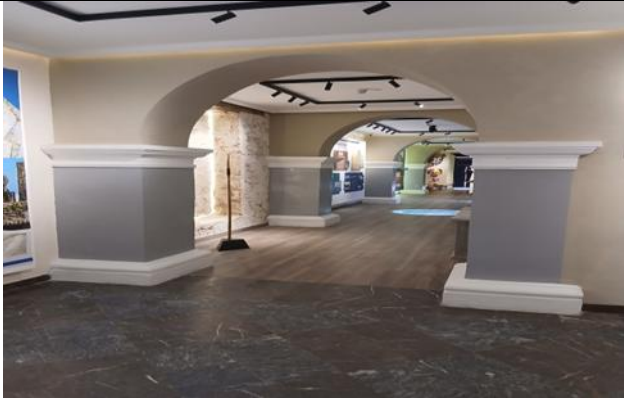
Table 2. Example of architectural forgeries

<p>Ceramic flooring in a colonial building is a historical forgery because it introduces a material and an aesthetic completely foreign to the period and construction techniques, threatening the original integrity of the building. The opening of areas that were previously closed is an architectural forgery because it is an alteration of the form and the constructive essence.</p> <p style="text-align: right;">Photo of the Puerto Cabello Museum.</p>
Source: author's archive (2025).

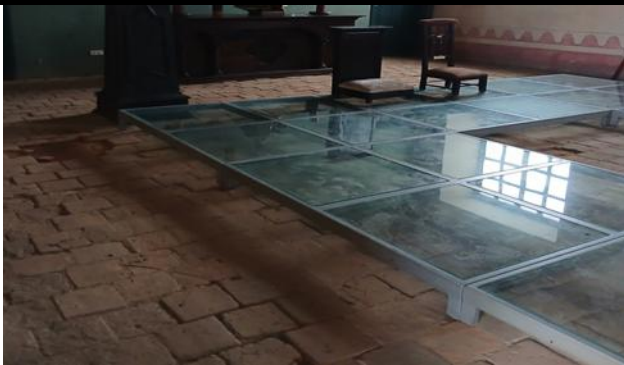
Table 3. Example of an easily distinguishable and reversible addition

<p>To protect the original slab from deterioration, a glass walkway with a platform-type steel structure was added for visitor traffic, which can be easily dismantled and relocated at any time. The principles of authenticity, integrity, and minimal intervention were maintained, and the use of forgeries is avoided.</p> <p style="text-align: right;">Photo of the Casa de la Estrella Museum.</p>
Source: author's archive (2025).

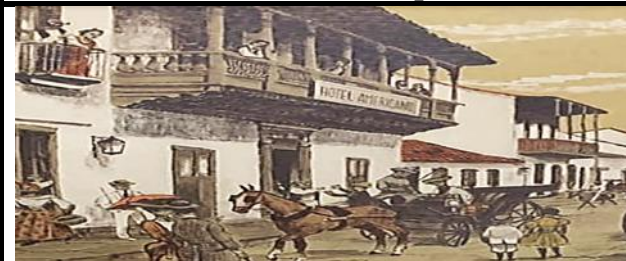
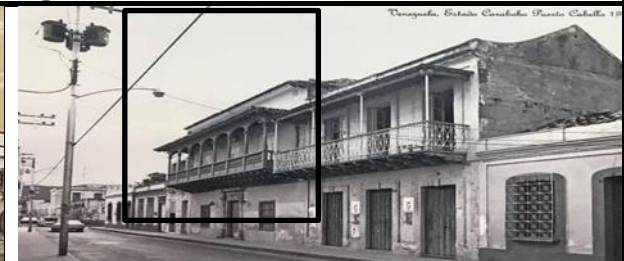
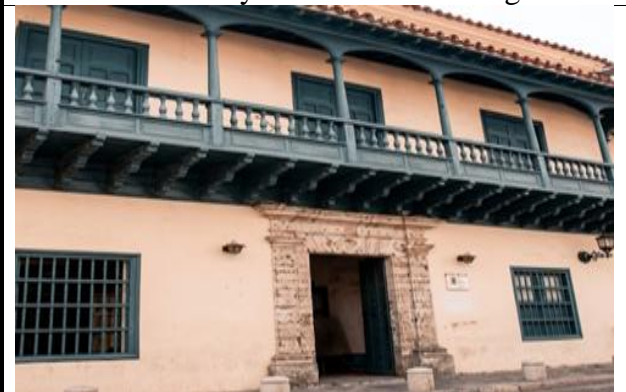
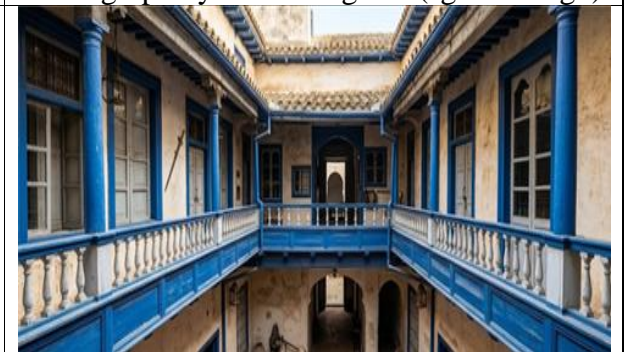
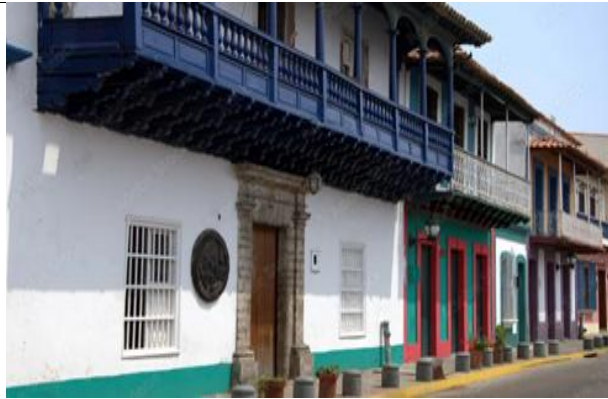
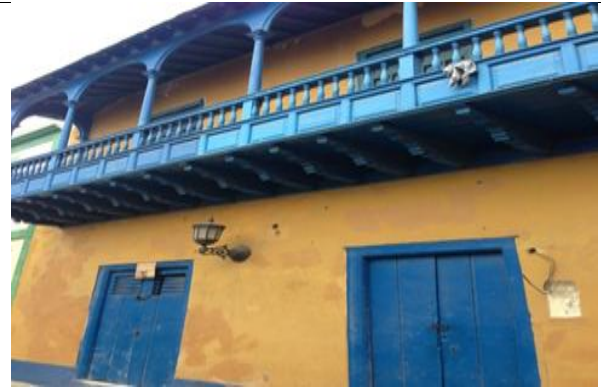
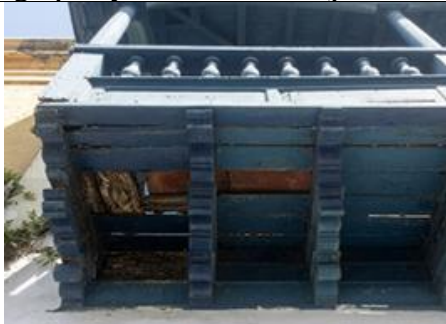
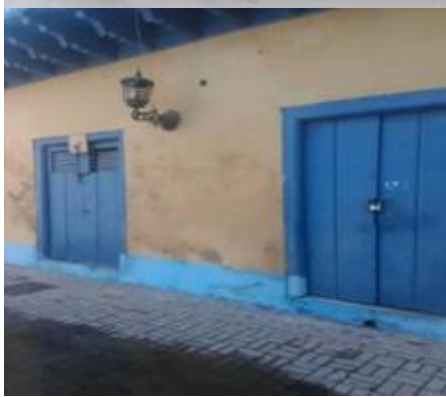
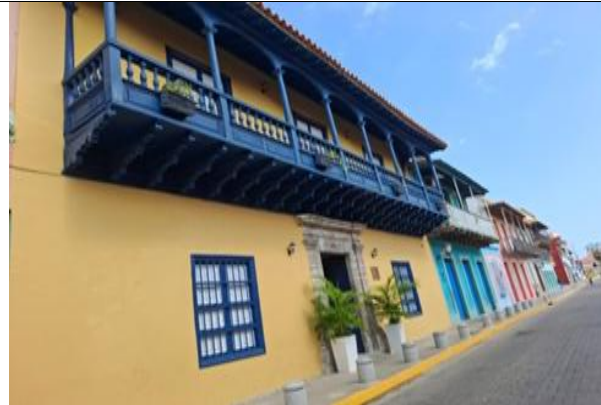
Table 7. Historical compilation of the image of the Museum of Puerto Cabello

- **Evidenced deterioration:** It suffered a period of deterioration due to lack of maintenance and the change of ownership between government entities, a situation denounced by the academy of history of Carabobo State. Information supported by the archives of El Carabobeño newspaper, June 28, 2021 edition.
- **Current ownership:** It passed into the hands of the government of Carabobo State.

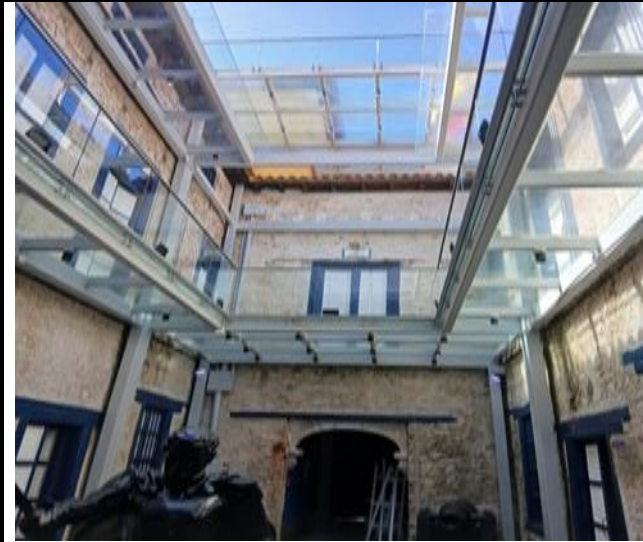
Table 8. Photographic analysis

<p>Steel and glass walkway replacing the original wooden corridor. 3 violated principles: minimal intervention, authenticity, material compatibility.</p>

- **Violation of material compatibility:** the use of contemporary materials (steel, glass, porcelain tile, vinyl) as structural substitution alters historical materiality and violates the principle of technical compatibility. The ICOMOS principle for structures requires that consolidation materials be physically and chemically compatible with the materials of the original structure. The installation of rigid and modern elements in soft colonial masonry structures can introduce stresses, disparate expansions, and long-term pathologies, compromising the functional character of the architectural building.

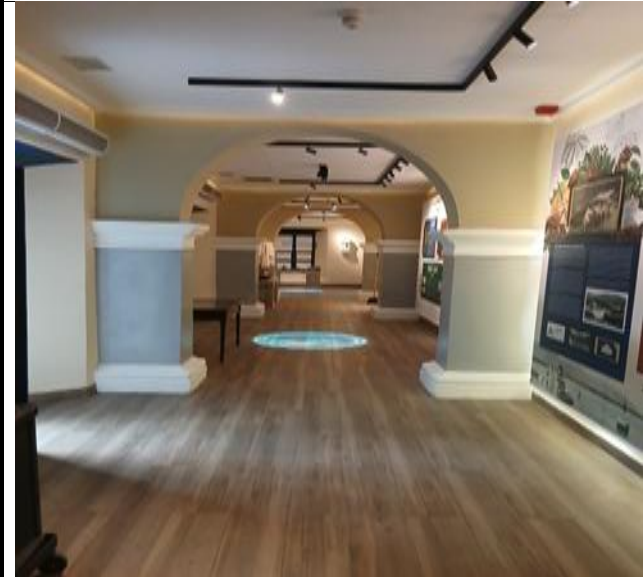
<p>Total covering of the original ground floor with ceramic material without leaving evidence of temporal witnesses. 5 violated principles: minimal intervention, reversibility, authenticity, material compatibility, avoidance of historical forgery.</p>

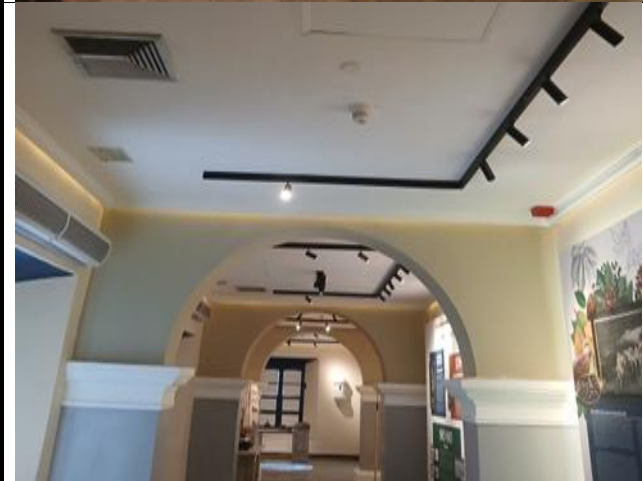
<p>Covering of original walls and ceilings with modern materials without leaving evidence of temporal witnesses. 6 violated principles: minimal intervention, authenticity, integrity, material compatibility, avoidance of historical and architectural forgery.</p>
