ICOMOS principles and contemporary additions: challenges to integrity in Venezuela's colonial heritage.

Table 1. Example of objective restoration

Table 8. Photographic analysis

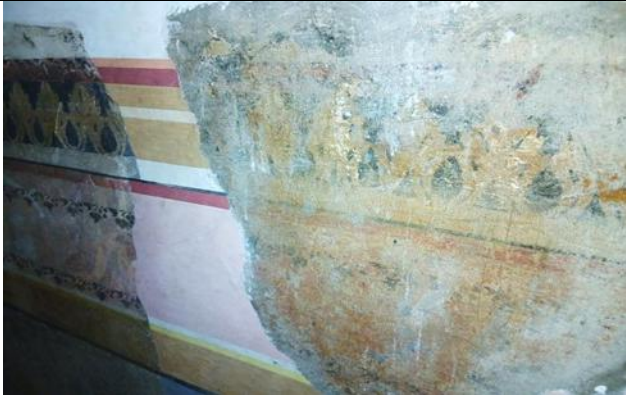
<p>In the mural painting, the missing areas of the original fresco were filled only with horizontal lines without the rest of the ornaments. From a certain distance, the eye merges the missing part and it visually disappears, but from up close, the stroke of the reintegration is obvious, differentiating it from the original. The aesthetic reading is restored without falling into falsification and respecting the historical instance of the loss. Photo of the Casa de la Estrella Museum.</p>
<p>Source: author's archive (2025).</p>

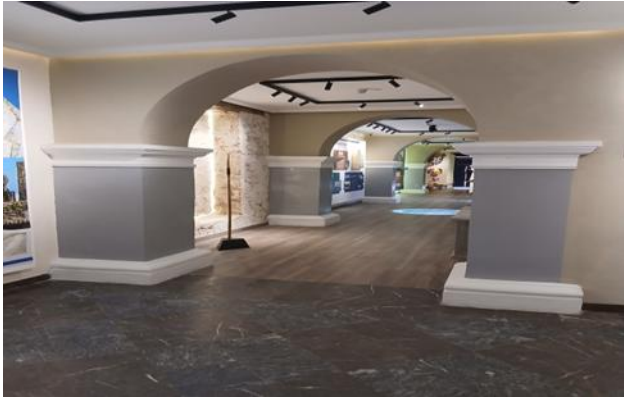
Table 2. Example of architectural forgeries

<p>Ceramic flooring in a colonial building is a historical forgery because it introduces a material and an aesthetic completely foreign to the period and construction techniques, threatening the original integrity of the building. The opening of areas that were previously closed is an architectural forgery because it is an alteration of the form and the constructive essence.</p> <p>Photo of the Puerto Cabello Museum.</p>
<p>Source: author's archive (2025).</p>

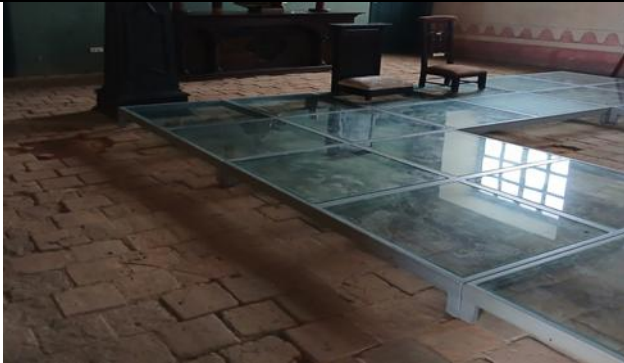
Table 3. Example of an easily distinguishable and reversible addition

<p>To protect the original slab from deterioration, a glass walkway with a platform-type steel structure was added for visitor traffic, which can be easily dismantled and relocated at any time. The principles of authenticity, integrity, and minimal intervention were maintained, and the use of forgeries is avoided.</p> <p>Photo of the Casa de la Estrella Museum.</p>
<p>Source: author's archive (2025).</p>

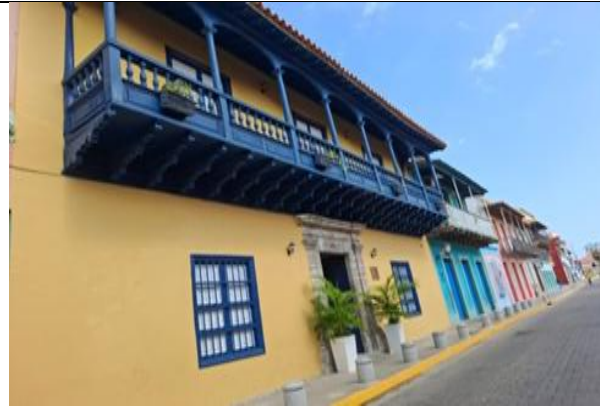
Year 2025

- **Evidenced deterioration:** It suffered a period of deterioration due to lack of maintenance and the change of ownership between government entities, a situation denounced by the academy of history of Carabobo State. Information supported by the archives of El Carabobeño newspaper, June 28, 2021 edition.
- **Current ownership:** It passed into the hands of the government of Carabobo State.

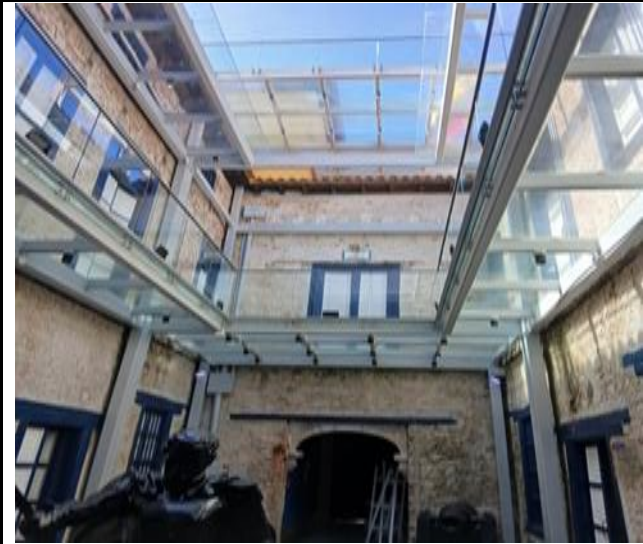
<p>Steel and glass walkway replacing the original wooden corridor. 3 violated principles: minimal intervention, authenticity, material compatibility.</p>

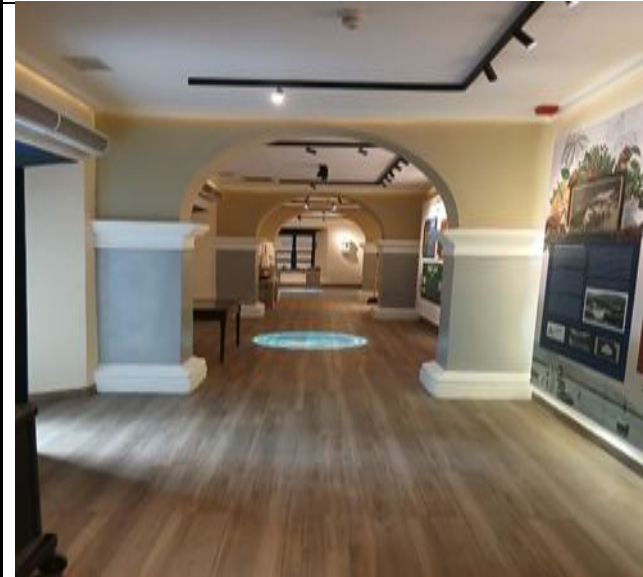
<p>Total covering of the original ground floor with ceramic material without leaving evidence of temporal witnesses. 5 violated principles: minimal intervention, reversibility, authenticity, material compatibility, avoidance of historical forgery.</p>

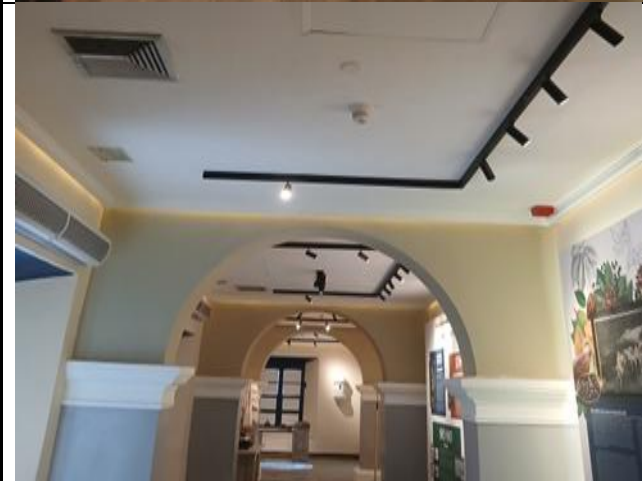
<p>Covering of original walls and ceilings with modern materials without leaving evidence of temporal witnesses. 6 violated principles: minimal intervention, authenticity, integrity, material compatibility, avoidance of historical and architectural forgery.</p>
