# Revista ALCNPAT

Journal of the Latin-American Association of Quality Control, Pathology and Recovery of Construction

Volume 6

Issue 2

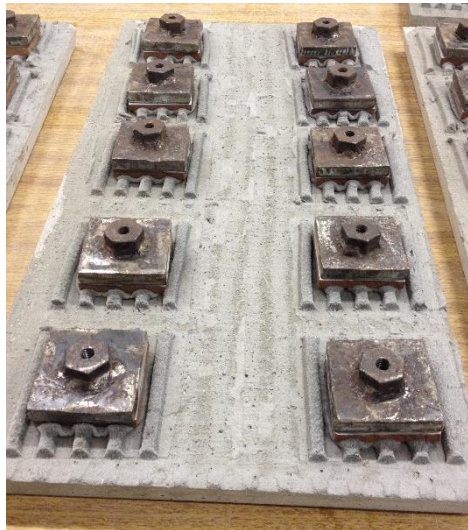
Figure 4. Metallic pieces attached on the ceramic tiles adhered to the substrate-pattern.

Following the setting of the ceramic tiles with the use of the mortar on the substrate-pattern, the sets were subjected to three curing conditions. In normal curing (N) the sets remained for 28 days in laboratory environmental conditions (a temperature of  $23 \pm 2^\circ\text{C}$  and a relative humidity of  $60 \pm 5\%$ ), in accordance to the specifications of the NBR 14.081-2 (ABNT, 2012). In curing with water immersion (IA) the sets were subjected to laboratory conditions for seven days, subsequently they were immersed in water at  $(23 \pm 2)^\circ\text{C}$ , where they remained for twenty days. In curing with stove heating (AE) the sets were subjected to normal curing in a laboratory environment for 14 days, after which they were placed in a stove with forced ventilation at a temperature of  $(70 \pm 2)^\circ\text{C}$  until the age of 28 days. The adherence resistance to traction test was carried out per the NBR 14.081-4 (ABNT, 2012), as can be observed in Figure 4. Ten tests were carried out in each substrate, evaluating the adherence resistance to traction and the extension of the adherence, following the curing period of the sets. The tests were carried out following the specifications of the NBR 14.081-4 (ABNT, 2012), using Dinatest brand equipment, model DS2-DPU-1100, with a maximum capacity of 5000N.

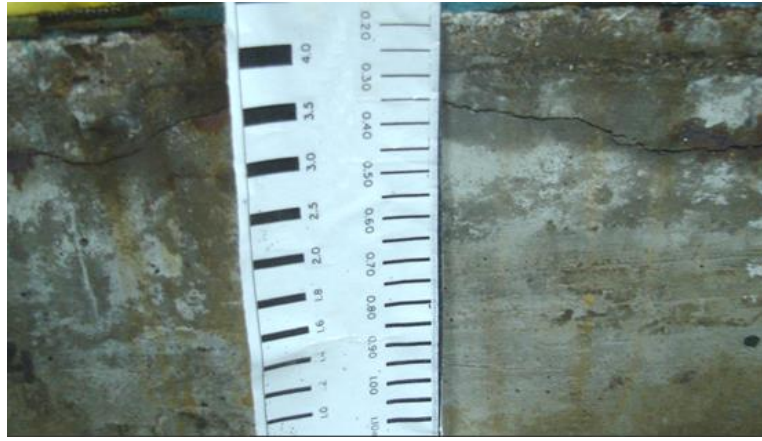
Figure 2. Measurement of the width of a crack generated by accelerated corrosion.

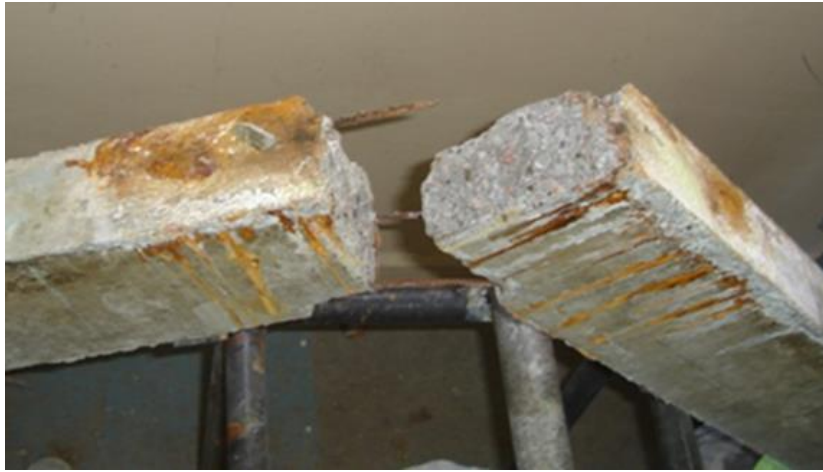
Figure 4. Beam V96 after collapse

It is worth noting that while the test was prolonged for approximately 160 days, when reaching 140 days, beam V96 reached the point of collapse (Figure 4) due to a significant reduction of the cross-section of its reinforcement, produced by the depth of the pitting caused by the corrosion. Whereas beam V100 broke at 160 days, at which time the tests were finalized. This indicates that the corrosive process as is known, affects the residual life of the structural element affected, but that pitting, in particular, can decrease it even more.

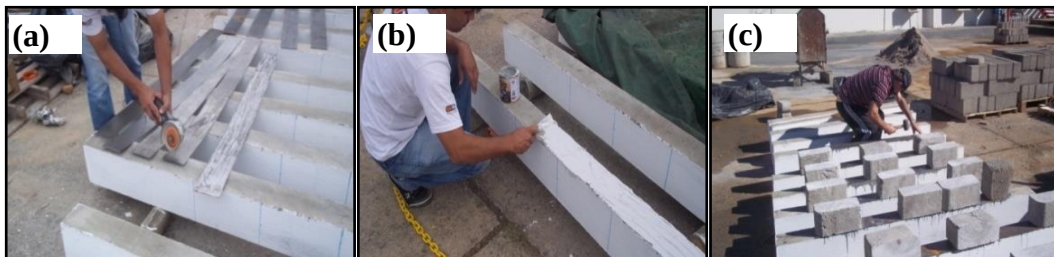
Figure 3. (a) Preparation of the sheets; (b) Application of the epoxy structural adhesive; (c) Fixing and support of the sheets.
