## Inspection of facades with Unmanned Aerial Vehicles (UAV): an exploratory study

The objective of this study was to evaluate the use of Unmanned Aerial Vehicles (UAVs) as a visual tool for the inspection of pathological manifestations in facades, through an exploratory study. Currently, the relevance of UAVs is growing as a new mechanism for obtaining data and visual inspection of buildings, optimizing time. The research strategy had three distinct steps: a literature review, an experimental procedure, and data processing, aiming to verify the viability of the inspection procedure. There is evidence of the convenience of UAV use, particularly where access is difficult, which reduces time and cost, generates greater security, and allows 3D reconstruction of the building under inspection, generating more accurate diagnoses.

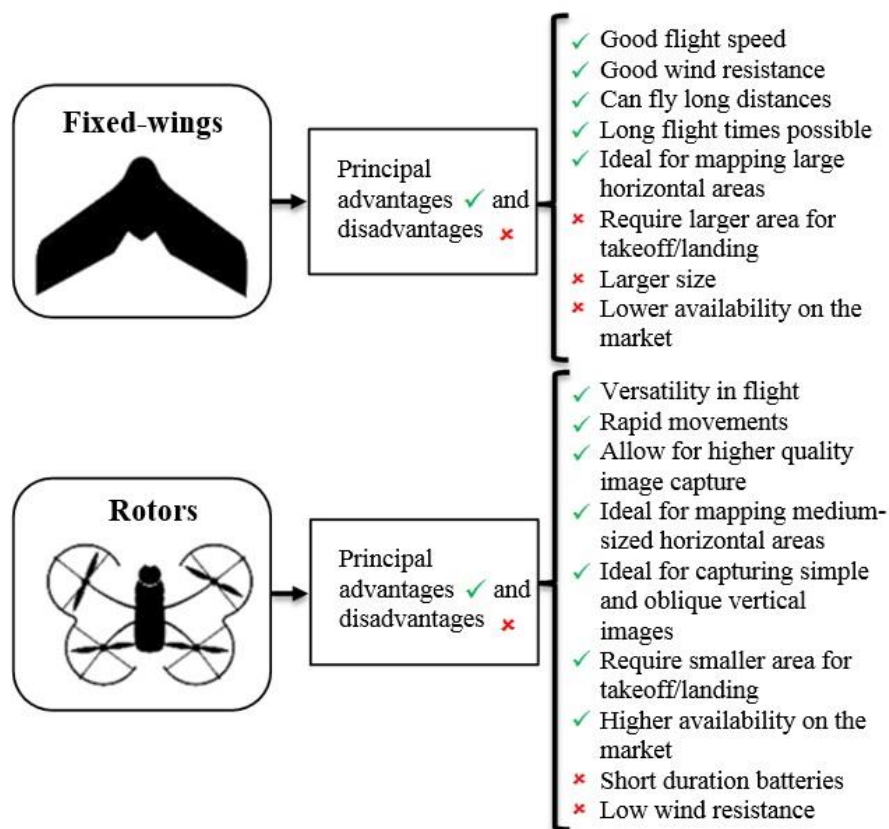
Figure 1. Advantages and disadvantages of UAVs depending on wing type.

Similarly, the versatility of this aircraft allows it to move on all possible axes, being effective in capturing simple vertical and oblique vertical images as shown in the case studies of Mader et al. (2016), Morgenthal and Hallermann (2015), and Reagan et al. (2018) in the detection of specific surfaces or elements, making it a useful tool for the visual inspection of vertical facades or, as in the case of Irizarry and Costa (2016), a visual tool for construction site management. Figure 1 presents the summary of the main advantages and disadvantages of vehicles with fixed and rotating wings.

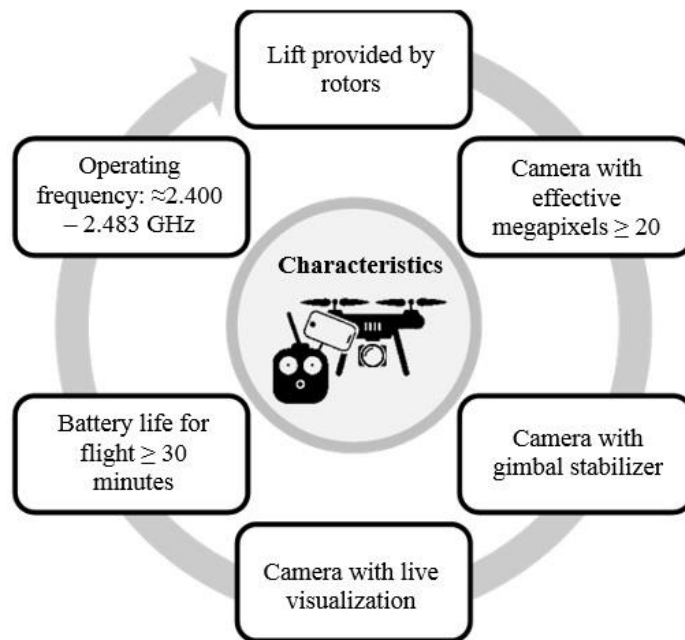
Figure 2. Minimum equipment characteristics for visual inspection of facades.

These vehicles are also usually simple to fly, supported by a set of engines controlled by a sophisticated electronic system that generally guarantees the aircraft's stability, allowing for vertical takeoff and landing. They are therefore the preferred choice for carrying cameras and other objects for short distances from the takeoff point. Figure 2 shows the minimum suggested equipment characteristics for the purpose of visual inspection of facades.

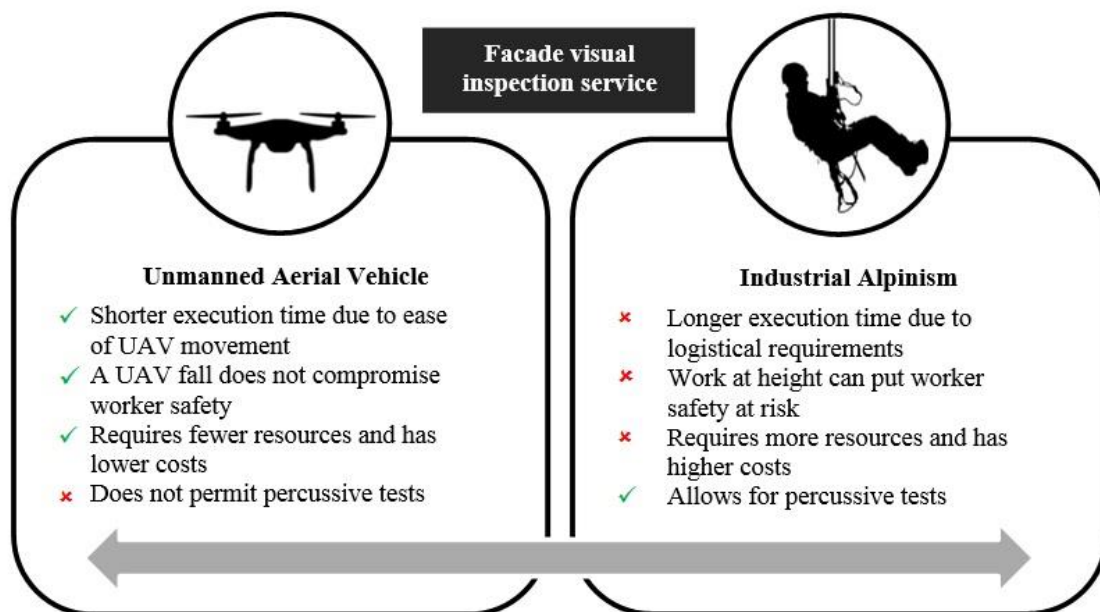
Figure 3. Comparison of visual façade inspection procedures.

In recent years, there has been an increase in the use of UAVs for inspection of structures, specifically buildings, due to their long range, area photogrammetry applications, efficient data recording, speed, security, and low cost, among others reasons (Izarry and Costa, 2016; Shariq and Hughes, 2020; Groso et al., 2020). In Figure 3, the advantages reported in the bibliographic review for the use of UAVs are compared to one of the most used traditional methods, industrial climbing.

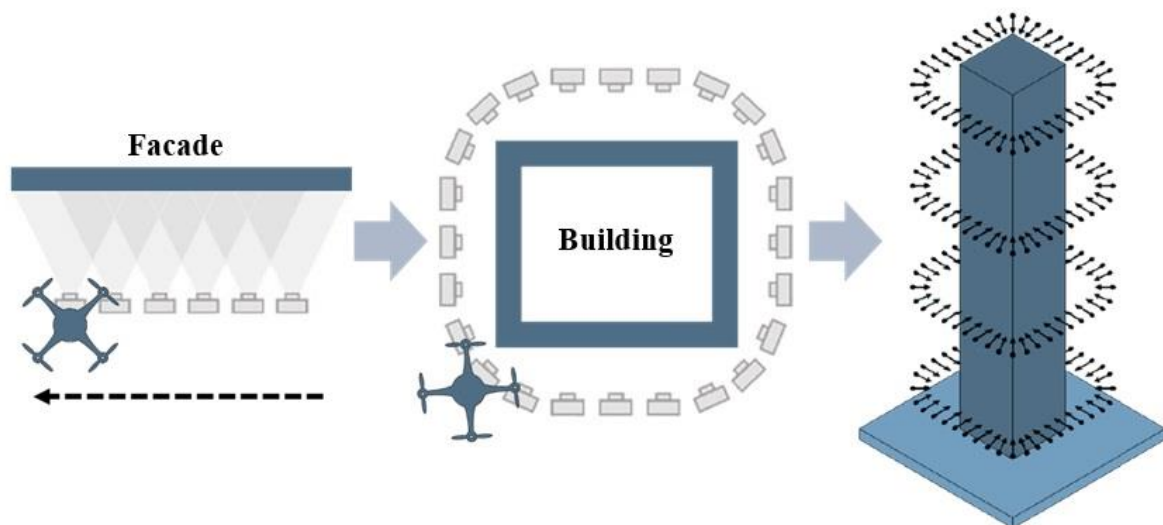
Figure 5. Image capture strategy. Adapted from Melo Jr (2016).

The data capture strategy followed the basic concepts of digital photogrammetry, seeking parallelism among photo positions and perpendicularity to the plane of the object of interest, as shown in Figure 5, and for each part of the object to be photographed from at least two different positions, guaranteeing image overlap (Groetelaars, 2015). These aspects are important for the correlations required to construct orthomosaics or three-dimensional reconstructions.

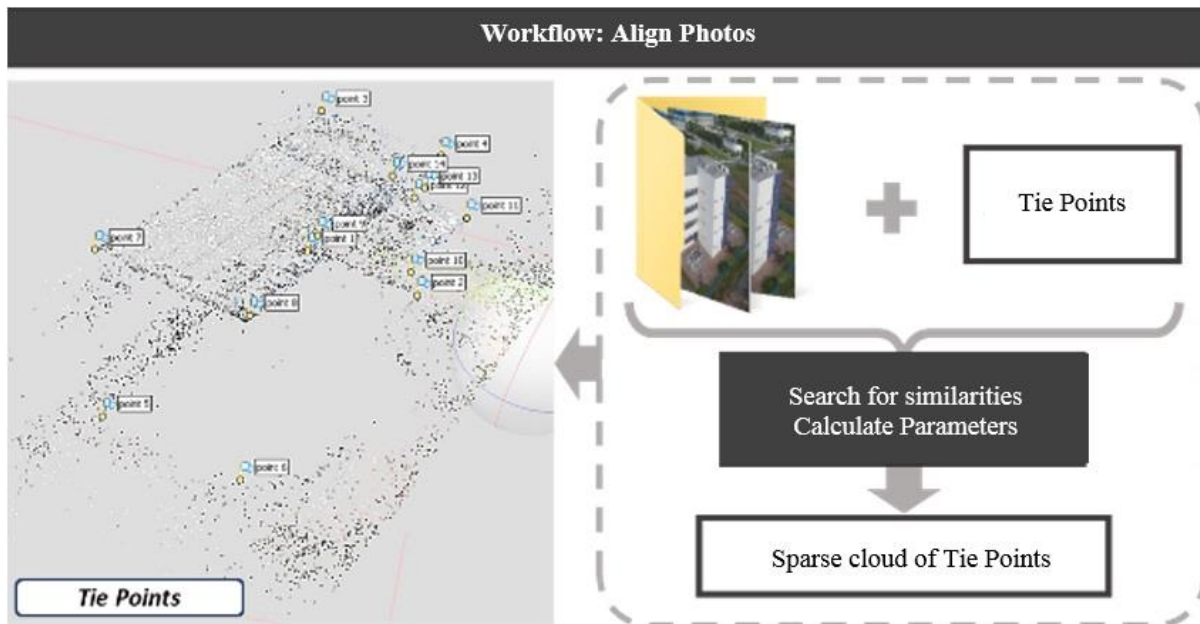
Figure 6. Cloud of tie points for IIT-UPE

The first step consisted of the alignment of the images (align photos), in which Agisoft PhotoScan seeks similarities between the images. The result is the generation of a cloud of tie points, the basic product for the generation of the densified point cloud and 3D models, as well as the connection point between the orthophotos in the mosaic process and the generation of the orthophoto mosaic. In this step, support points were also collected in the field to improve positional accuracy of the point cloud, followed by the elimination of unwanted points or noise, such as: poorly captured surfaces, areas belonging to other objects, and distant points. The final result from this step was the model shown in Figure 6, a sparse or low-density point cloud, which also defines the building's geometry.

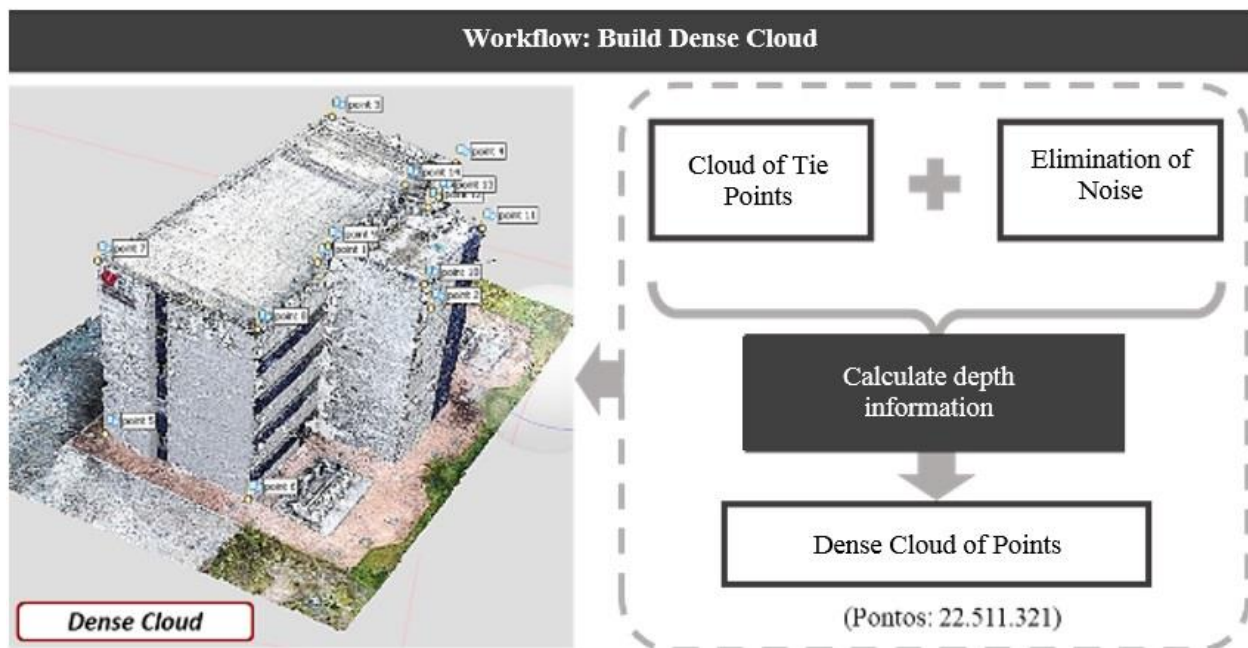
Figure 7. Densified point cloud for IIT-UPE

In the second step, the dense cloud of 3D points was built by filtering unwanted points or noise. From the estimated camera positions, the software calculates depth information for each camera to be combined at a single point in the dense cloud.

The highest level was chosen for the densification configuration, generating more than 22 million points. The main function of this step is to densify the point cloud generated in the previous process, increasing the number of points in the point cloud and reducing the empty spaces to better represent the mapped area. The model generated in this step is shown in Figure 7, with most of the geometric details of the building digitally reconstructed.

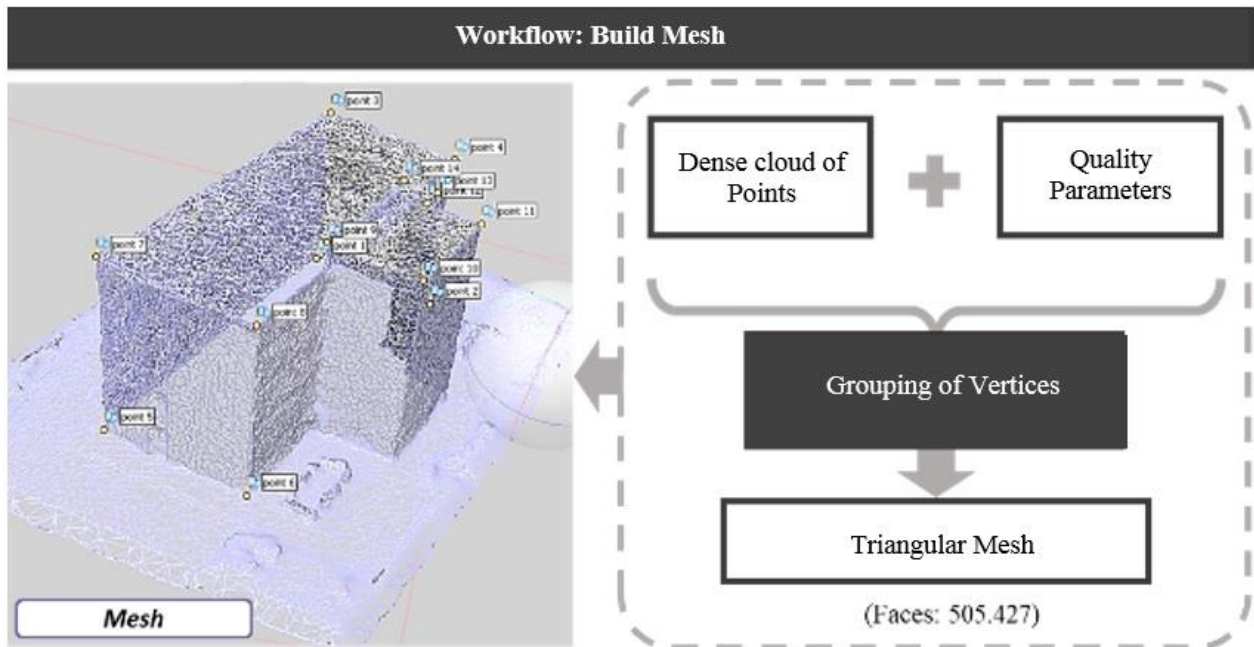
Figure 8. Triangular mesh model of IIT-UPE

In the third step, the mesh was built, generated from the grouping of vertices from the dense point cloud. The 3D model generated in this step is shown in Figure 8, with more than 500,000 faces (or adjacent polygons) sharing edges of the object's boundary surface.

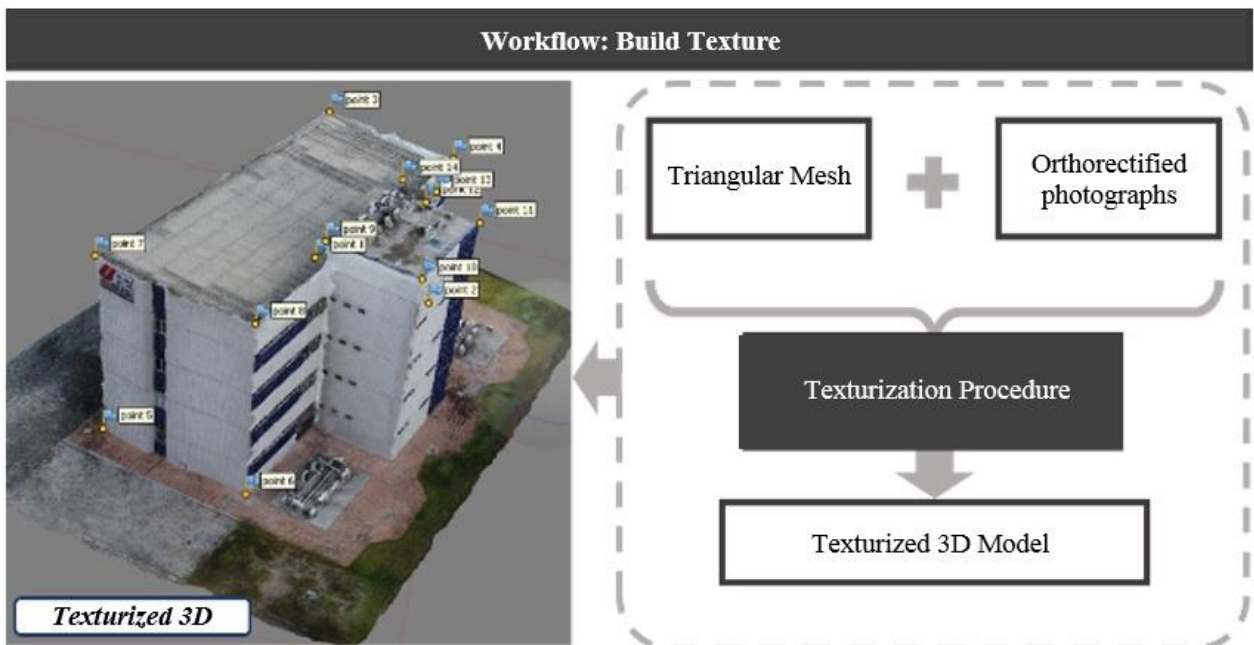
Figure 9. Texturized model of IIT-UPE

In the fourth step, the goal is to apply a texture to the three-dimensional model to improve its visual aspect, in order to allow visualization of the pathologies on the facade. The textured 3D model generated in this step is shown in Figure 9.

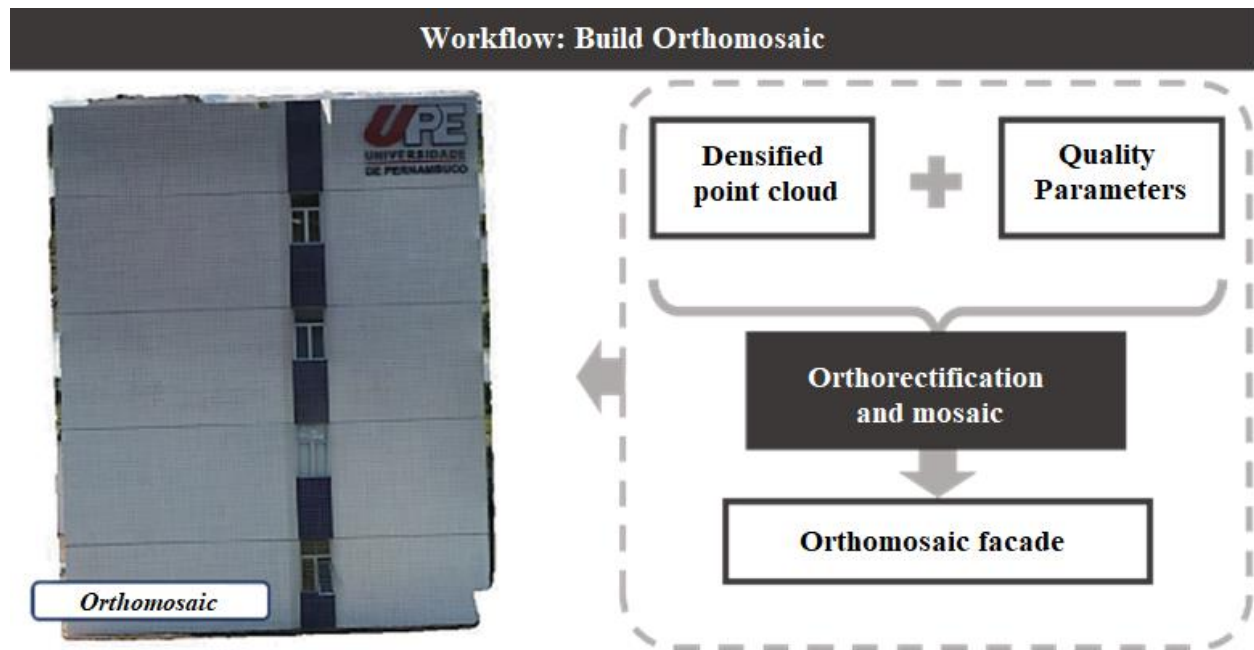
Figure 10. Orthomosaic model of IIT-UPE south Orthomosaic facade

The Agisoft PhotoScan software allows orthomosaics to be exported from previously generated models. For example, Figure 10 shows the orthomosaic corresponding to the south facade of the IIT building.

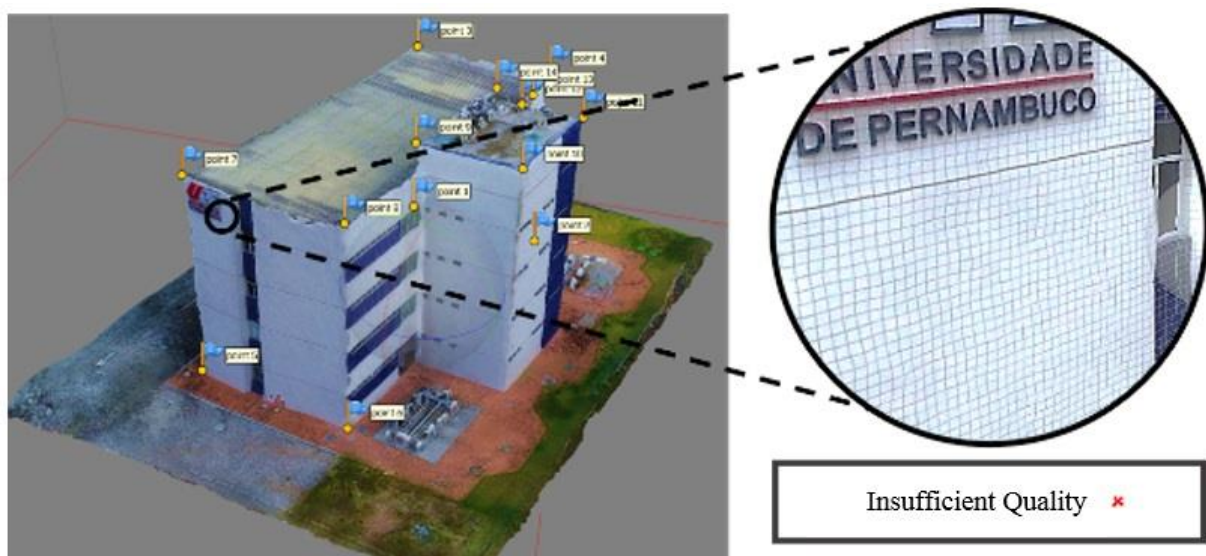
Figure 11. Final product – IIT-UPE 3D texturized model

The final product of these processing steps was the 3D digital model shown in Figure 11. A satisfactory result in terms of geometric reconstruction is exportable in various formats for various uses, according to the desired application.

However, the quality of this model is insufficient for the purpose of detecting pathologies on the facade, due to distortions on the texturized facades.

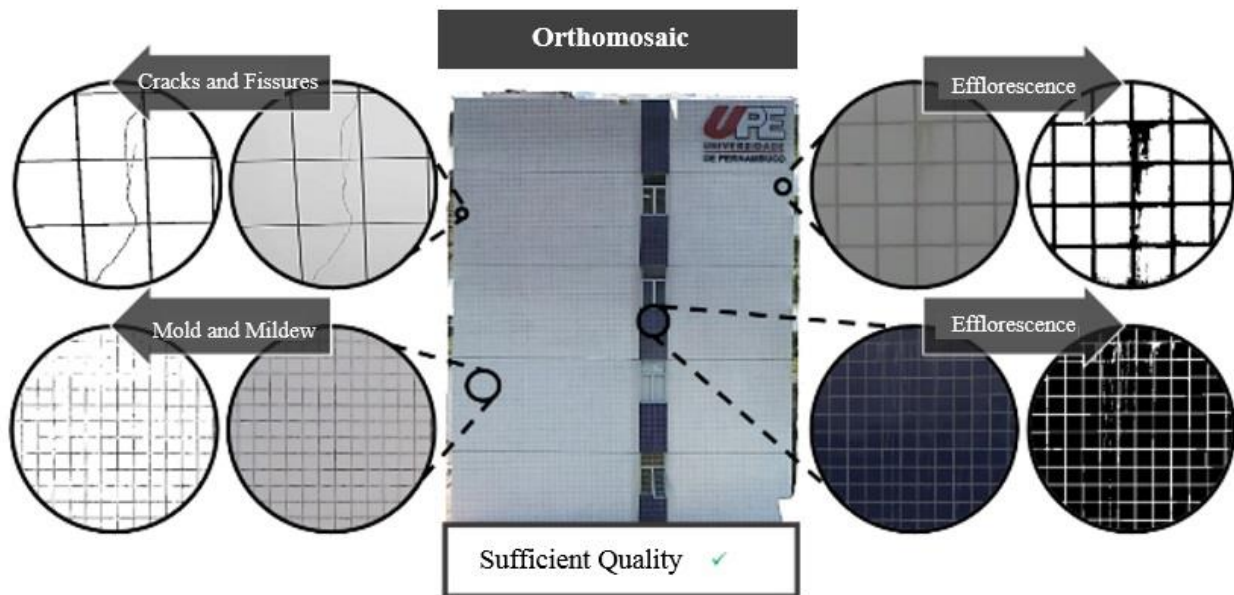
Figure 12. Detection of pathological manifestation on the south facade of IIT-UPE

This is shown in Figure 12, in which the orthomosaic of the south facade made possible to discover cracking in the ceramic coating, the beginning of efflorescence, and pathologies resulting from biological processes (mold and mildew).
